HISTORIC BUILDING ASSESSMENT

**RUNKINS FARM
LANGHAM ROAD
BOXTED
CO4 5HZ**

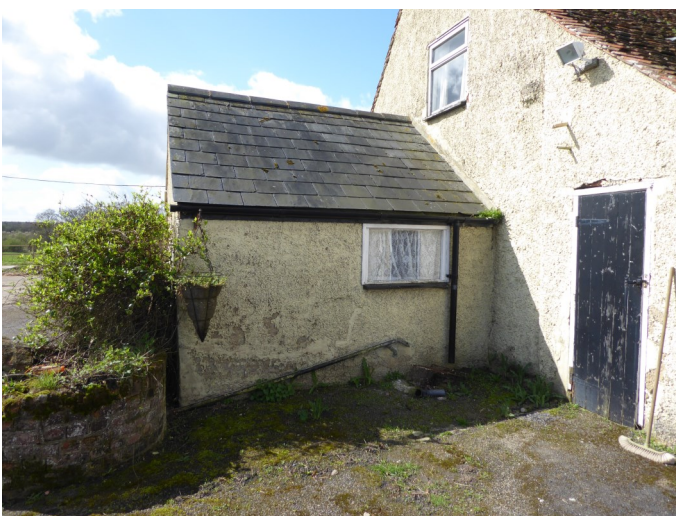
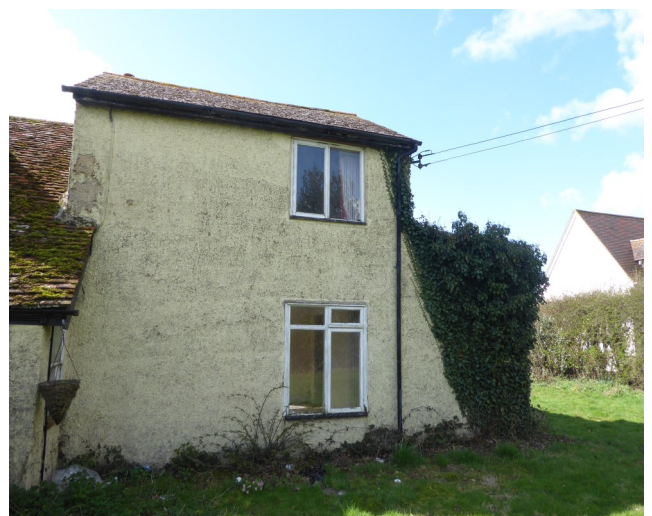
The two extensions have been added to each side of the original property. Both have solid brick walls most probably built using Flemish bond, all external surfaces have a pebbledash render coating. The roofs are double pitched with a timber framework; there is no access to the right side roof structure but the left side roof can be seen to have been formed using machine sawn 100x50mm timbers as a traditional cut roof. This roof has a slate covering; the two storey extension to the right has a composite tile covering which is likely to be asbestos based. Windows are modern timber casement opening with single glazing. The ground floor is solid concrete, ceilings are modern plasterboard and the first floor is suspended timber with modern machine sawn floor boards which has active infestation of wood boring insect.

My assessment of both these extensions is they have no historic value whatever.

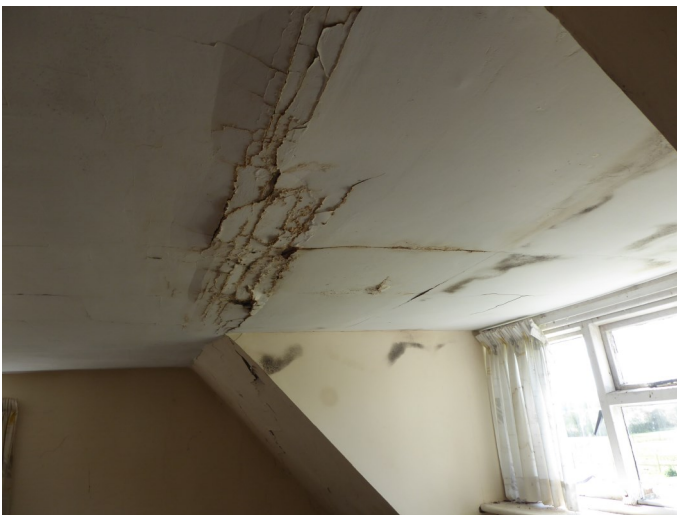
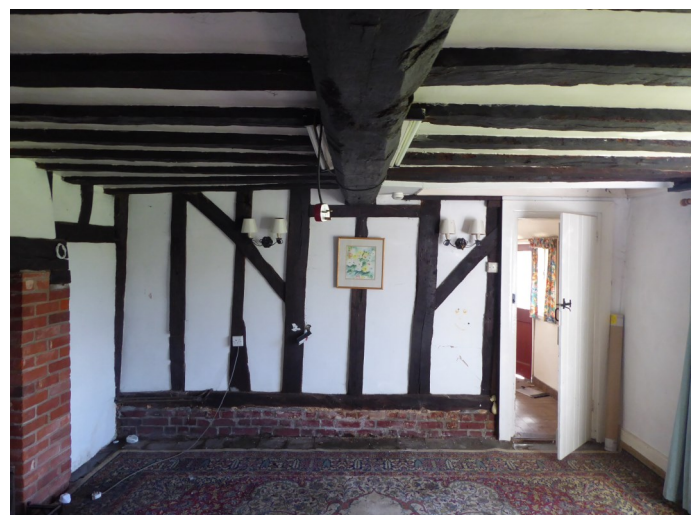
First floor ceilings have deteriorated to such an extent that they are considered to be past economic repair. Water damage and general ageing have contributed to their poor condition.

Whist old timbers remain in place at ground floor; the infill between beams is modern plasterboard which has no historic value.

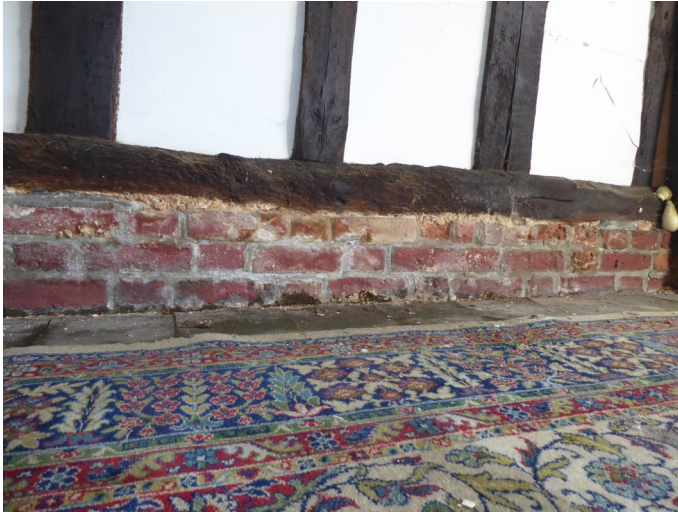
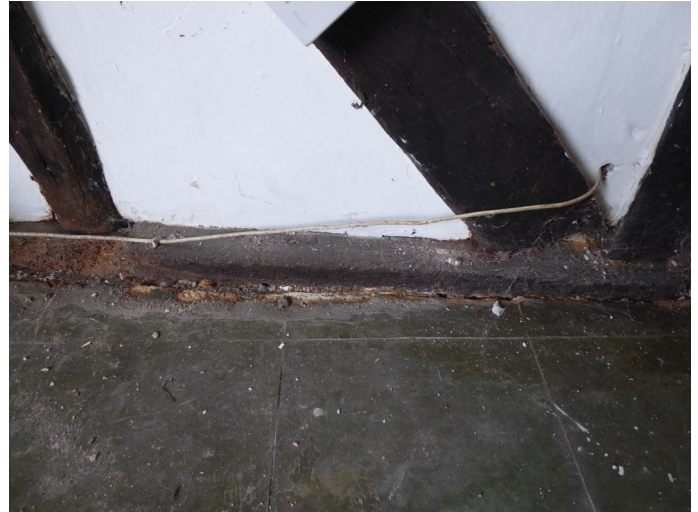
The ground floor is covered with lino tiles which could have asbestos content. Perimeter edges of the floor have risen and contorted which can be attributed to long term moisture damage. I would fully expect that certainly the edges of the floor and probably all the floor have deteriorated to such an extent as to require full renewal.

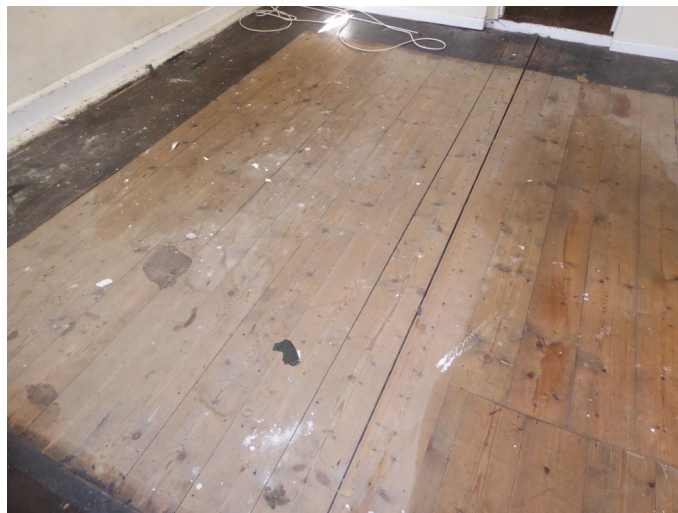
The first floor is suspended timber. Floor joist ends are supported by perimeter walls and by a large central beam spanning between walls. The original floorboards have been replaced with modern tongue and groove with no historical value.

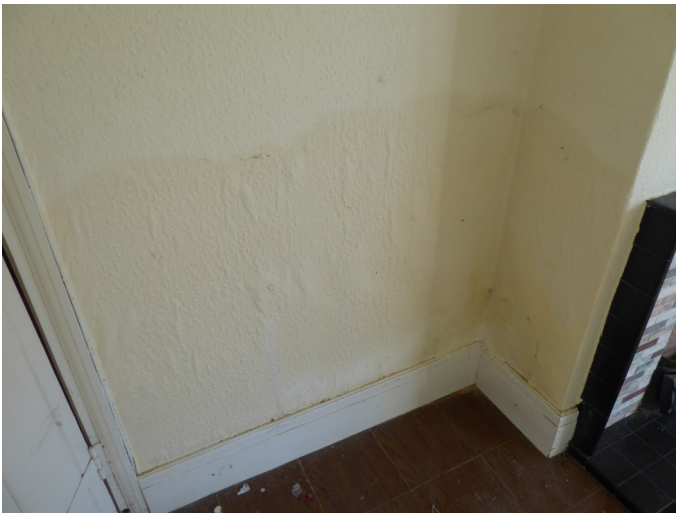
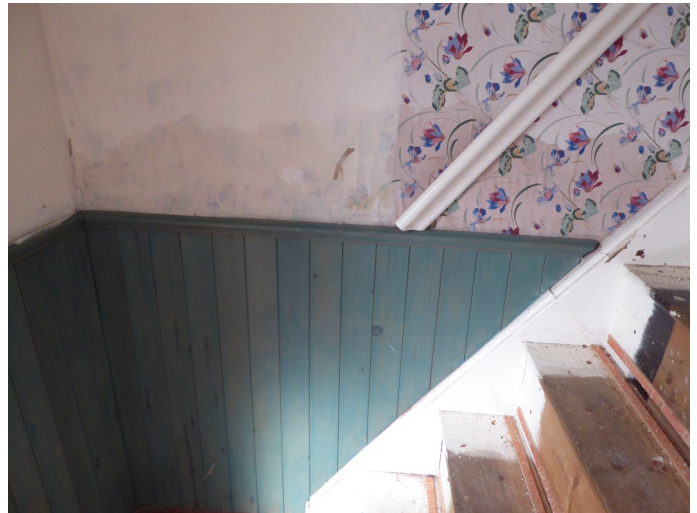
There are numerous cracks in masonry walls all of which have been filled. These cracks materialise internally indicating a past problem with movement in the ground. There is a relatively fresh crack in the front wall indicating a possible current problem with movement.

There is a serious problem with moisture within the masonry walls which is probably caused by rising moisture from the ground. The line of the moisture is 1.2m high and affects the whole of the right side wall

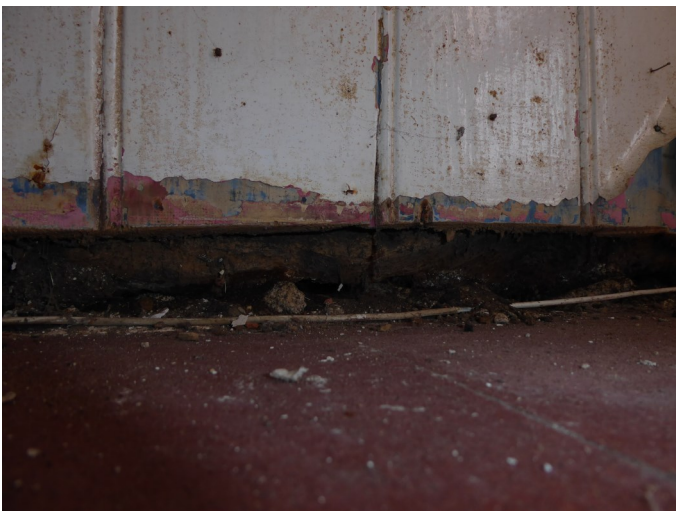
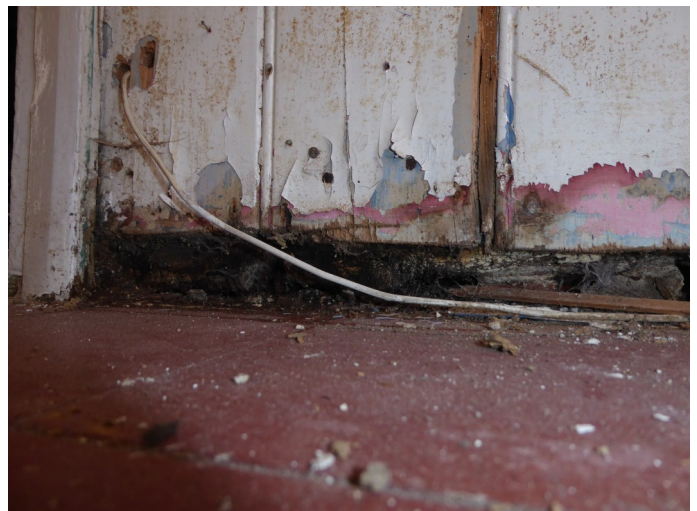
The timber frame walls are supported by low level brick plinths on which sit timber sole plates. The brick walls are saturated and the undersides of the sole plates have been badly affected by moisture. Fungal spores can be seen growing from the affected wood. I would estimate that as much as 60% of the soleplates have rotted away as a result of prolonged contact with water.

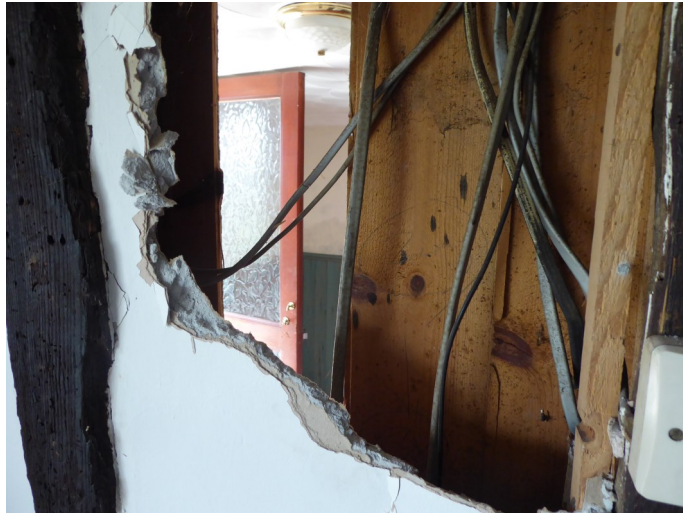
The timber frame walls are the only part of the property that are likely to date back to time of construction however; the soleplates which are an integral supporting part of the framework have deteriorated beyond economic repair.

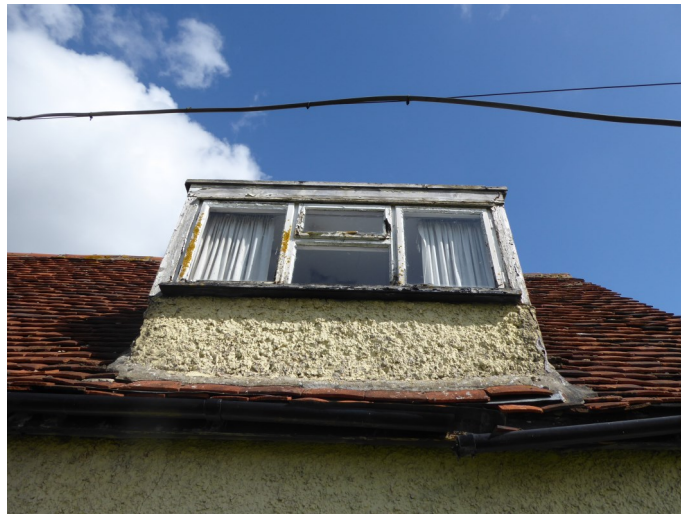
A dormer window has been added to the rear section of the roof. This is modern construction and modern materials have been used; there is no historic value.

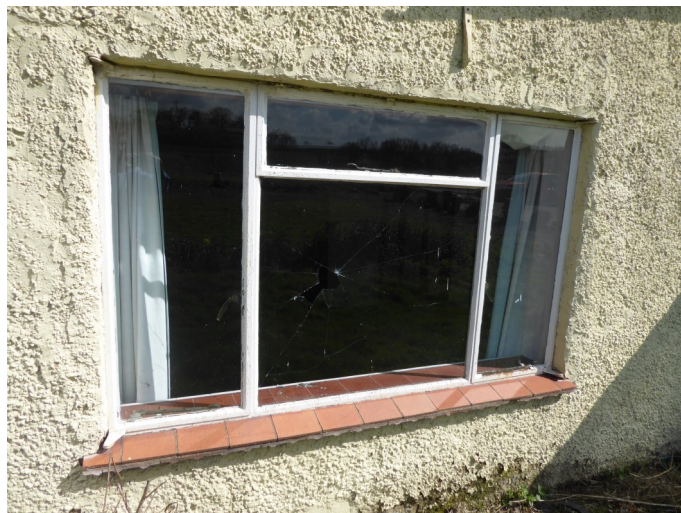
Windows throughout the property are modern timber frame or metal crittal; casement opening style . None of the windows have any historic interest.
