THE MORTON PARTNERSHIP LTD.

**RE: RUNKINS FARM, LANGHAM LANE, BOXTED, SUFFOLK CO4 5HZ**

You have appointed The Morton Partnership to look specifically at the remaining timber frame to the property and to provide a structural assessment of the frame and whether it would be considered salvageable for reuse as part of renovation proposals, or whether demolition is recommended.

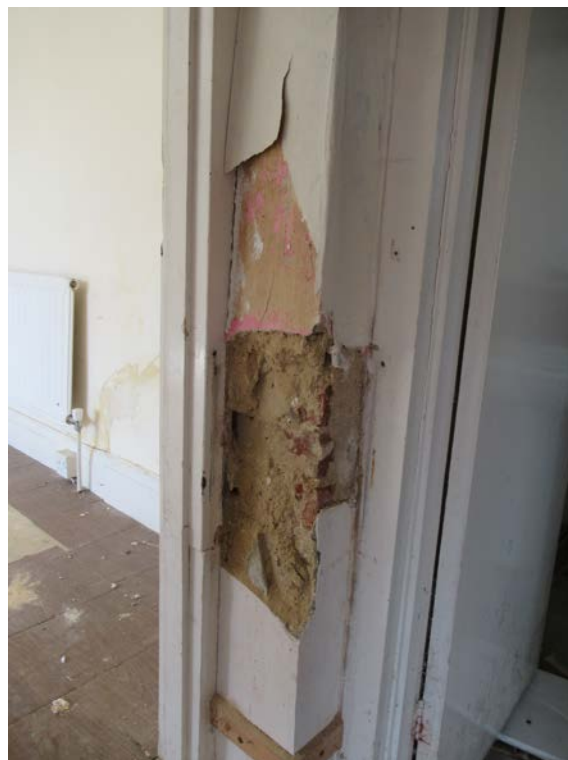
Photograph 04

The extensions to both the left and right-hand side of the property were not reviewed as part of our survey, although these are of masonry construction (Photograph 04) with rendered finish, as previously detailed.

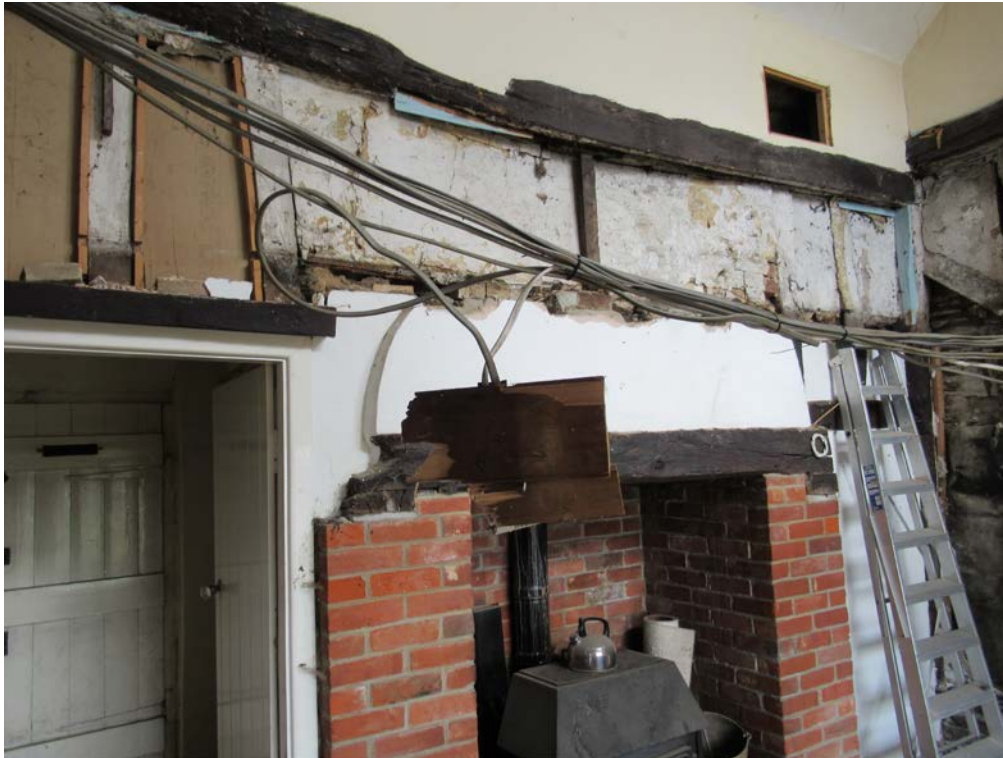
Photograph 05

The original structure (centrally) comprises timber frame construction with the remains of timber frame noted to the front elevation (Photographs 05 & 06), the two original gable walls (Photographs 07 & 08) and an internal partition (Photographs 09 & 10). The timber frame to the rear elevation has been lost in its entirety and is replacement masonry.

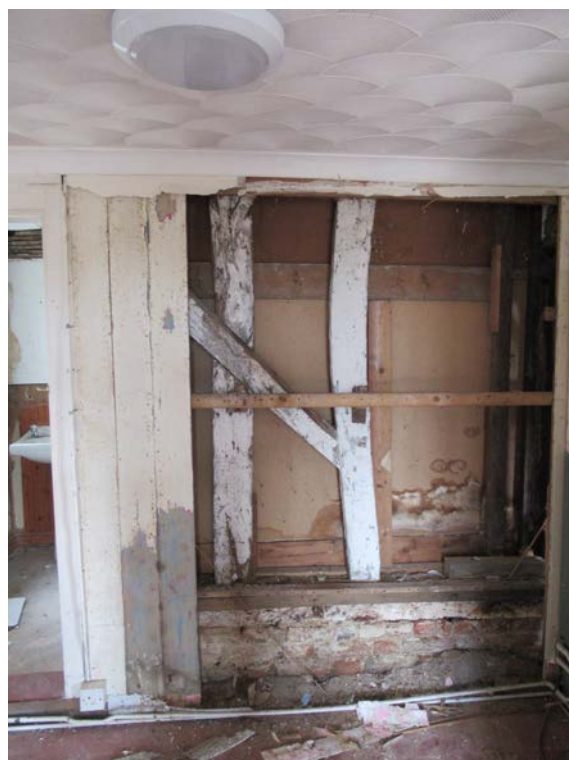
Photograph 06

To the remaining section of the front elevation (observed to the adjacent room which houses the stair access to first floor level), there is a section of original timber frame comprising sole plate detail supported off a brick plinth wall (Photograph 06). This brick plinth wall is thought to be original detail constructed in soft red brick and lime based mortar. This section remains only through an approximately length of 1.5m with a further door access cut through the frame and plinth wall.

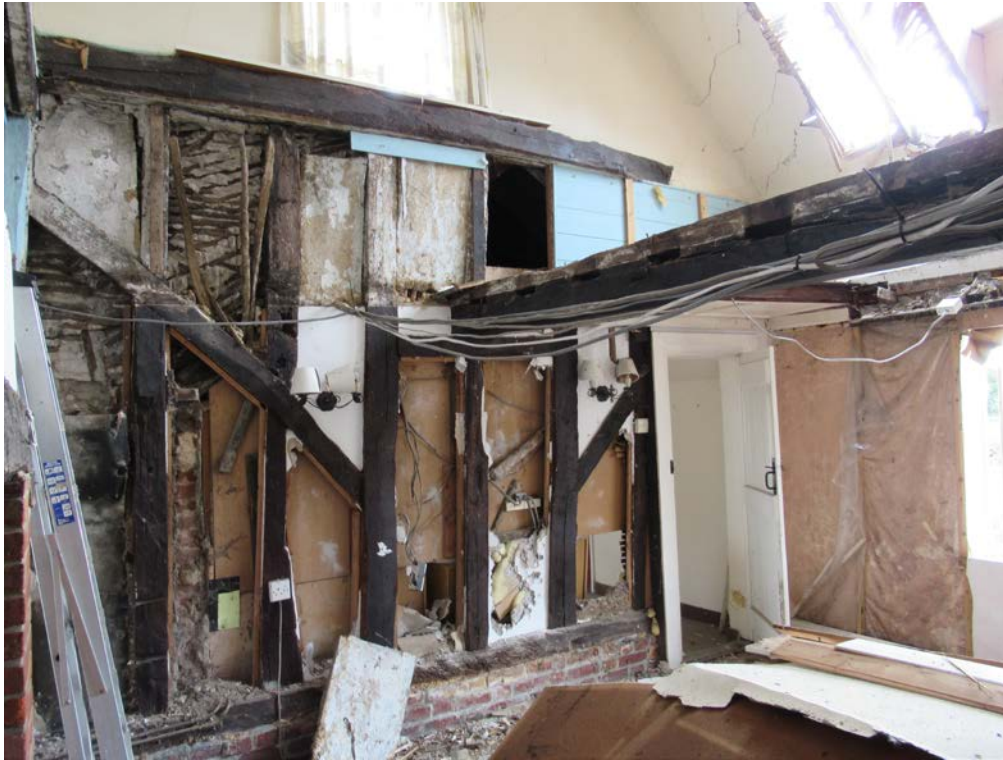
Photograph 07

For the purpose of this survey detail, the two original gable walls and internal partition are described as Frames 1-3, with Frame 1 forming the original left-hand side gable (Photograph 07), and Frame 3 the original right-hand side gable, now forming a partition to the later addition extension to the right hand side of the property (Photograph 08)

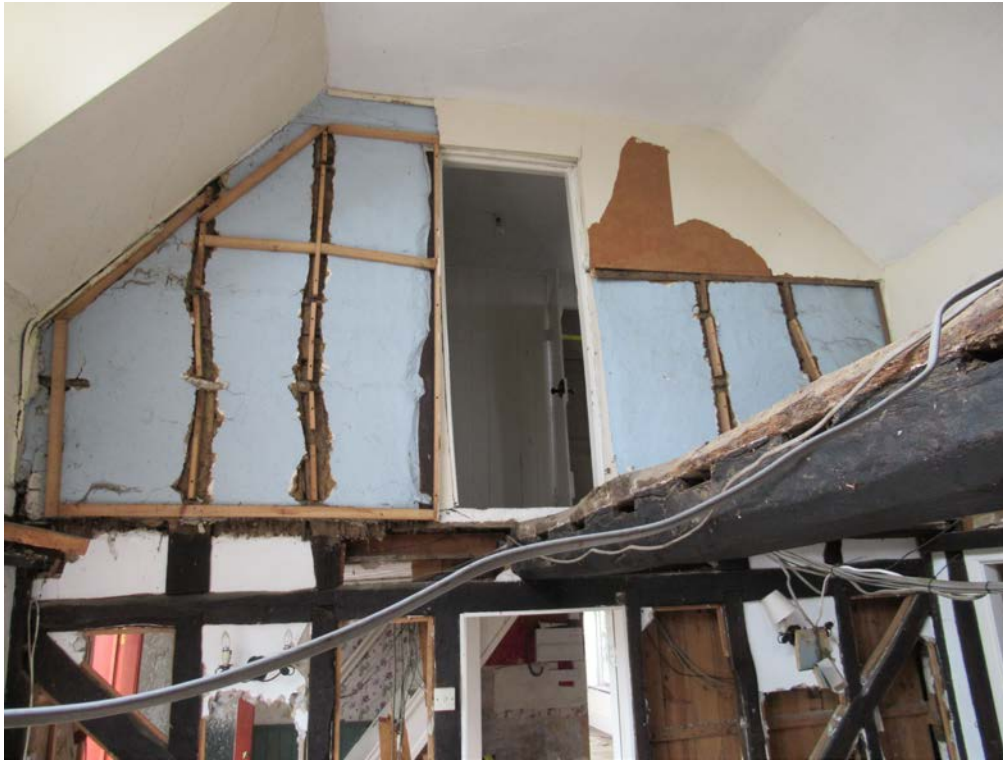
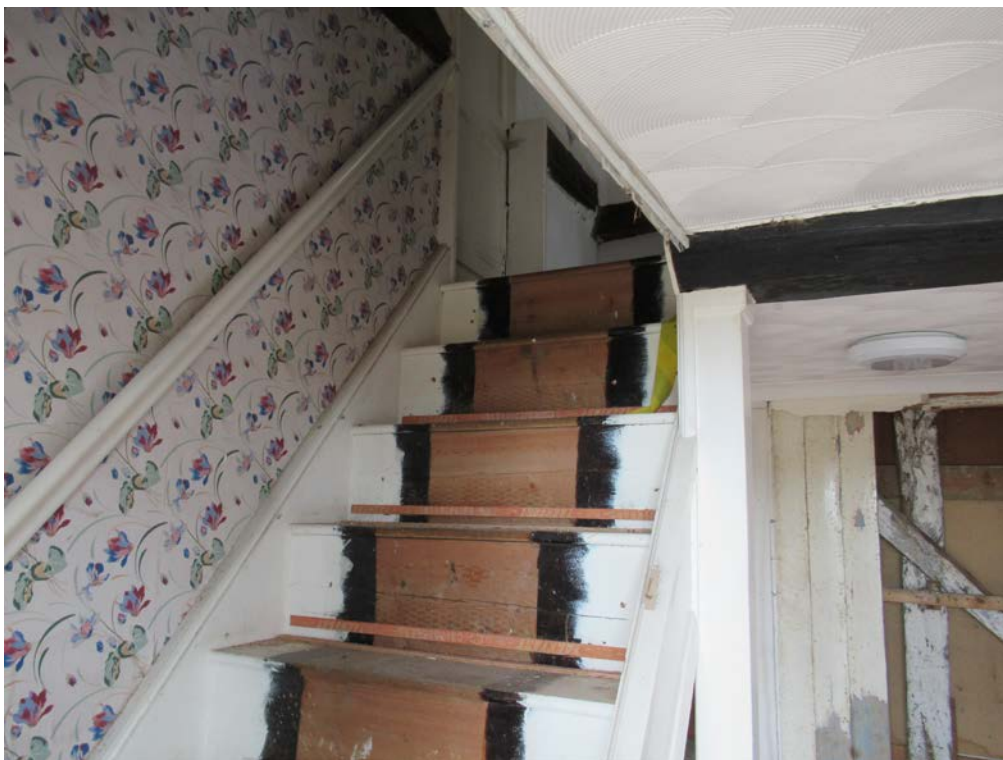
First floor timbers (which remain only in part to approximately one-quarter of the first floor area) are softwood and are not considered to be original detail (Photographs 11 & 12).

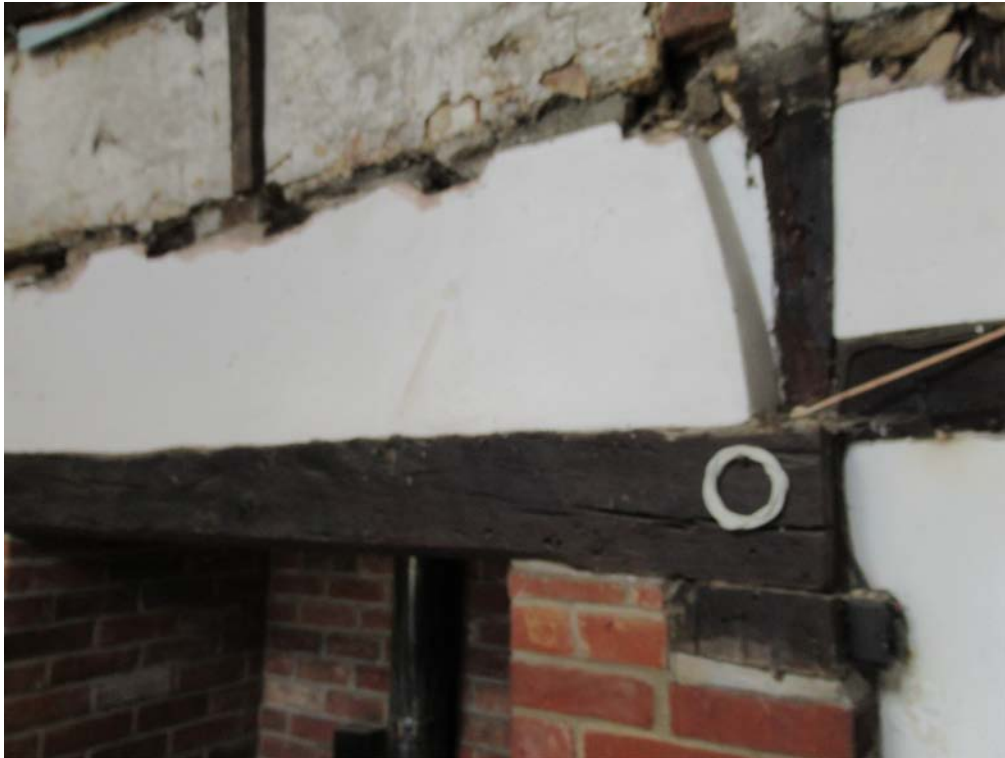
Photograph 13

The introduction of the fireplace and chimney to the front elevation is not considered to be original detail due to the interruption to the original timber frame detail (Photograph 13).

The later addition fireplace centrally located to the main room of the original property disrupts the original frame of this elevation, with evidence of this having been cut to accommodate the fireplace detail (Photograph 13).

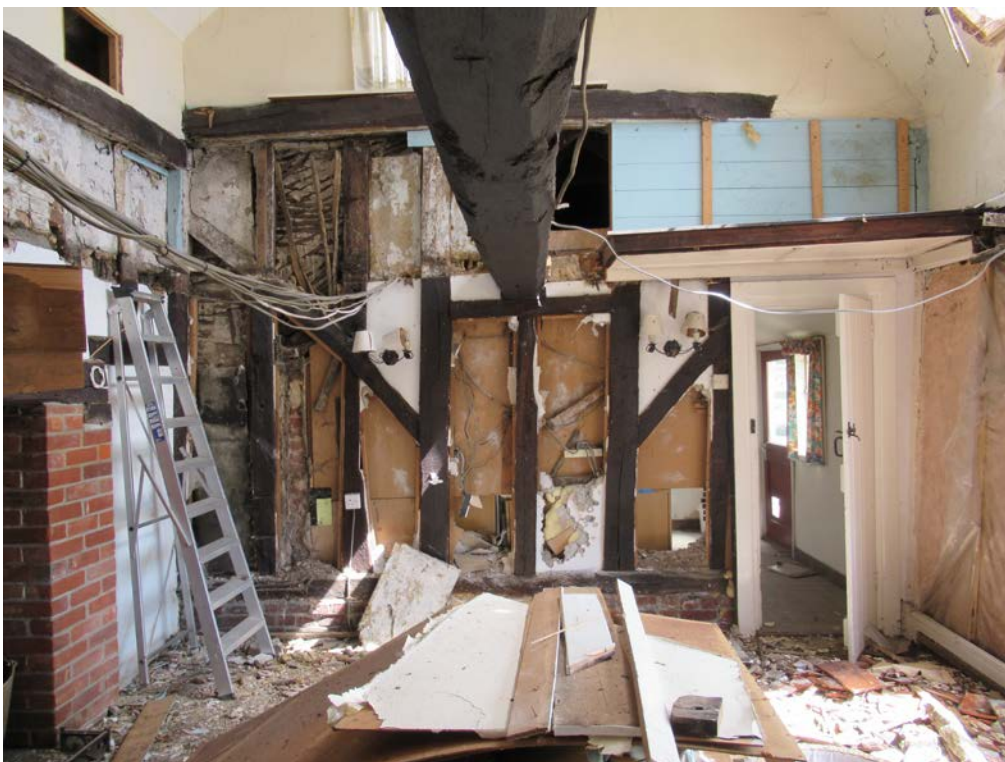
Photograph 14

- The roof structure is replacement with no original fabric remaining.
- The rear elevation has been replaced in masonry throughout its full length.
- To the front elevation, the timber frame remains in part considered to be approximately 50% of this elevation, with later addition fireplace detail cutting into the frame. 2No. door openings cut through the frame. Localised reconstruction in masonry at ground floor level to the left-hand side of the chimney (when viewed externally).
- Frame 3 remains only in part with the tie beam visible. Elsewhere the wall is considered to be masonry construction throughout.
- Frames 1 & 2 remain in-situ, with Frame 1 having been cut to accommodate door access through to the later addition extension (Photograph 14). The door access to Frame 2 is considered original detail (Photograph 15).

- Rotation of the rear masonry wall with significant lateral displacement towards the rear (Photograph 16).
- Rotation to the tie beam of Frame 1 (Photograph 17).
- Racking to the timber frame of Frame 1 (Photograph 14).
- Pulling away of connections visible particularly to Frame 2 adjacent to the front elevation (Photograph 18).

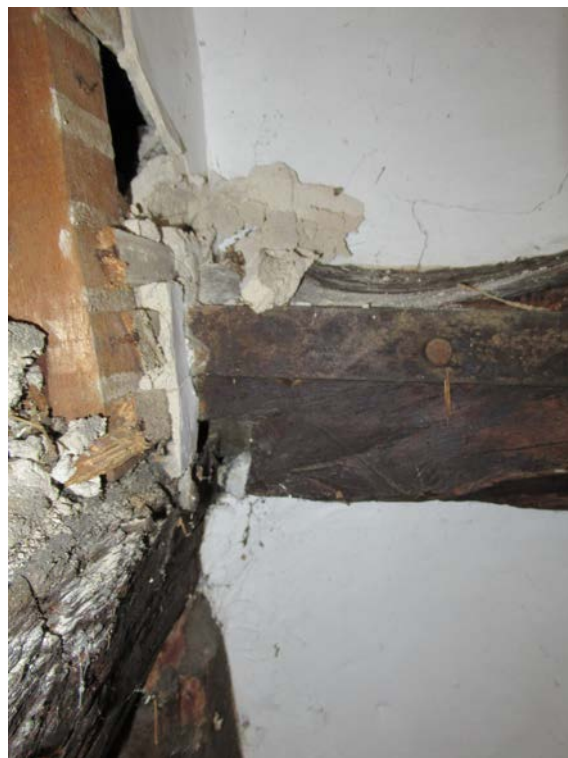
Photograph 18

To the tie beam at original eaves level to this frame, there is no connection to the rear wall at the eaves plate of the roof structure (Photograph 20). To the front elevation of the tie beam there is movement visible of at least 40mm in the original timber lap joint between tie beam and eaves plate (Photograph 18). Strapping detail has been provided thought to assist with movement, although this is not considered to be a suitable detail. This movement is as observed to Frame 1 and relates to the loss of continuity of structure with the alteration undertaken to the rear wall and roof structure.

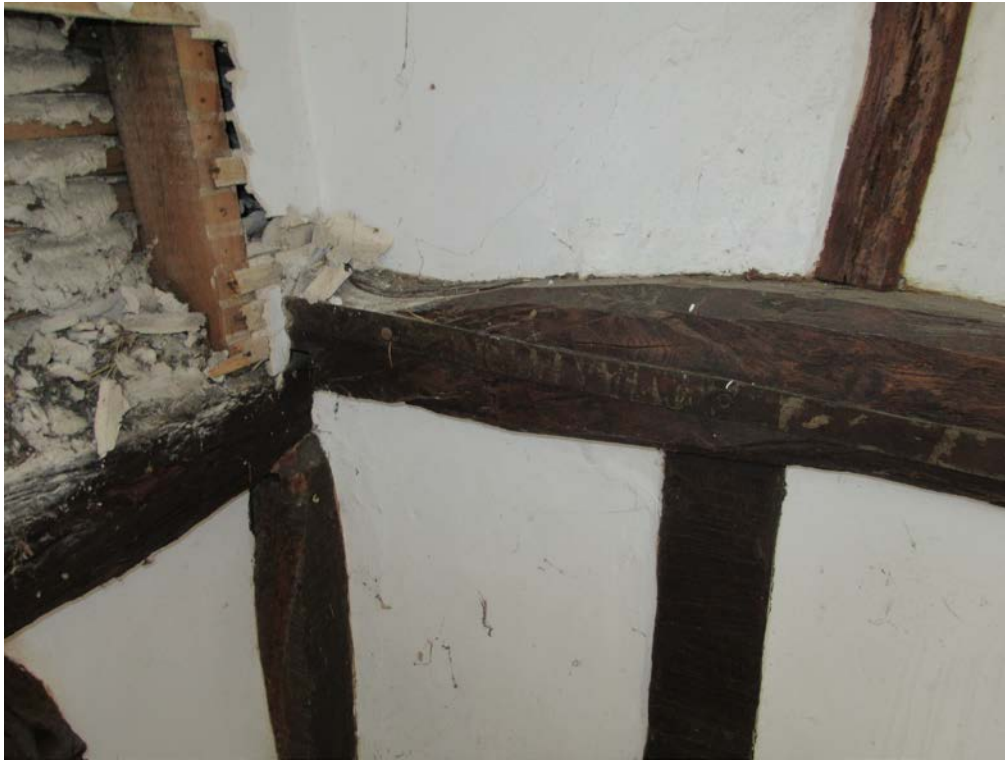
Photograph 19

Metal strap details have been provided throughout, although these are considered to be a relatively crude detail and strapping detail has buckled, further suggesting progressive movement (Photograph 19).

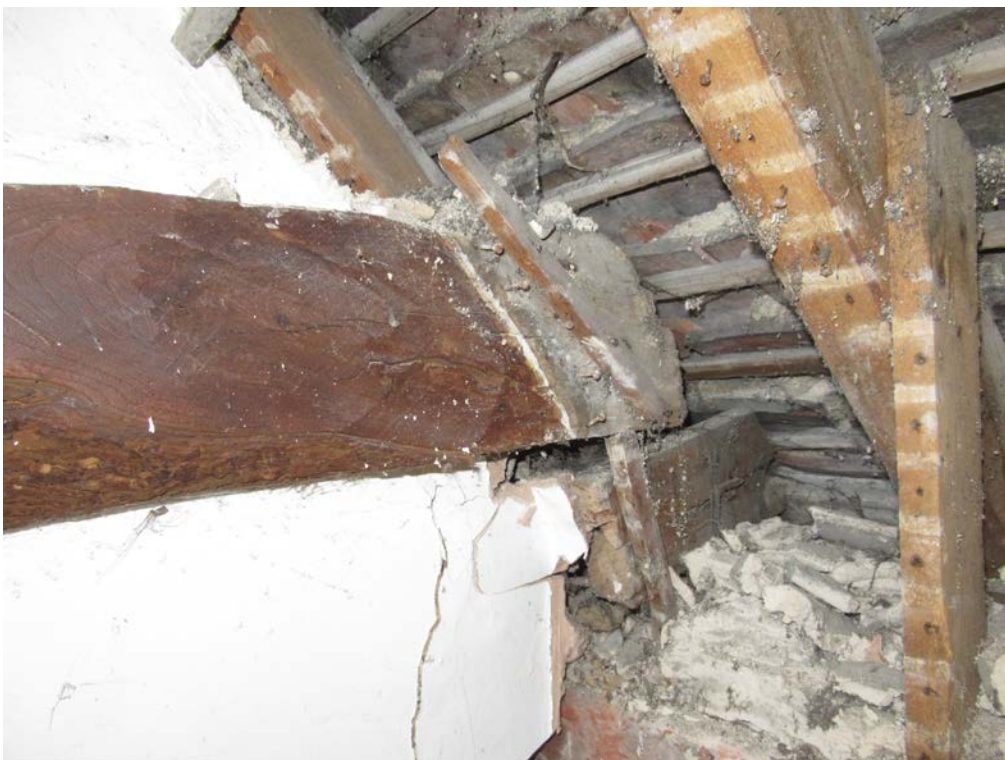
Photograph 20

The rear wall has rotated outward due to the loss of connection with the remaining structure, likely when this section was reconstructed in masonry and the roof structure replaced. From what could be observed, the tie beams do not appear to tie into the later addition roof structure and wall plate at eaves (Photograph 20). Therefore, the continuity of the structure has been lost and would need to be regained.

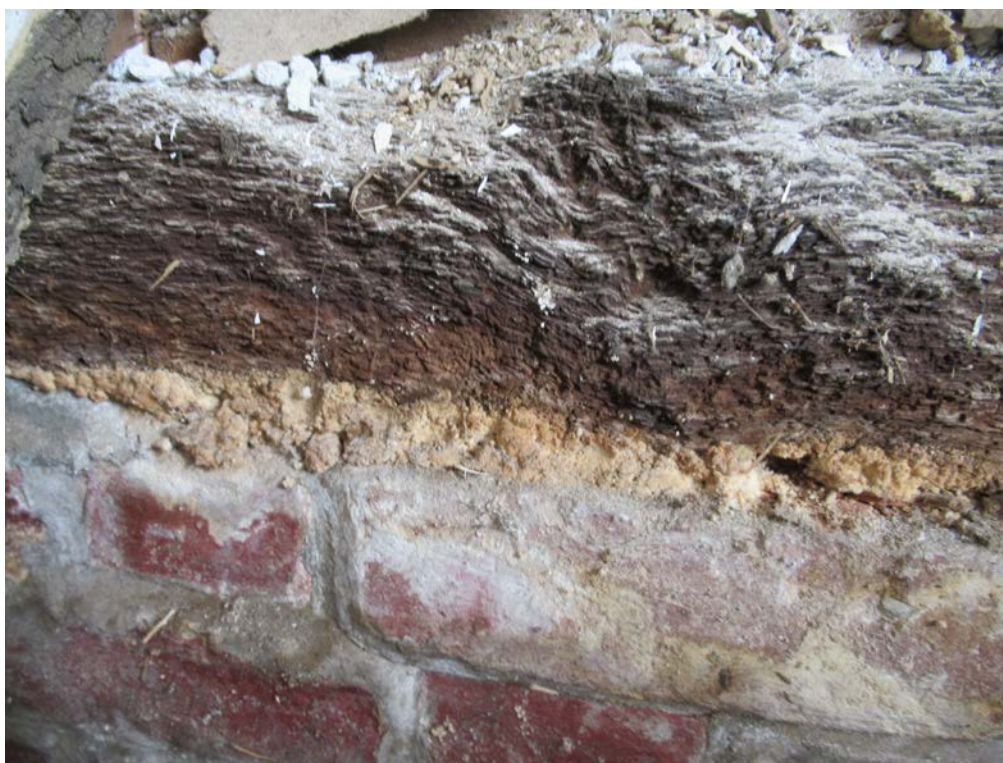
Photograph 21

The plinth wall appears to be reconstructed in a cement based mortar, either replaced or repaired at some stage. There is a high level of moisture noted to the plinth wall, migrating through to the lower

section of the sole plate causing decay (Photograph 21). Alongside this there is a light brown powdery residue which suggests active infestation.

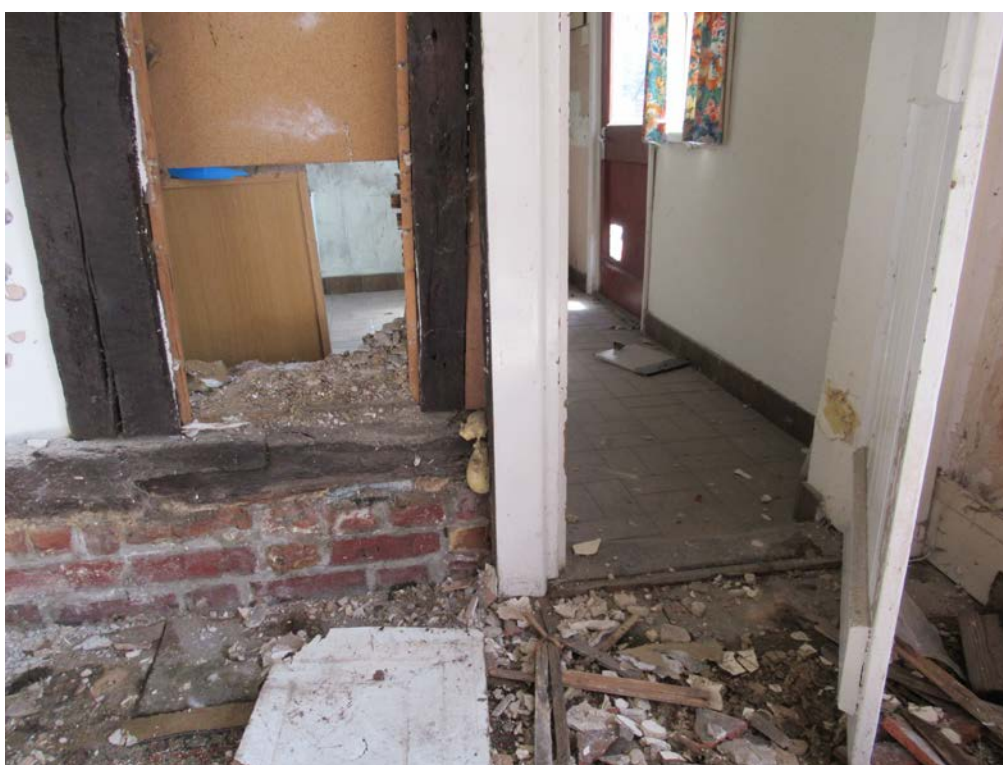
Photograph 22

The brick plinth wall supports a sole plate (175mm width x 125mm depth) which in turn, supports the timber frame above. The sole plate has been cut to allow the door opening through to the Kitchen which is a later addition extension (Photograph 22). The sole plate has decayed through its lower section through approximately 10-30mm in depth (Photograph 23). Removal of decayed material and replacement with packing timbers or slate shims would be required, alongside rising damp consideration to prevent future decay. The external face of the sole plate appears to have deteriorated suggested by the timber frass within the debris adjacent. Full observation was not possible due to kitchen units remaining. It is likely that a face plate repair would be necessary to regain the structural integrity of this member and provide sufficient bearing for the studs above.

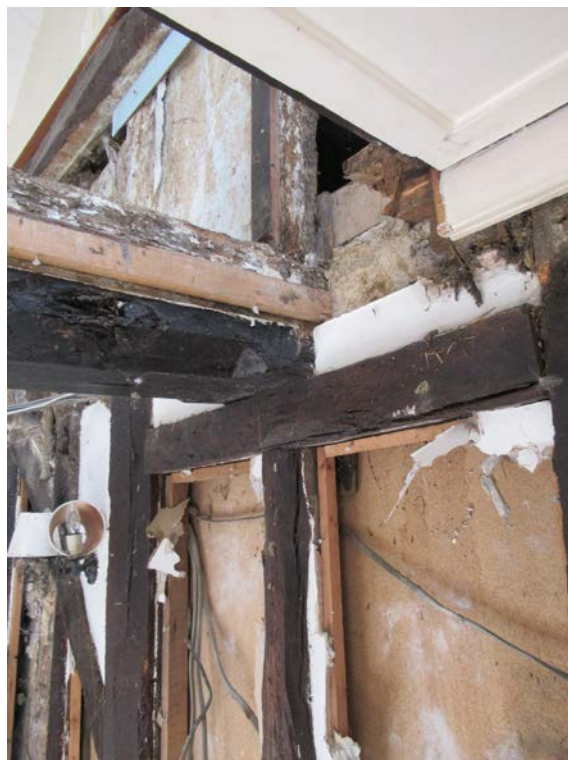
Photograph 24

The timber frame comprises studs approximately positioned at 550mm centres, varying in size (125-170mm width x 100mm depth). The studs have been cut centrally to the frame to support a later addition beam and similarly the frame has been cut towards the rear of the property to accommodate door access through to the later addition extension (Photograph 24).

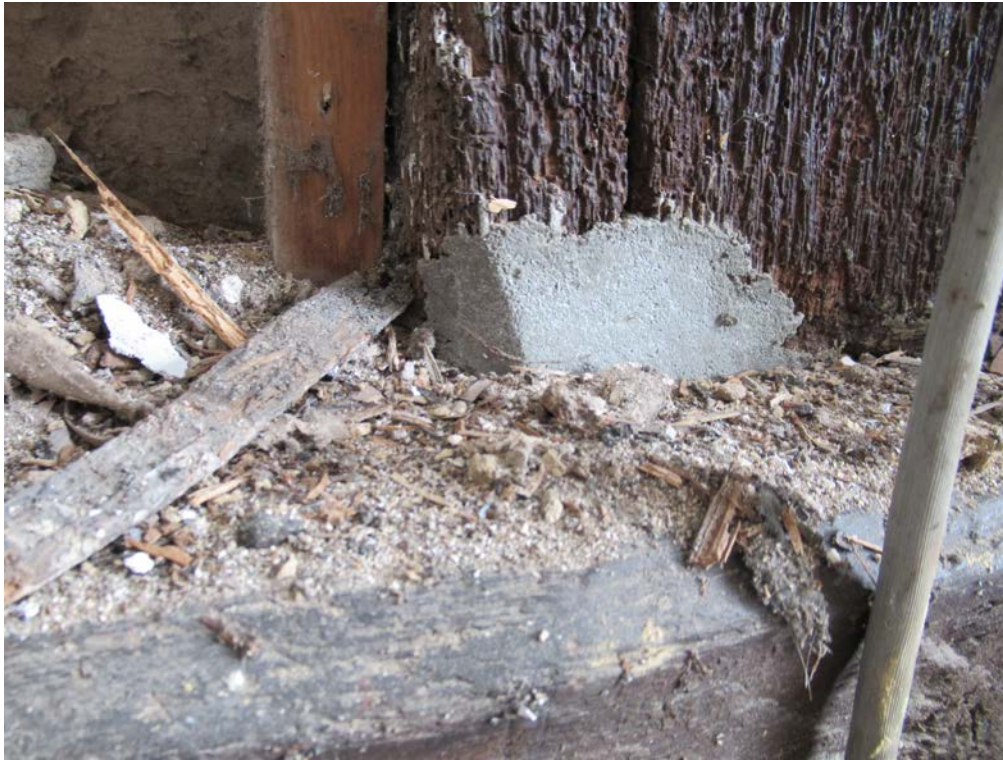
Photograph 25

The studs to Frame 1, to their base, remain in fair condition although there are locations of infill cement repair (Photograph 25) which would increase the likelihood of moisture and result in decay locally. The outside face of studs in locations have decayed with loss of fabric through at least 50% of its depth and, as a minimum, would require face plate repair in locations, to regain structural integrity (Photograph 26). In locations, full replacement may be required.

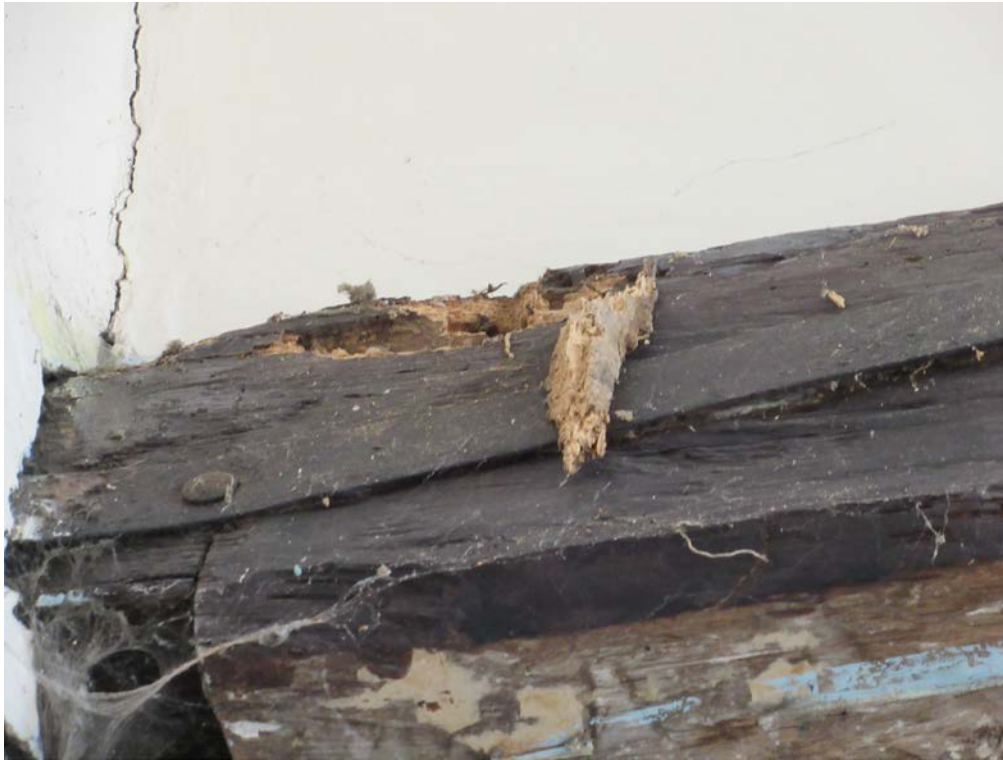
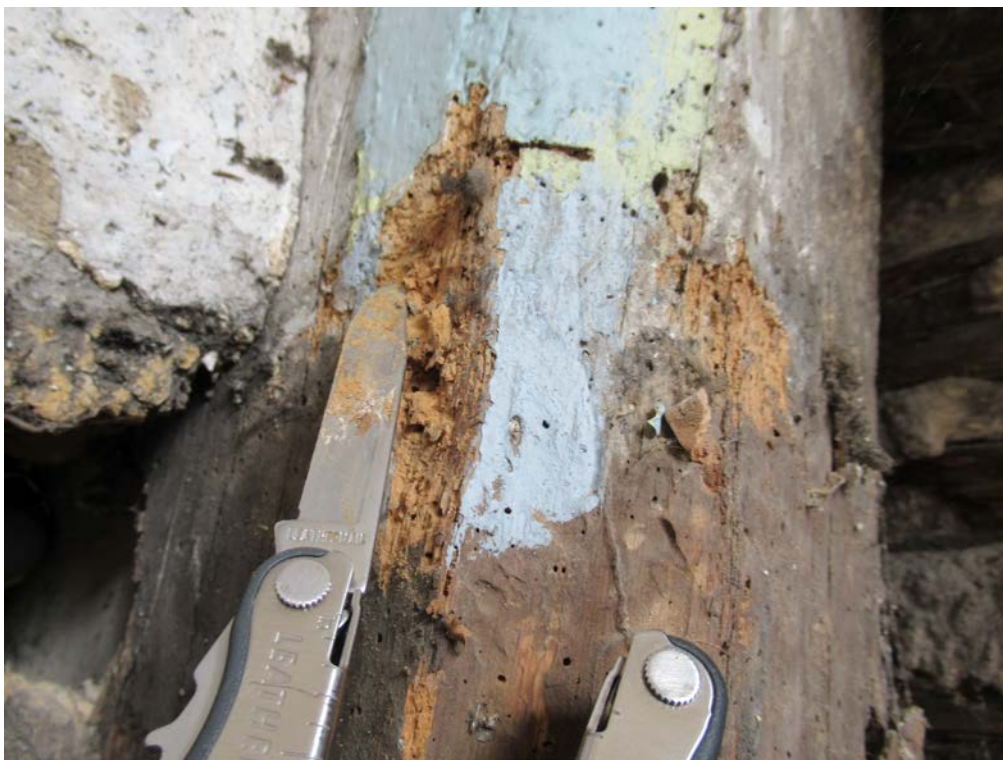
The tie beam shows signs of decay to its external face, which will require a minimum of face plate repair. To the corners of the tie beam, there is evidence of decay to the top face of the member, possibly due to infestation. When prodded with a knife, the member was dry and flaky with brown residue. Similar detail was noted to the corner post to the front of the property relating to this frame at high level. To these members, splice repairs would be necessary to ensure sufficient section of timber to provide a sound connection to regain lateral restraint across this frame (Photographs 27 & 28).

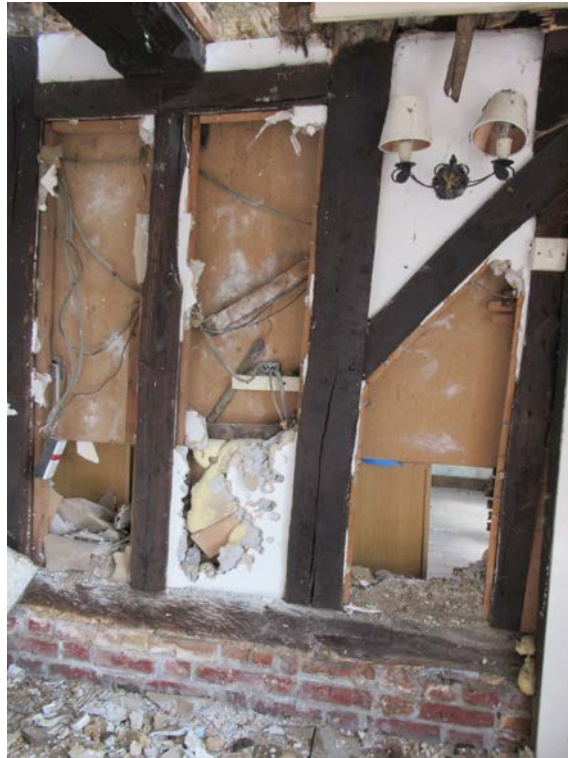
Photograph 29

Small sections of wattle and daub remain to this frame. Elsewhere, Gypsum plaster is evident suggesting loss of wattle and daub and replacement with more modern material. There is also evidence of foam insulation infilling gaps to the timber frame (Photograph 29). These materials alongside the cement based render observed externally will reduce the ability for the frame to 'breathe' and so there is a risk that decay may be to a greater extent than currently observed. This could only be confirmed on full removal of the internal and external finishes.

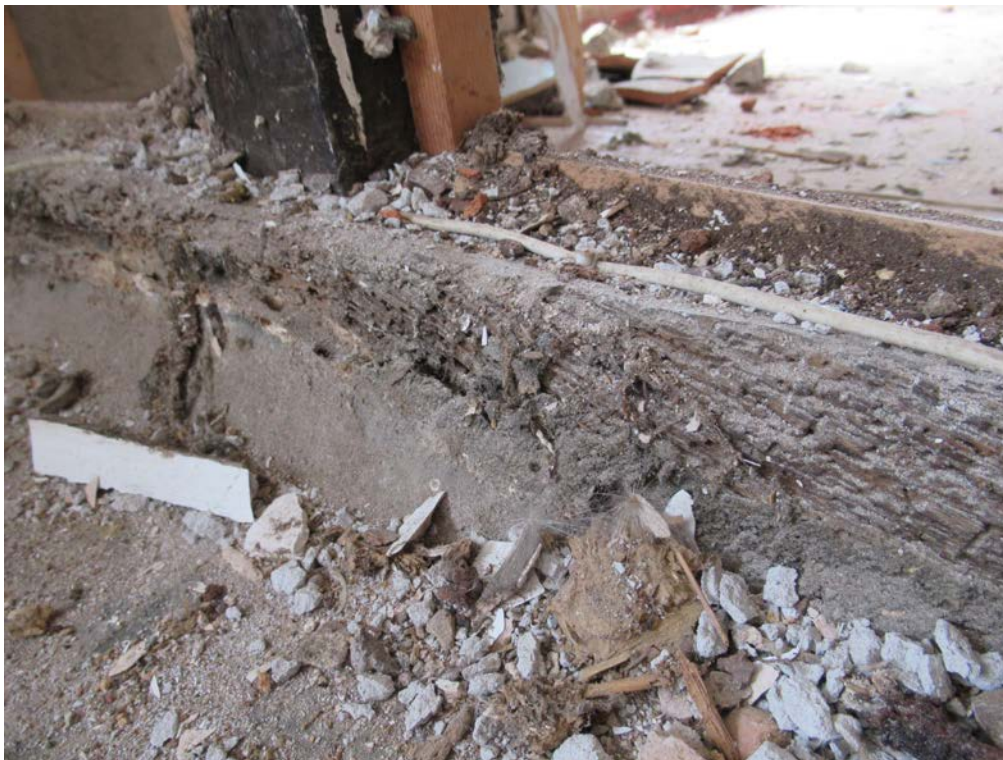
Photograph 30

The sole plate to this frame is not constructed off a plinth wall and sits directly at ground level. The floor structure to the original property has been replaced at some stage with a concrete slab/screed and this returns up the face of the sole plate to Frame 2 in part (Photograph 30). As a result, the sole plate is partially encased, which has contributed to its decay which is considered significant, hollow through the majority of its section (Photographs 31 & 32). It is likely that full replacement of the sole plate would be required to this frame.

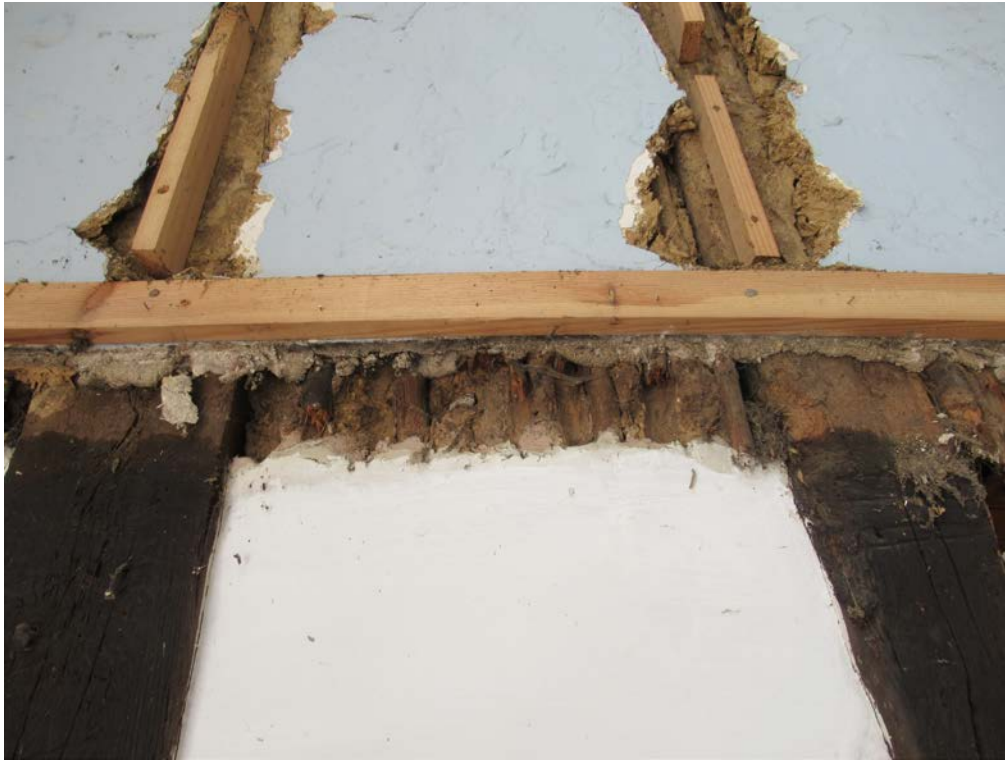
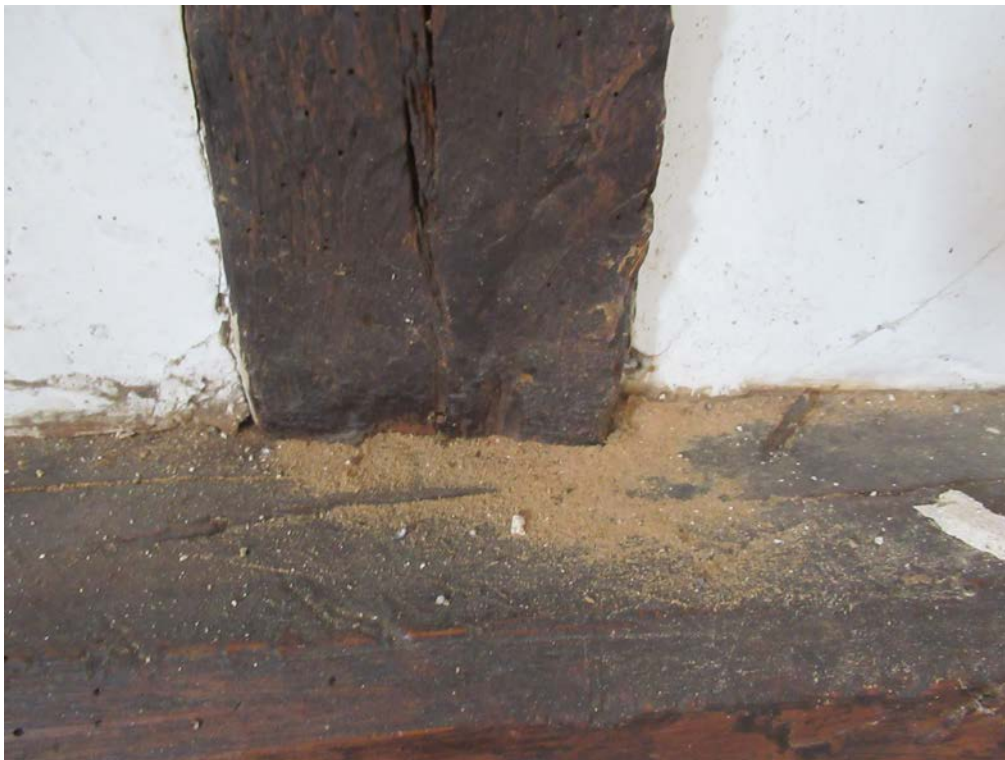
Above the wall plate, studs continue up to rafter level. Wattle and daub remains through the upper section of this wall. The upper studs are light brown in colour and there is a light brown residue further suggesting active infestation (Photographs 33 & 34).

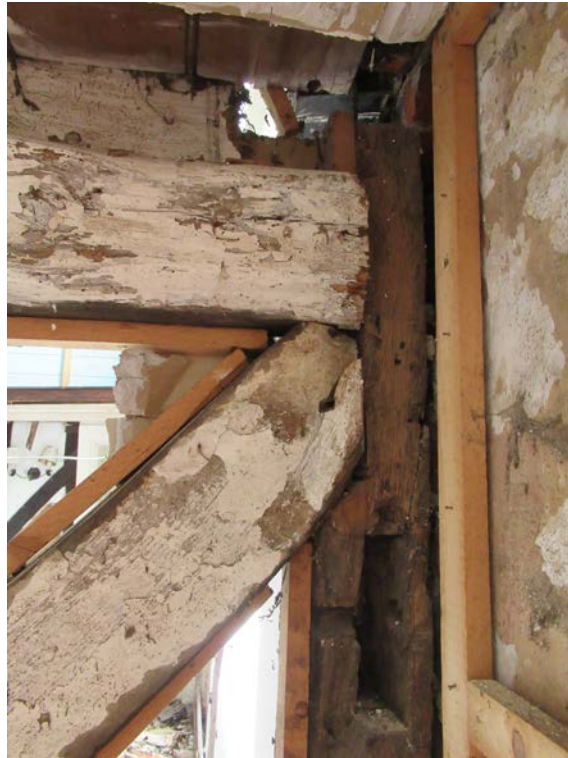
Photograph 35

To Frame 2, there are local defects to connections with some loss of connection, and 1No. replacement stud towards the rear of the property (Photograph 35).

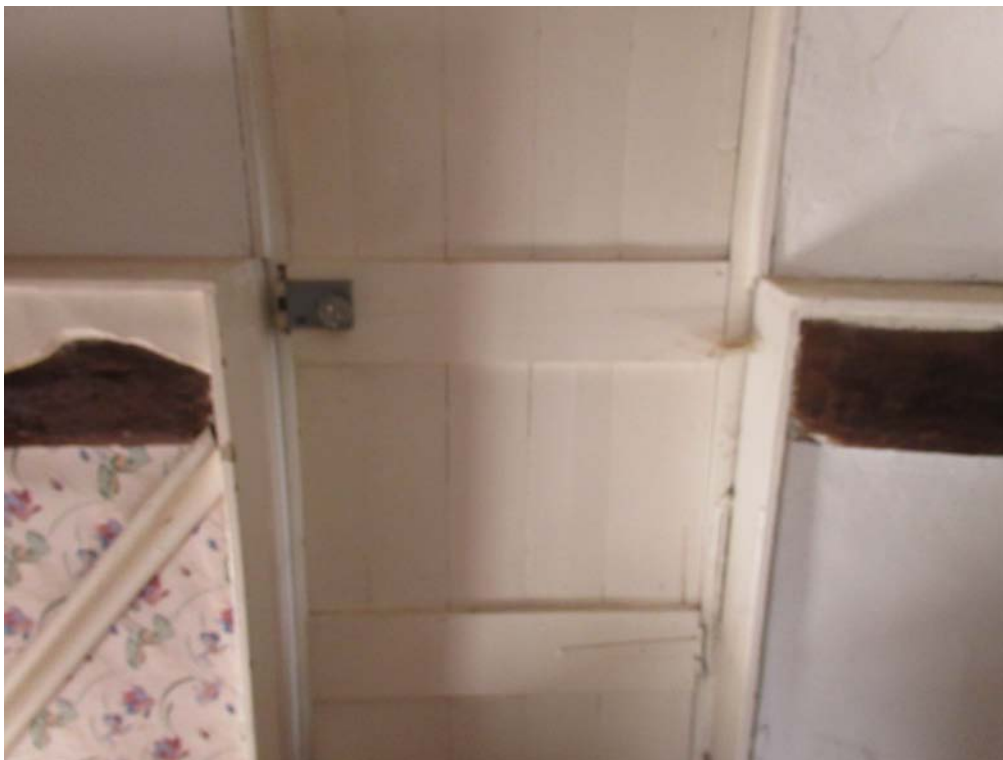
Photograph 36

To this frame, only the tie beam remains and this has been cut to accommodate door access at first floor level (Photograph 36). Otherwise, the tie beam remains in fair condition from what could be observed, although it should be noted that this bears onto masonry below and is embedded in masonry in part and therefore is likely to have decayed to its faces which were not visible, as the member has been unable to 'breathe'.

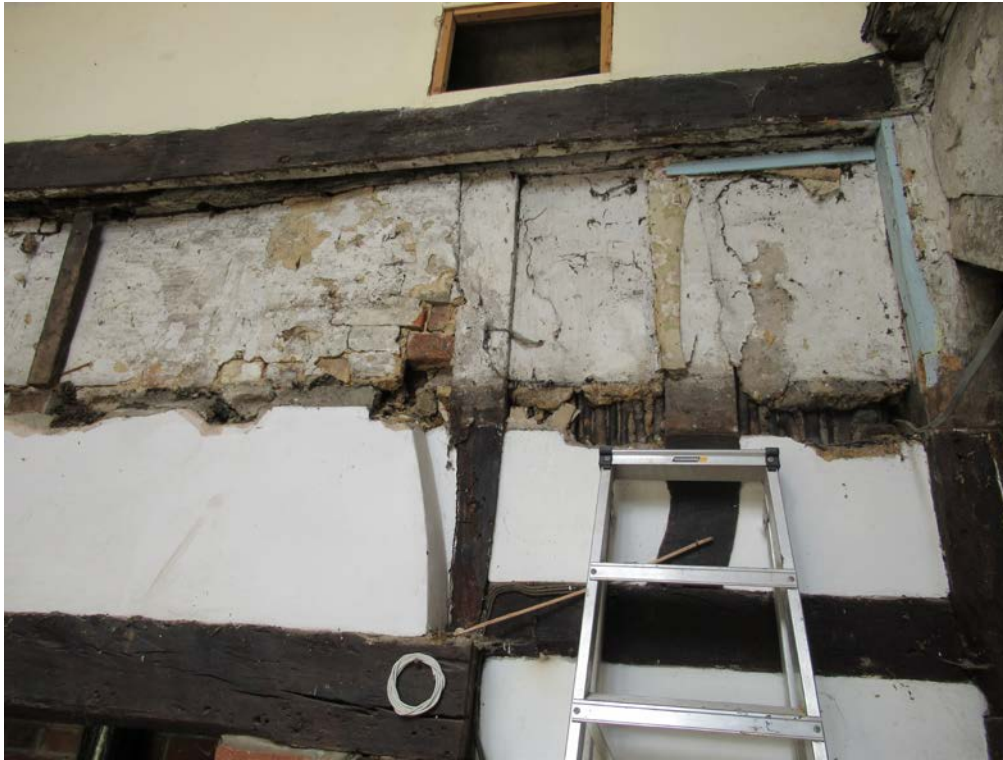
Photograph 37

Below the eaves plate, this is infill masonry down to the timber lintel creating the fireplace opening (Photograph 37). When looking at the fireplace internally to the right-hand side, this has been reconstructed in masonry. To the left-hand side, the frame has been cut to accommodate door access through to the later addition extension to the front of the property.

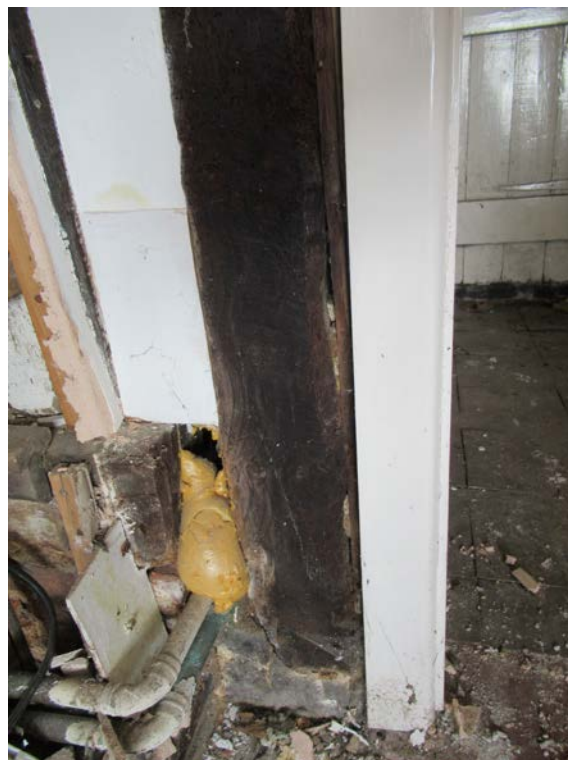
Photograph 38

Original timber frame studs remain only through the upper section of this wall, with only 1No. full stud remaining at ground floor level forming a frame to the door access (Photograph 38). The remaining 4No. studs to the upper level are approximately through a length of 800mm. These studs remain in fair condition.

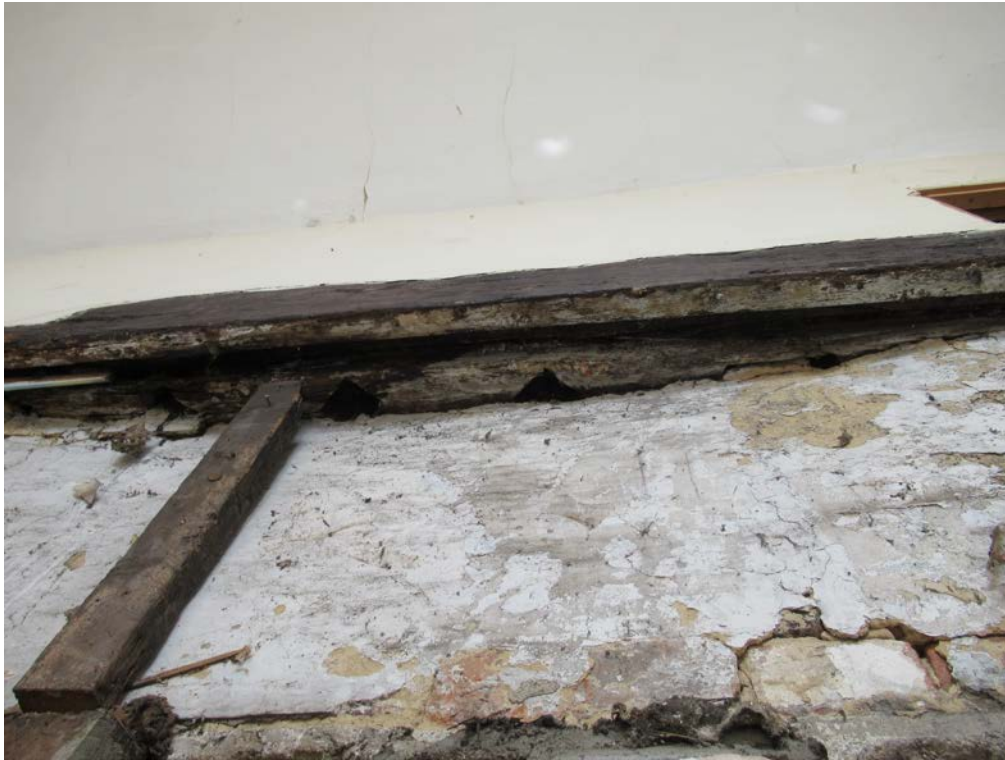
Photograph 39

The eaves plate above these studs has suffered loss of fabric to its underside (Photograph 39). This relates to a combination of localised decay and removal of fabric to accommodate alterations over time. It is likely that additional fabric will need to be scarfed to this member to improve its structural integrity.

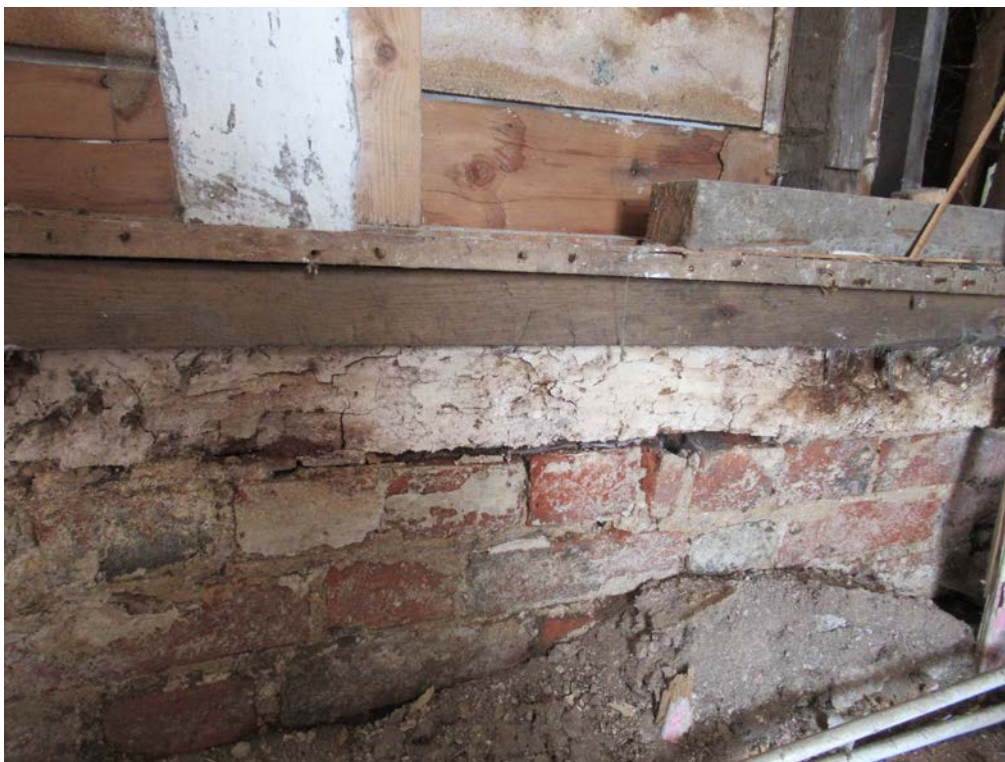
Photograph 40

The plinth wall has deteriorated due to moisture ingress and the sole plate above has discoloured and is soft. The remaining section of sole plate does not appear to be connected at either end to adjacent structure. It is likely that this section of sole plate would need replacing with improved connection detail to adjacent structure (Photograph 40).

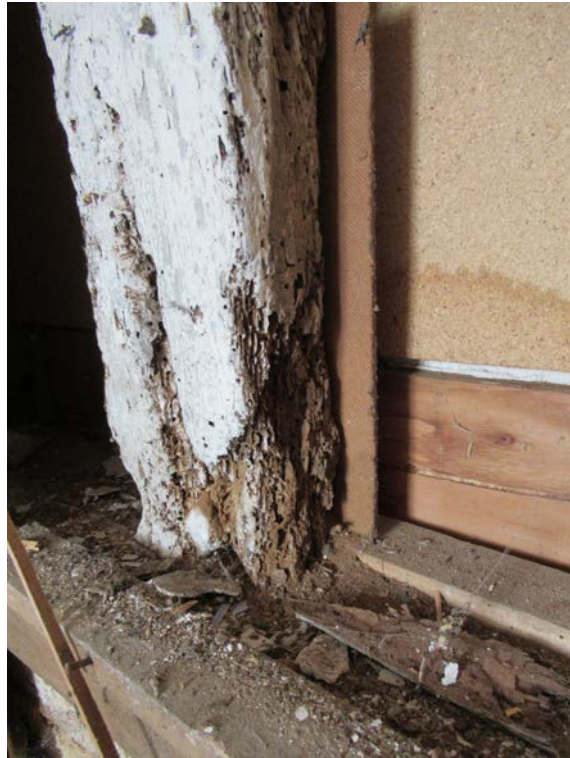
**Photograph 41**

The stud wall detail above the sole plate to this section comprises two studs with diagonal bracing. 1No. stud has decayed at low level with localised loss of fabric (Photograph 41). To the second stud, there is some loss of fabric to its external face (Photograph 42).

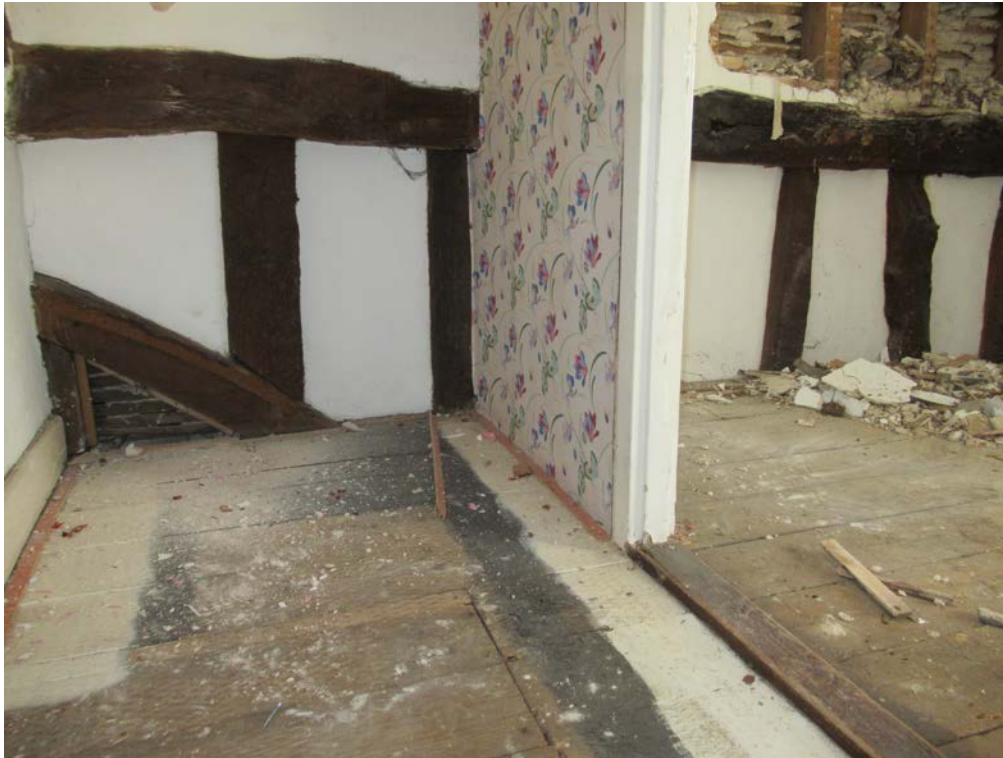
Photograph 43

Above this section at first floor level, timber frame remains through to original eaves plate level (Photograph 43) Above this, later addition softwood increases the frame height to the new eaves plate position. The original timber frame detail remains in fair condition, although the eaves plate is soft to its underside and is dry and flaking, suggesting infestation (Photograph 44).
