THE MORTON PARTNERSHIP LTD.

**RE: RUNKINS FARM, LANGHAM LANE, BOXTED, SUFFOLK CO4 5HZ**

You have appointed The Morton Partnership to look specifically at the remaining timber frame to the property and to provide a structural assessment of the frame and whether it would be considered salvageable for reuse as part of renovation proposals, or whether demolition is recommended.

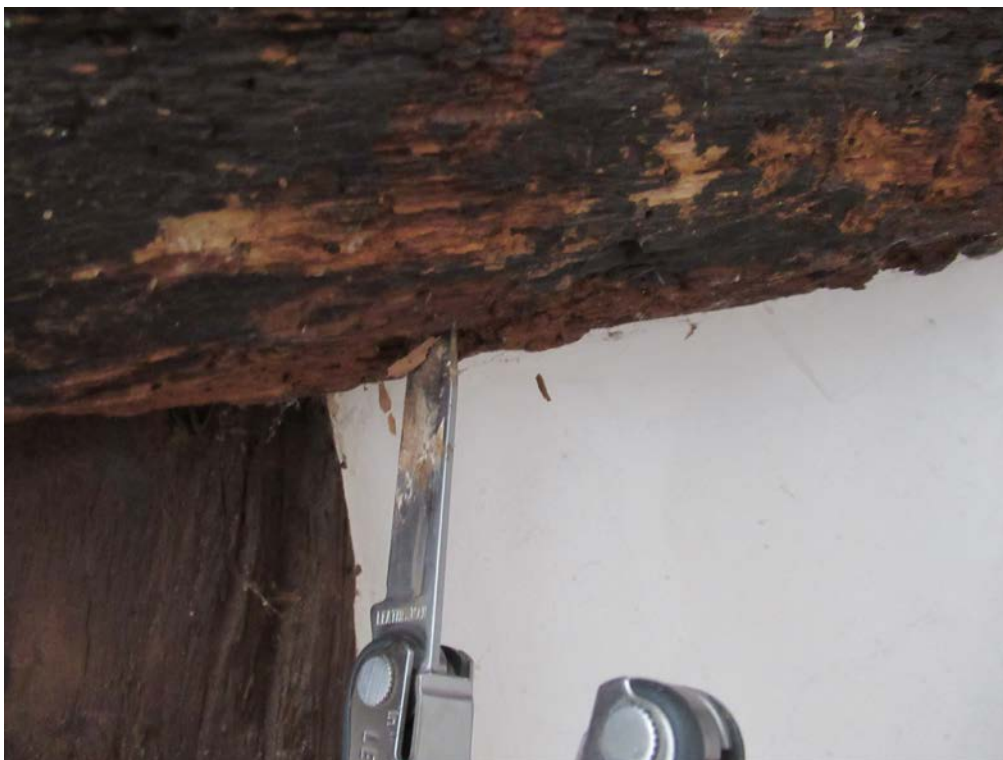
Photograph 44

Above this section at first floor level, timber frame remains through to original eaves plate level (Photograph 43) Above this, later addition softwood increases the frame height to the new eaves plate position. The original timber frame detail remains in fair condition, although the eaves plate is soft to its underside and is dry and flaking, suggesting infestation (Photograph 44).

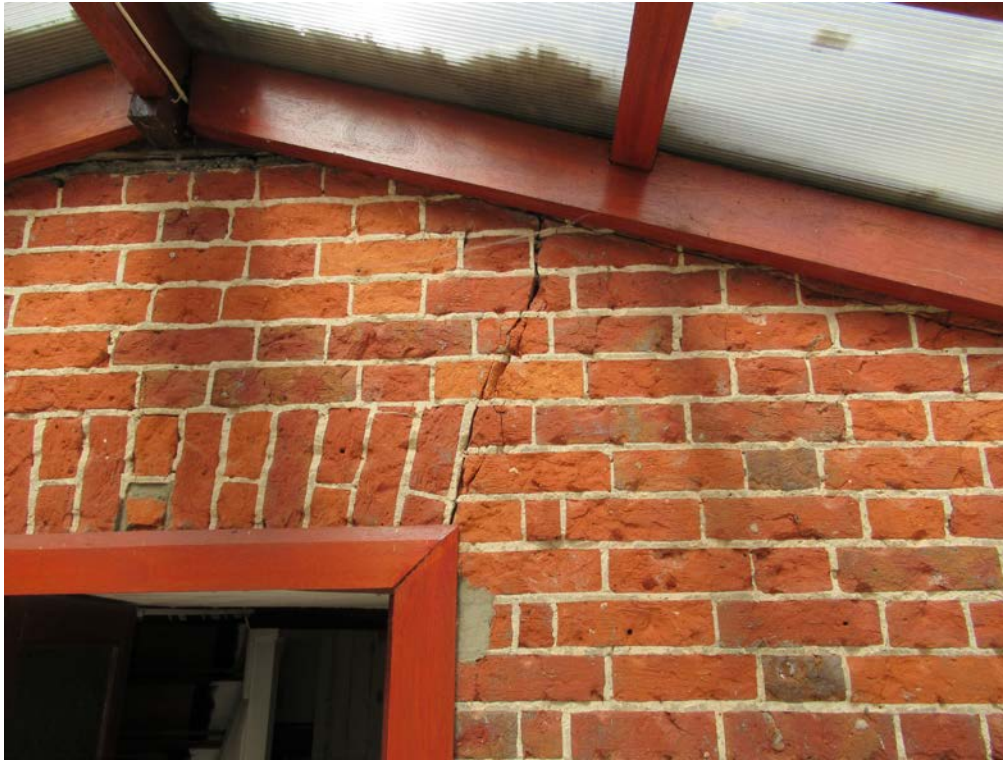
Photograph 45

There is a section of masonry visible externally, which is constructed in soft red brick and lime based mortar. There is cracking above the door access up to 10mm in width (Photograph 45), with the wall rotating outwards, as previously detailed.
