Proposed Works at Gatehouse Farm Tiptree  
Assessment of Significance.

Title: 30,01,2018.  
Project: Gatehouse Farm  
DWG No: 1458-Report 01.

Gatehouse of Cherry Chase Tiptree.  
Former farm house for Gatehouse farm.  
Has been lived in by directors & managers of the  
Wilkin & Sons company for 100 years, as part of  
the fruit growing and Jam making business.

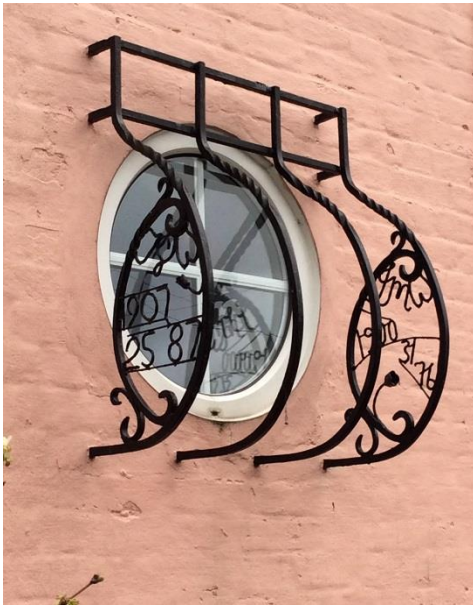
Window grille with initials & dates of members of the Wilkin family.

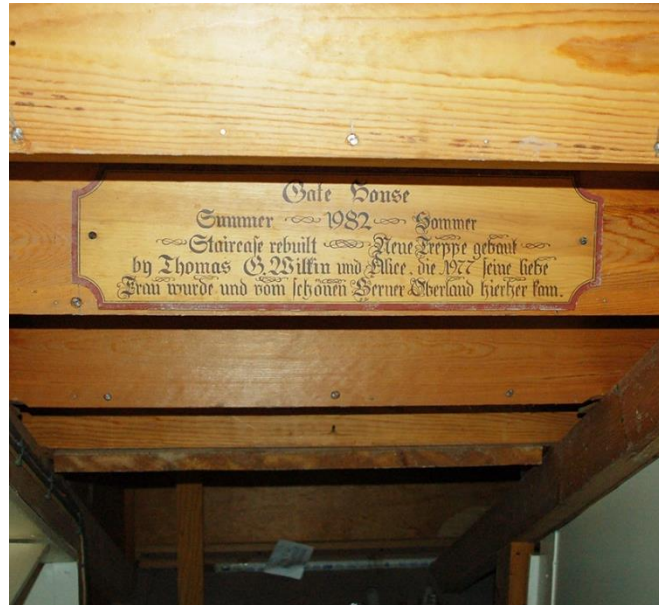
Panel over the cellar stairs, commemorating the alteration of the original stair in 1977.

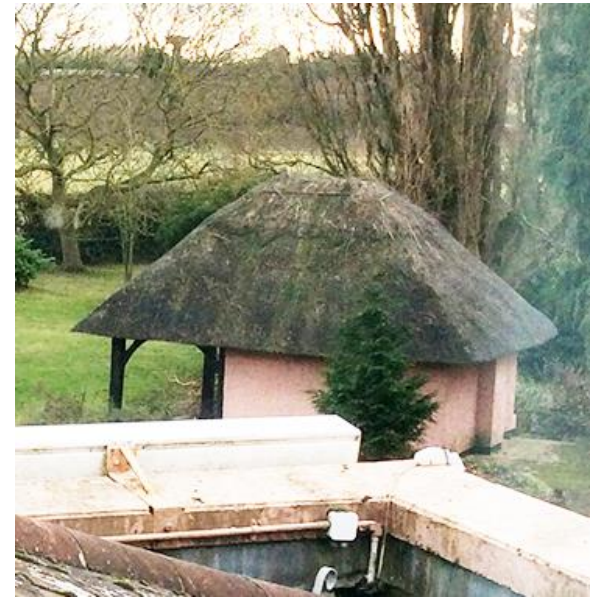
Early 20c garden house constructed by member of the Wilkin family.

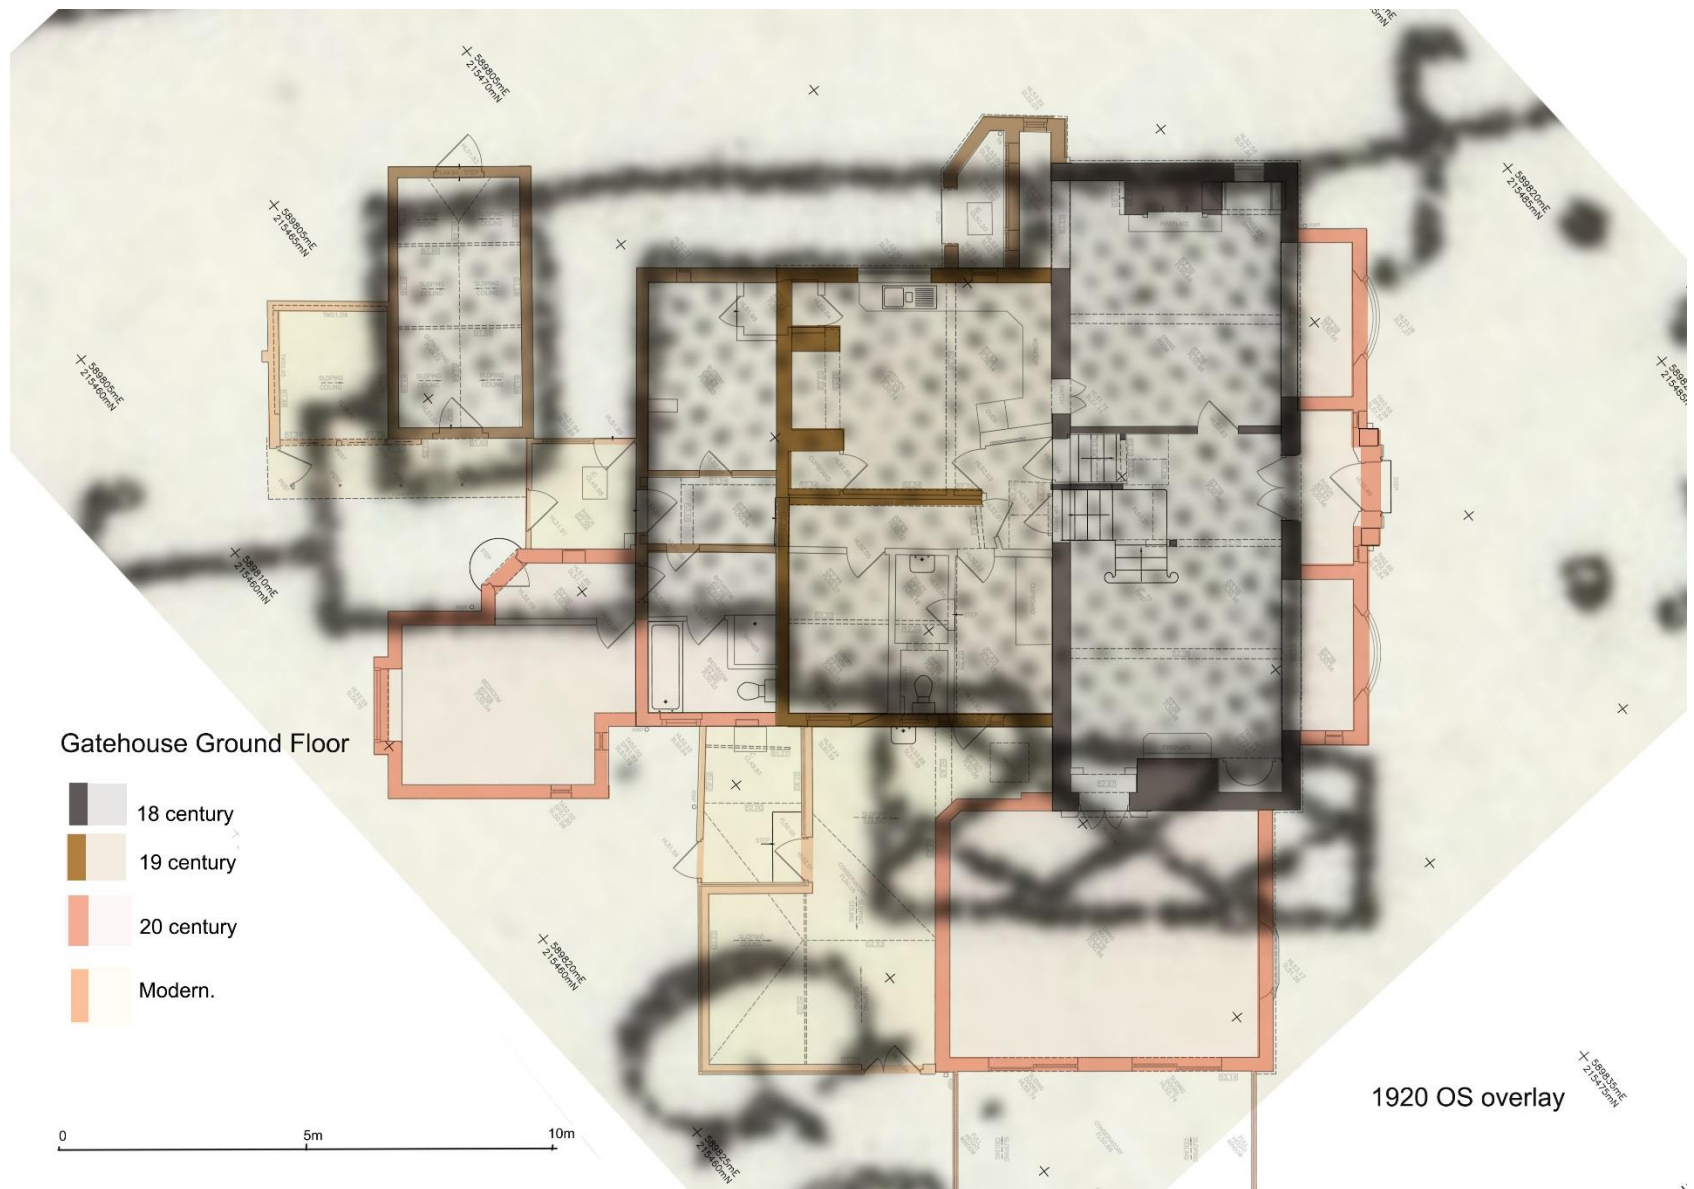
1920 OS plan overlaid on survey plan, showing the extent of additional works post 1920 & providing evidence for dating 20 century works, despite stylistic appearances.

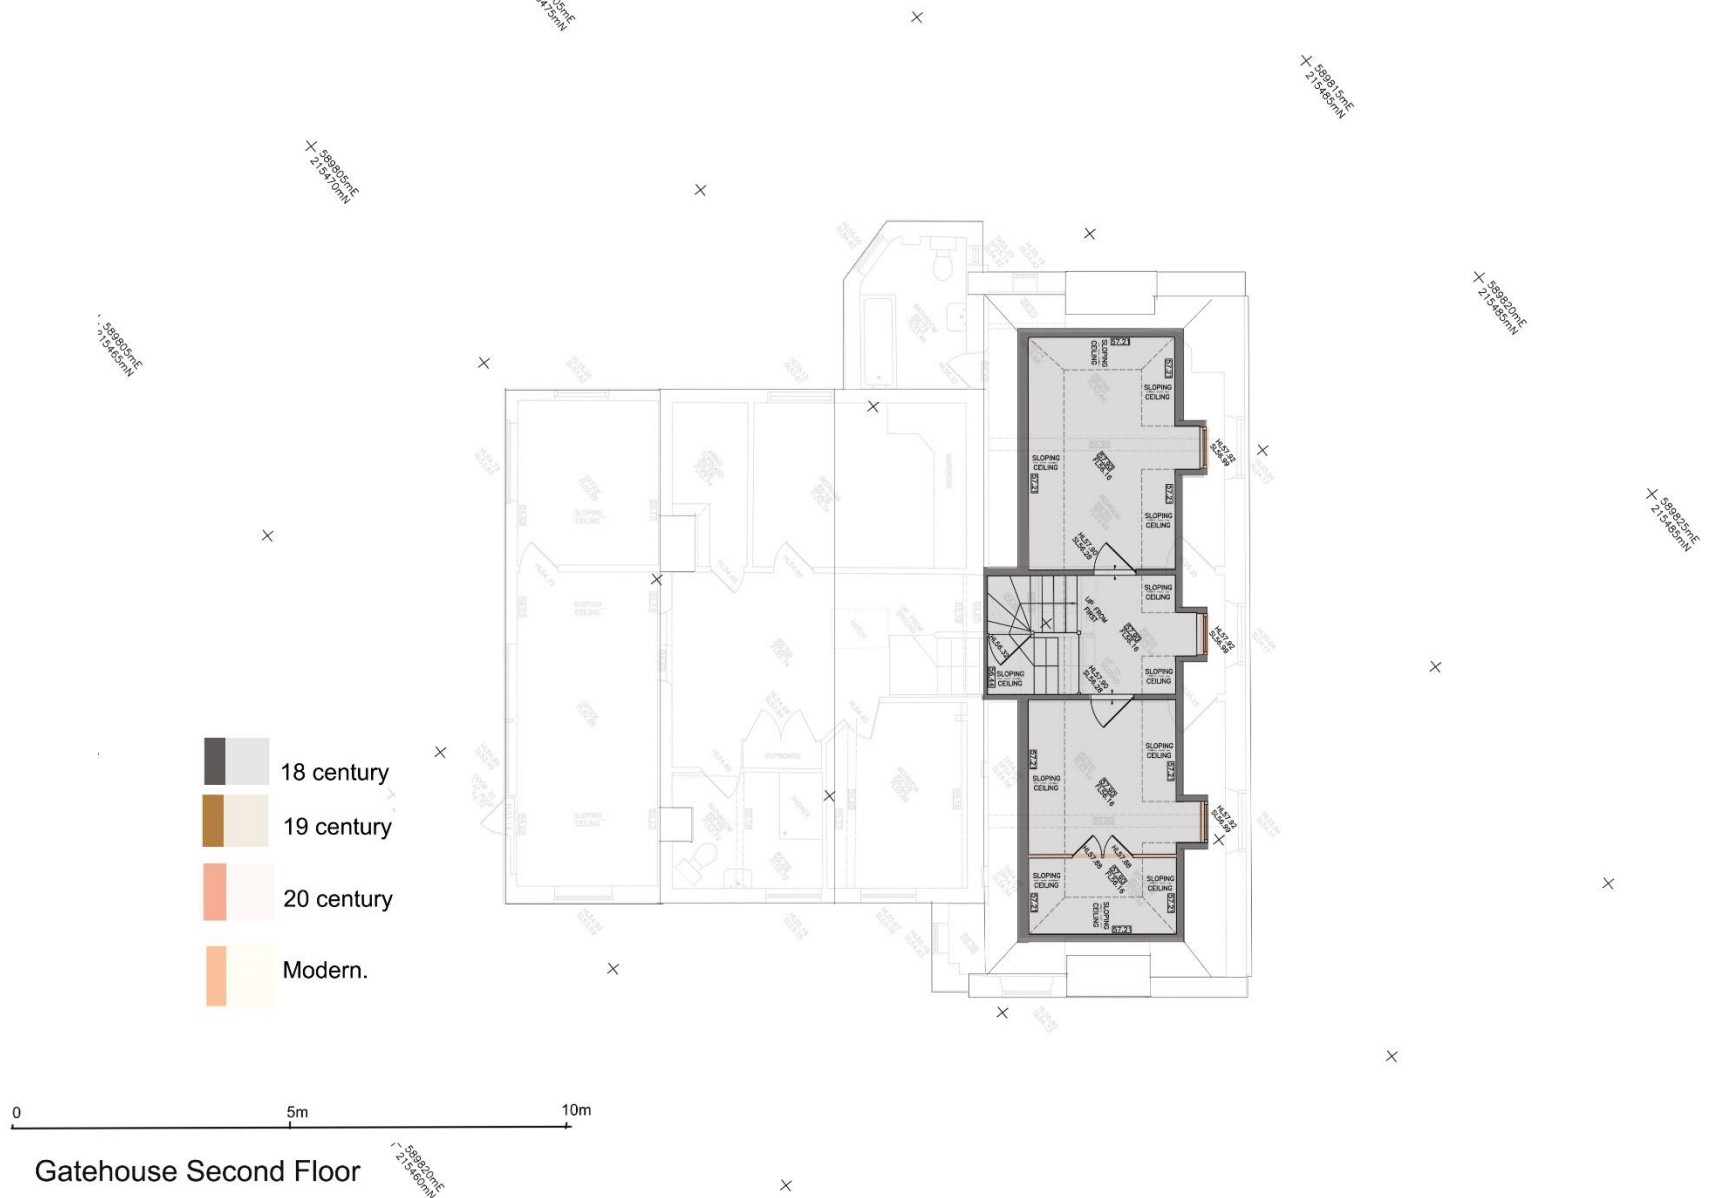
Although in a poor condition, much of the attic floor remains original 18c structure, although original lath and plaster has been replaced with fibre board and the original timber windows have been replaced by modern upvc.

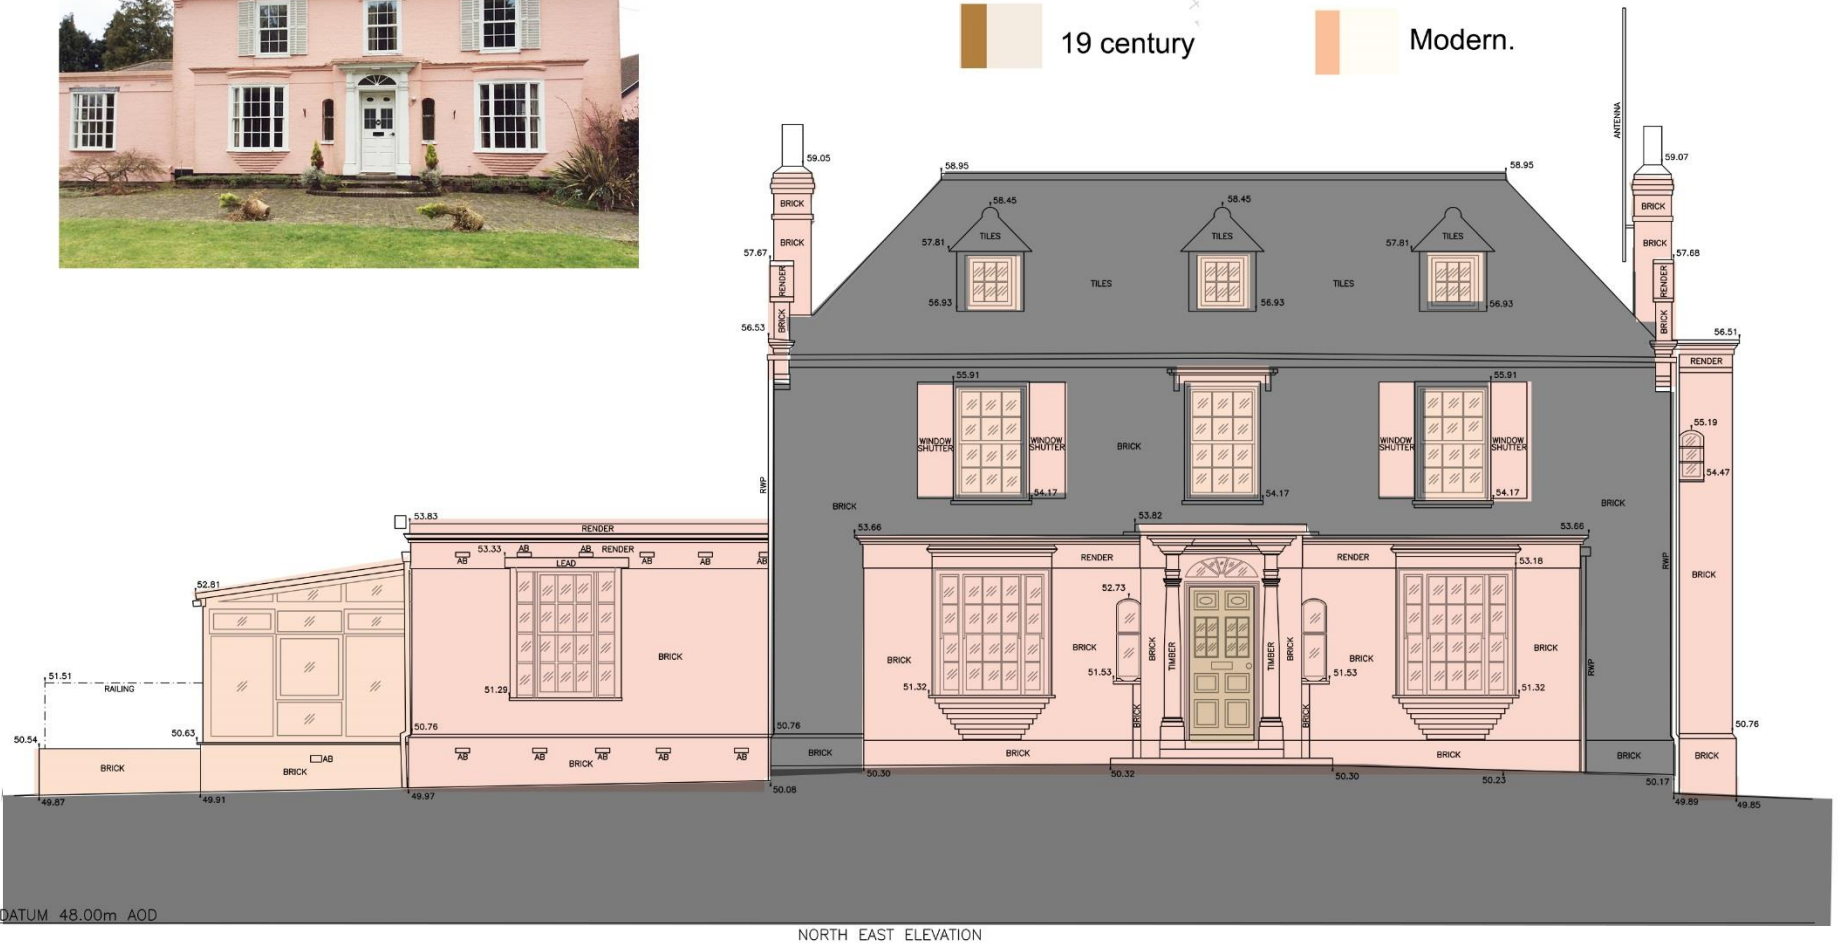
Assessment of Age: North Elevation.

Although “Georgian” in character, much is later extensions from 1960s & 70s in a debased style.

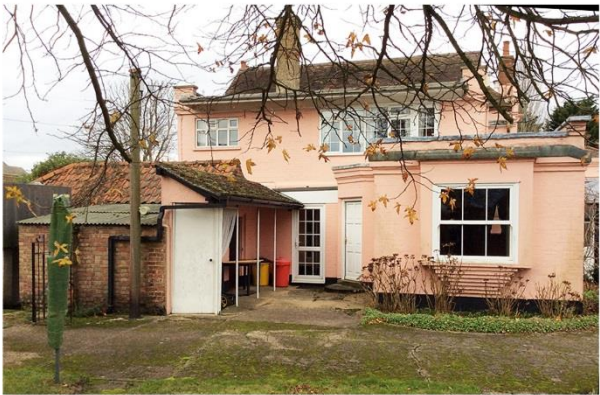
SOUTH WEST ELEVATION.

Low quality gallery, conservatory and plastic windows mar character of the original building.

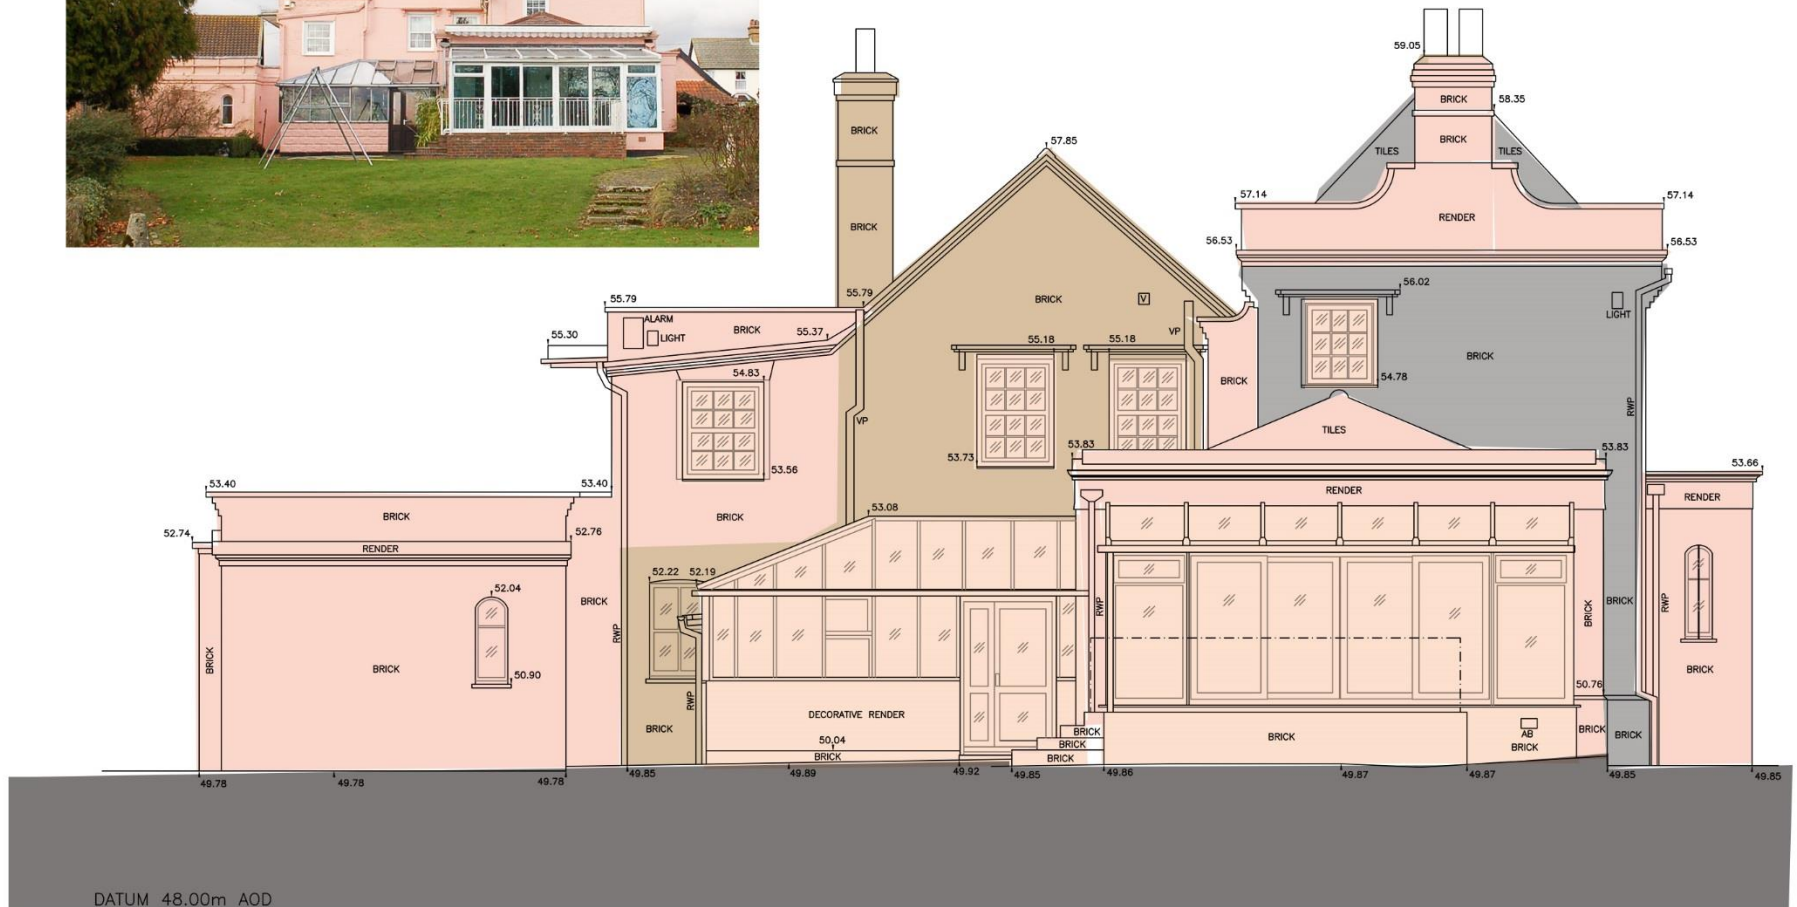
SOUTH EAST ELEVATION

Assessment of Age. East Elevation. Garden elevation masked by poor quality conservatories and extensions.

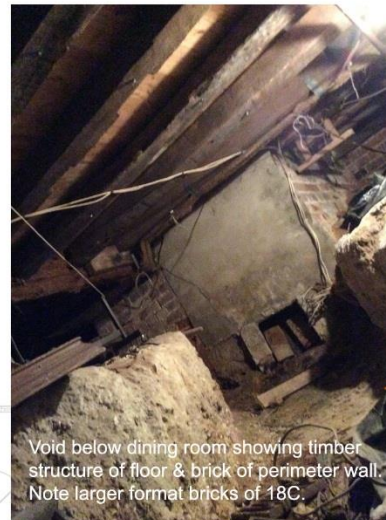
Void below dining room showing timber structure of floor & brick of perimeter wall. Note larger format bricks of 18C.

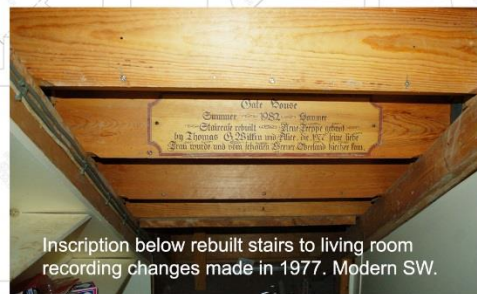
Inscription below rebuilt stairs to living room recording changes made in 1977. Modern SW.

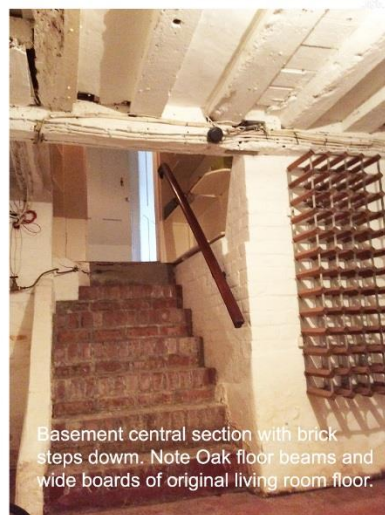
Basement central section with brick steps down. Note Oak floor beams and wide boards of original living room floor.

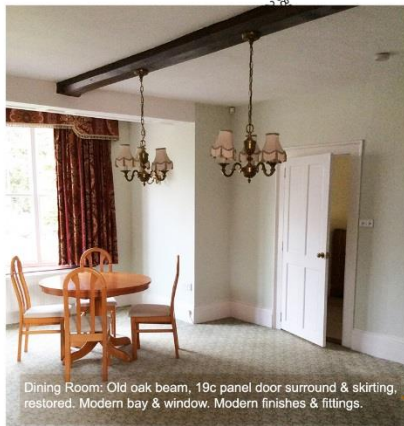
Dining Room: Old oak beam, 19c panel door surround & skirting, restored. Modern bay & window. Modern finishes & fittings.

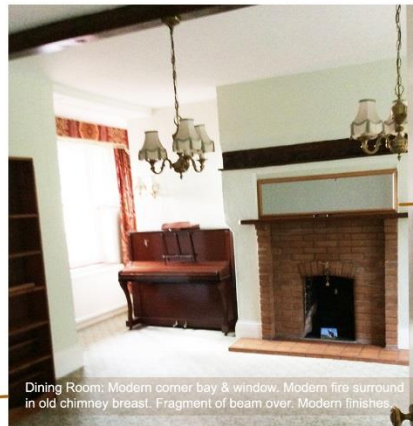
Dining Room: Modern corner bay & window. Modern fire surround in old chimney breast. Fragment of beam over. Modern finishes.

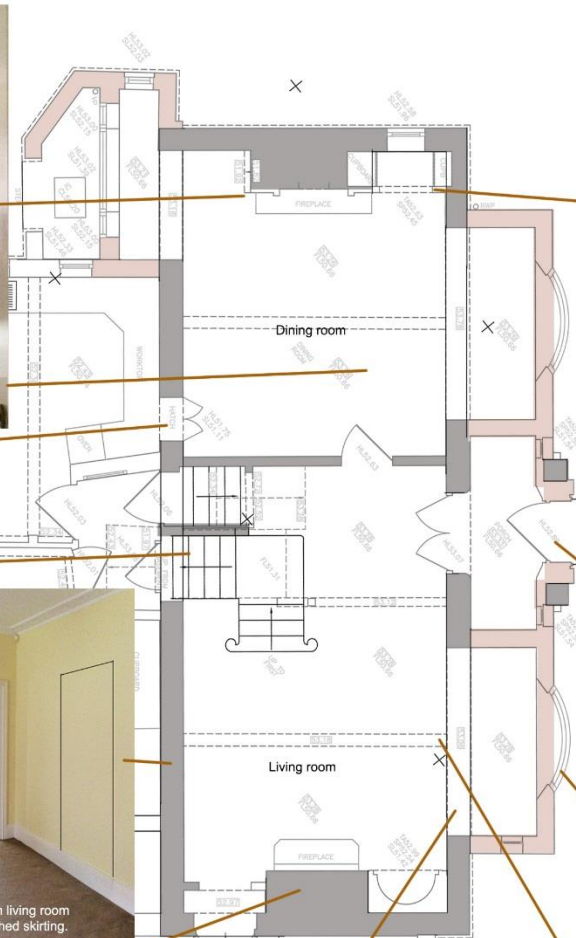
Dining room 1960s whimsy UPVC lunette window.

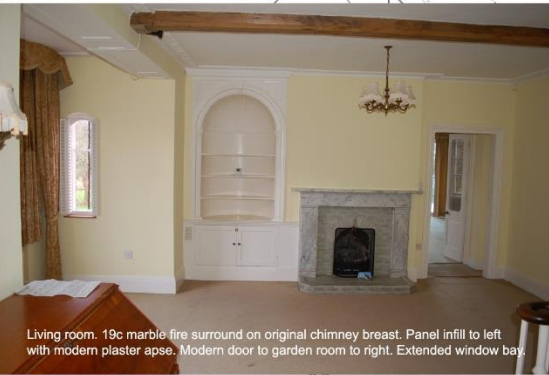
Living room. 19c marble fire surround on original chimney breast. Panel infill to left with modern plaster apse. Modern door to garden room to right. Extended window bay.

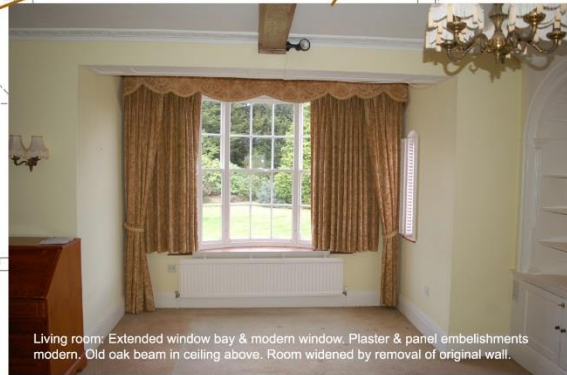
Living room: Extended window bay & modern window. Plaster & panel embellishments modern. Old oak beam in ceiling above. Room widened by removal of original wall.

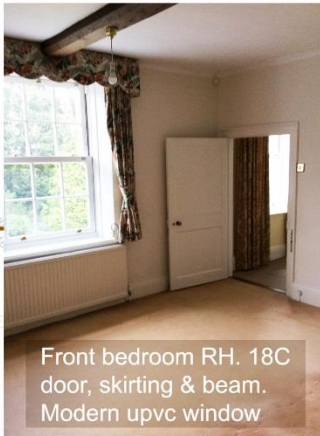
Front bedroom RH. 18C door, skirting & beam.  
Modern upvc window

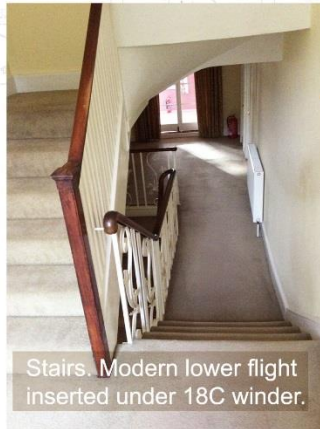
Stairs. Modern lower flight inserted under 18C winder.

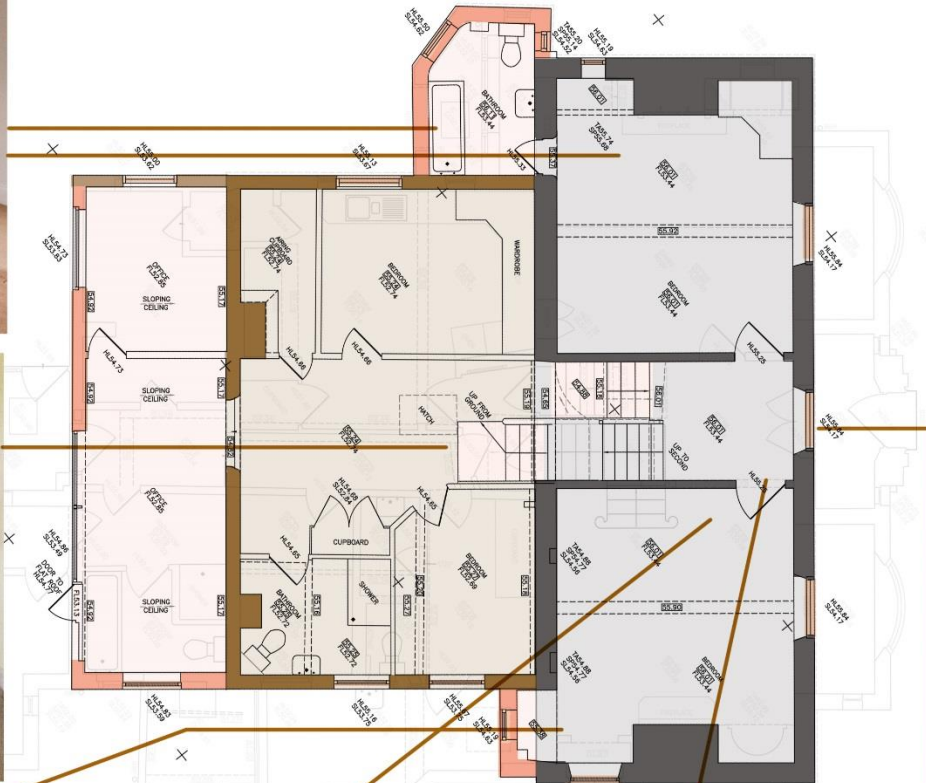
Gatehouse First Floor

Surviving significance  
compromised by  
modern extensions &  
alterations.

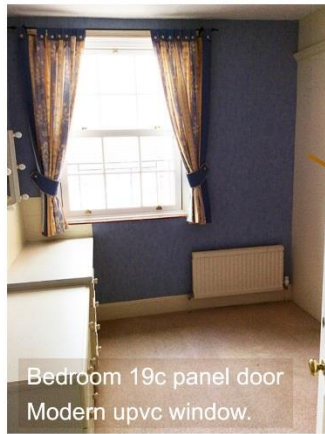
Bedroom 19c panel door  
Modern upvc window.

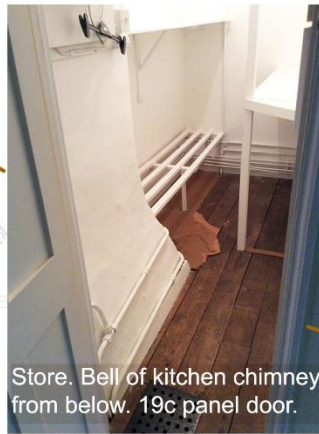
Store. Bell of kitchen chimney  
from below. 19c panel door.

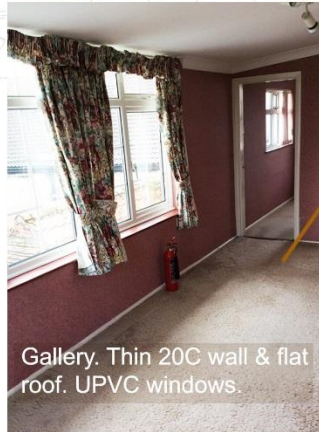
Gallery. Thin 20C wall & flat  
roof. UPVC windows.

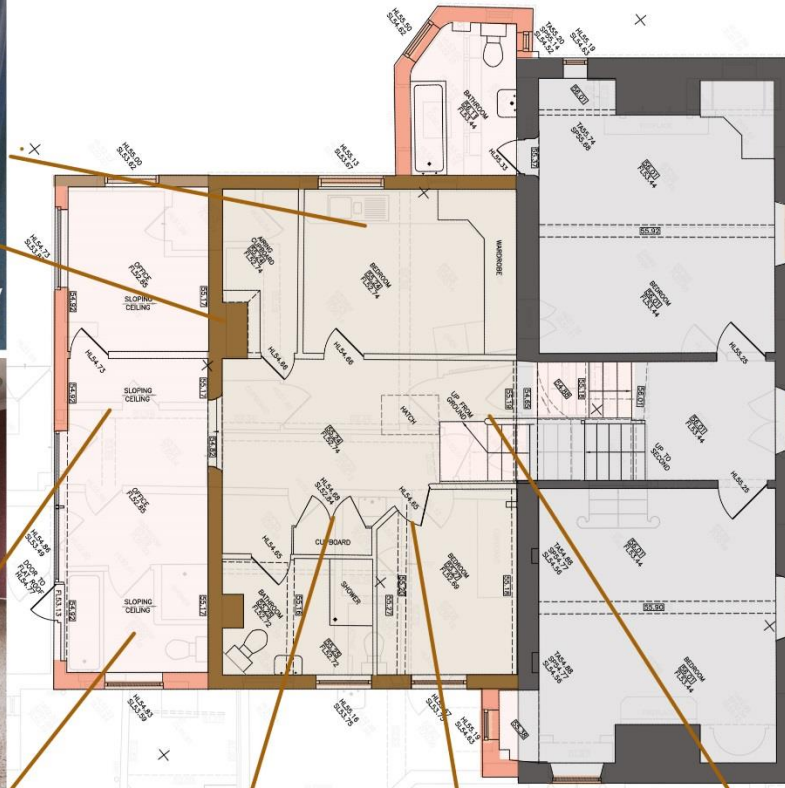
## Gatehouse First Floor Mid Section Significance

Some 19c joinery  
survives but spatial  
alterations change  
original character.

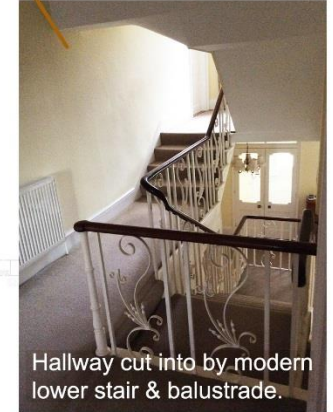
Hallway cut into by modern  
lower stair & balustrade.

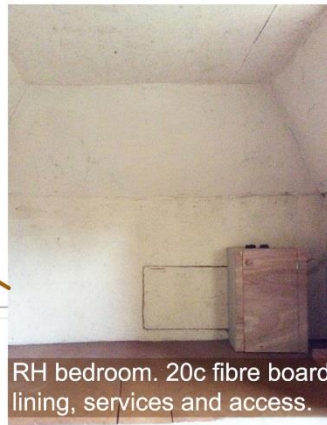
RH bedroom. 20c fibre board lining, services and access.

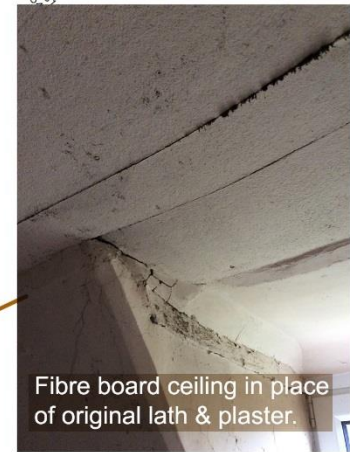
Fibre board ceiling in place of original lath & plaster.

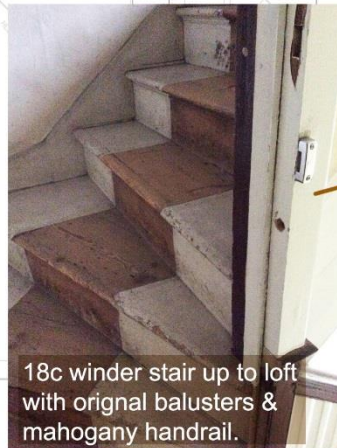
18c winder stair up to loft with original balusters & mahogany handrail.

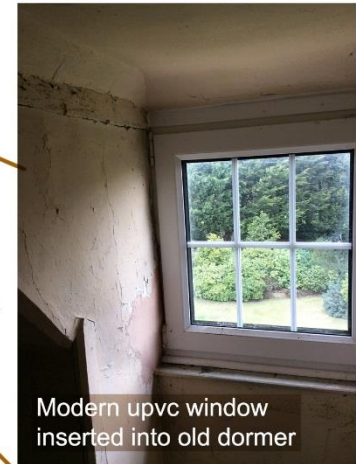
Modern upvc window inserted into old dormer

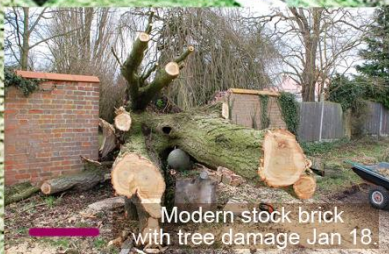
Modern stock brick with tree damage Jan 18

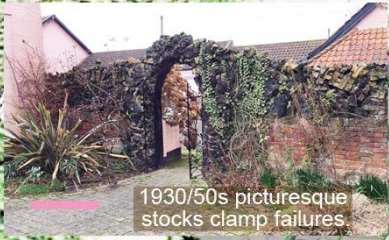
1930/50s picturesque stocks clamp failures

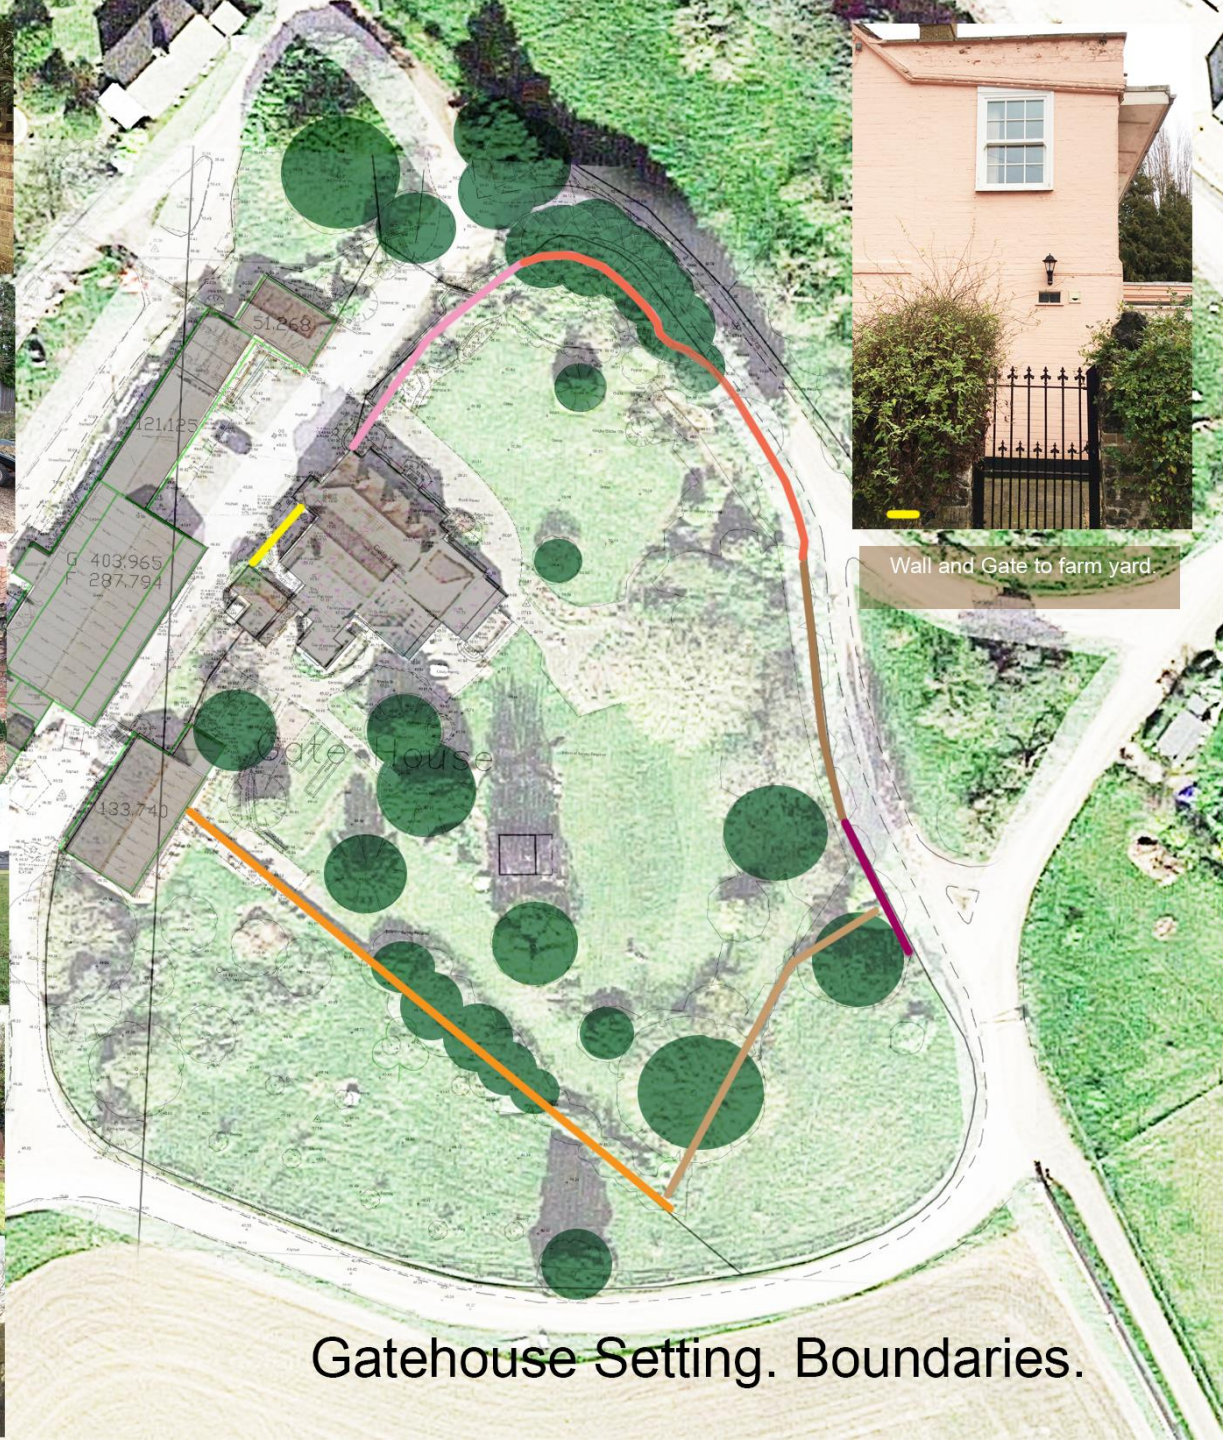
# Gatehouse Setting. Boundaries.

1900 stocks with modern repairs & displacement

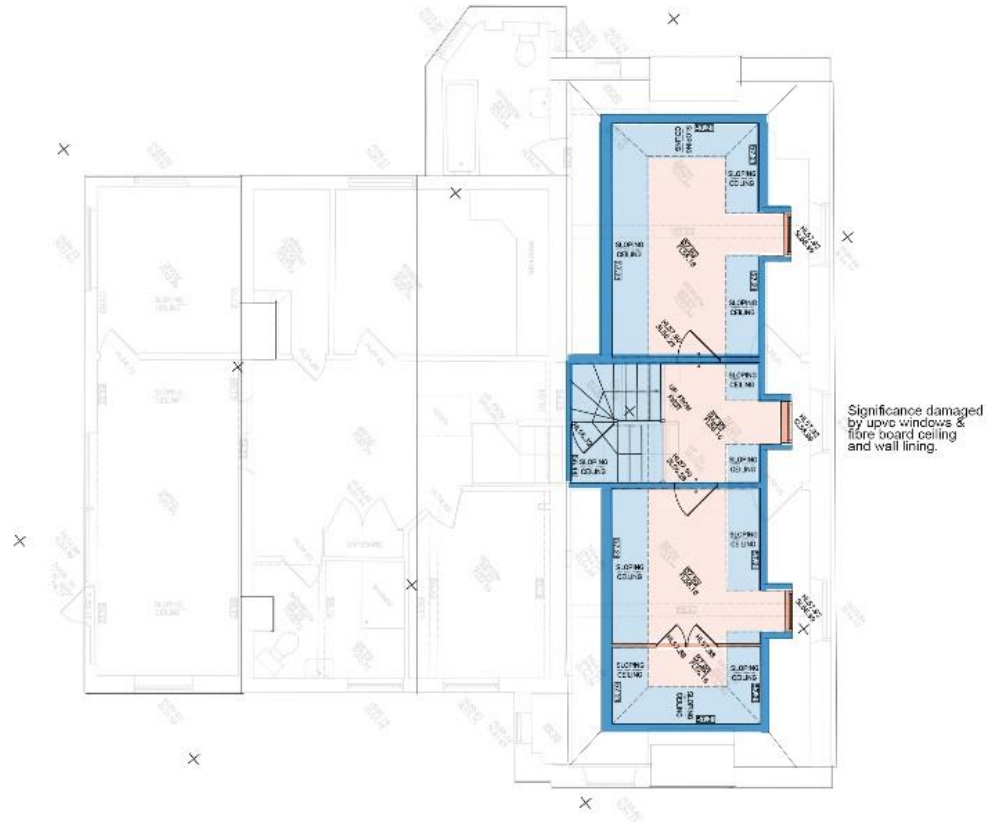
Gatehouse Second Floor

More significance retained due to less use, but modern upvc windows are damaging.

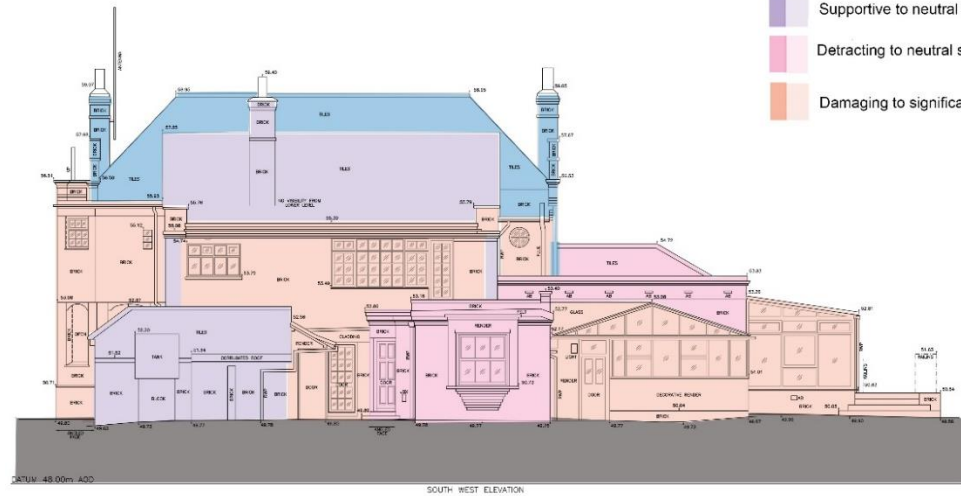
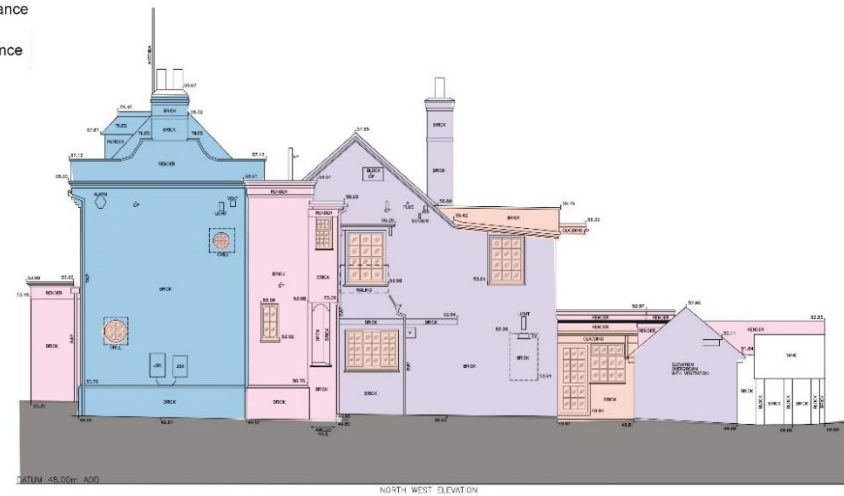
Significance masked and diminished by later extensions, pink paint & upvc windows.
