# **Colchester Town Wall: Management Plan 2019-2024**

## **Colchester Borough Council**

Written by Jess Tipper, Archaeological Advisor

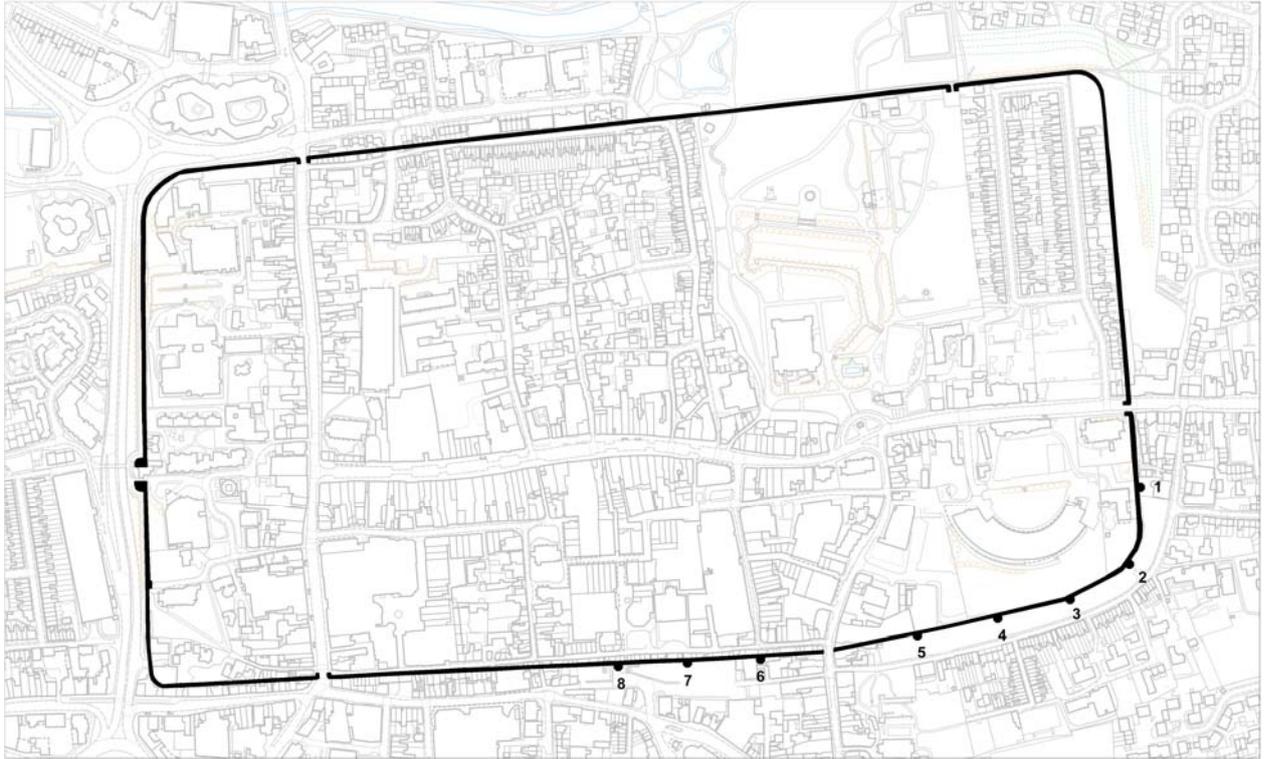
*Figure 8: Location of the Medieval Bastions. Bastions 1, 2, 5 and 6 survive above ground level.*

- 9.11.1 Colchester was refortified in the 14<sup>th</sup> century. A programme of repairs was carried out during the reign of Richard II (1379-1399) and the Wall was extensively refaced (Gascoyne and Radford 2013, 264-266). The most significant alteration was the addition of eight bastions (MCC2705 - MCC2711

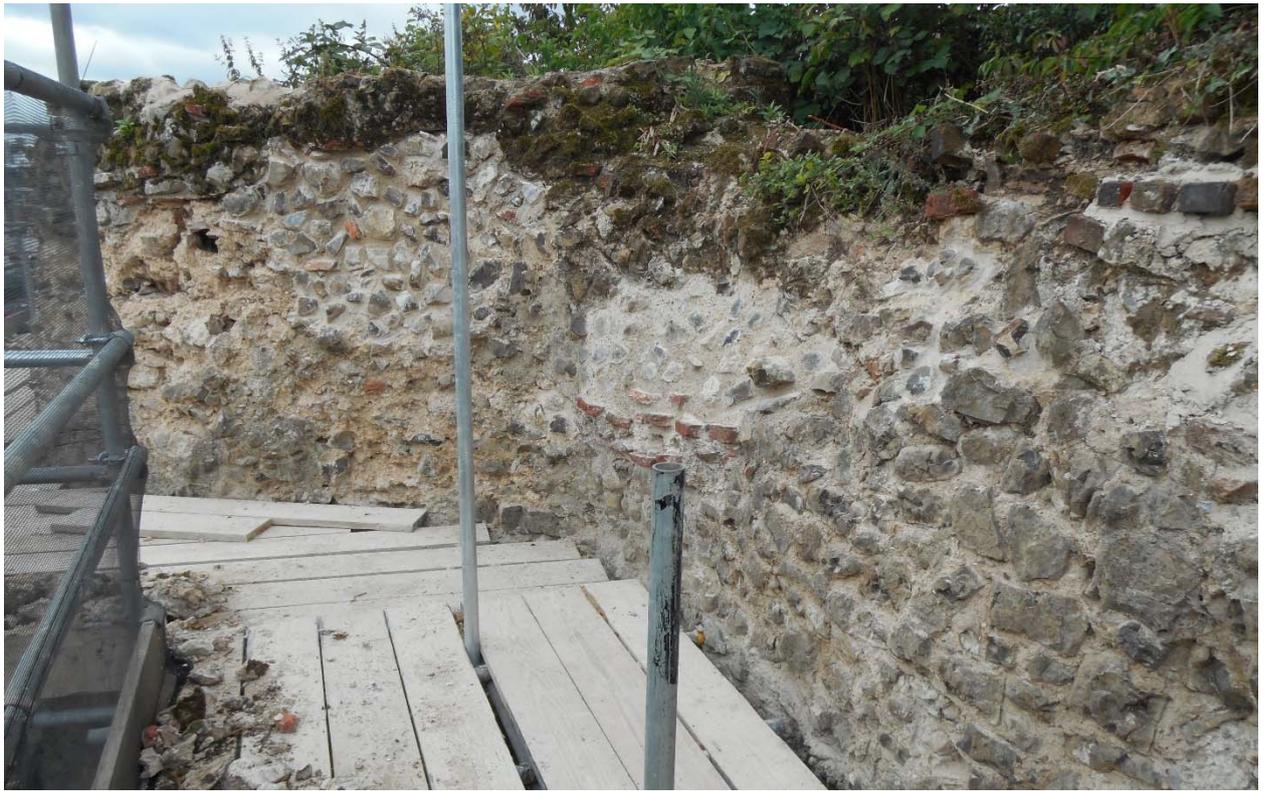
*Photograph 1: Repairs in progress to Bastion 1 in 2017 (image taken in September 2017)*

Condition Survey, an extensive programme of repairs and maintenance has been completed (and funding providing by the Council in accordance with Objective 5.3 of the previous Management Plan)(Photographs 1, 2, 3, 4, 5, 6, 8, 9, 11 and 12). All major repairs identified have been satisfactorily completed (in accordance with the Heritage Partnership Agreement), along the publicly accessible parts of the Wall:

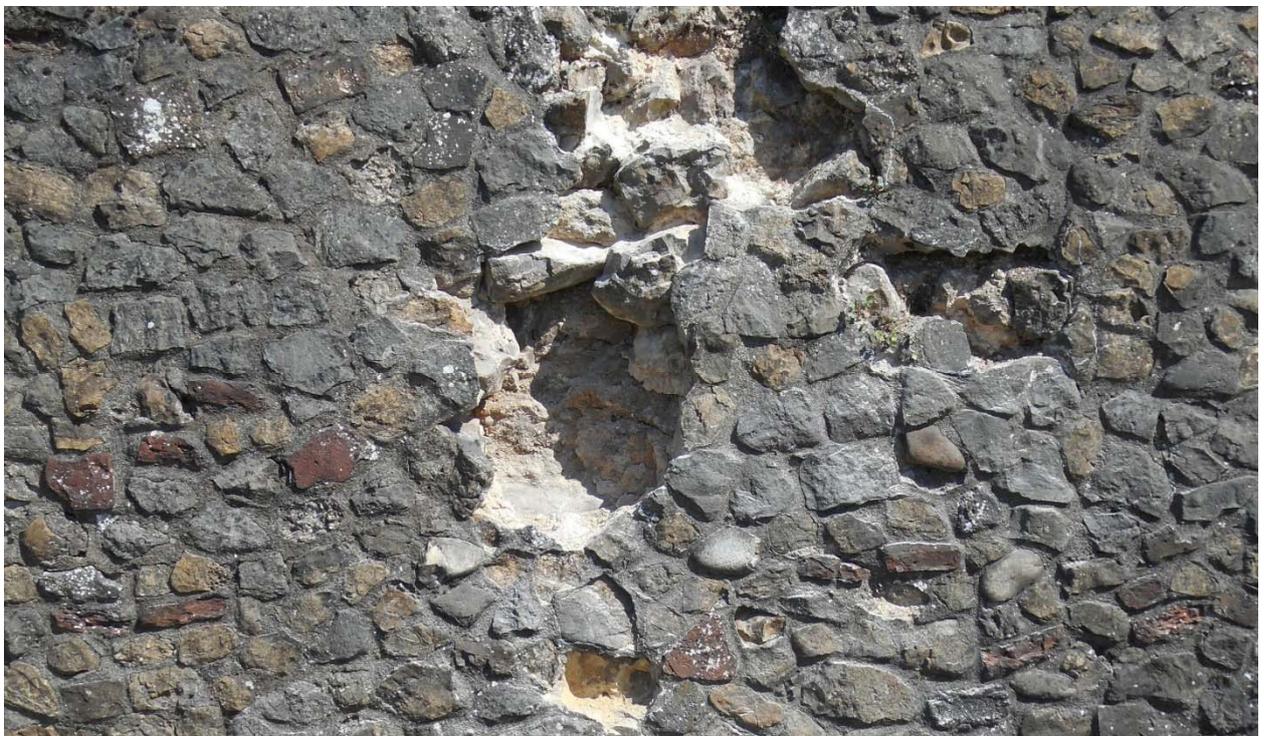
*Photograph 2: Repairs in progress at the NW corner of the Town Wall (northern end of Balcerne Hill). Loose septaria and cement mortar (part of the protective skin added during the 1950s and 1960s) have been removed, prior to patching with septaria and lime mortar (May 2017)*

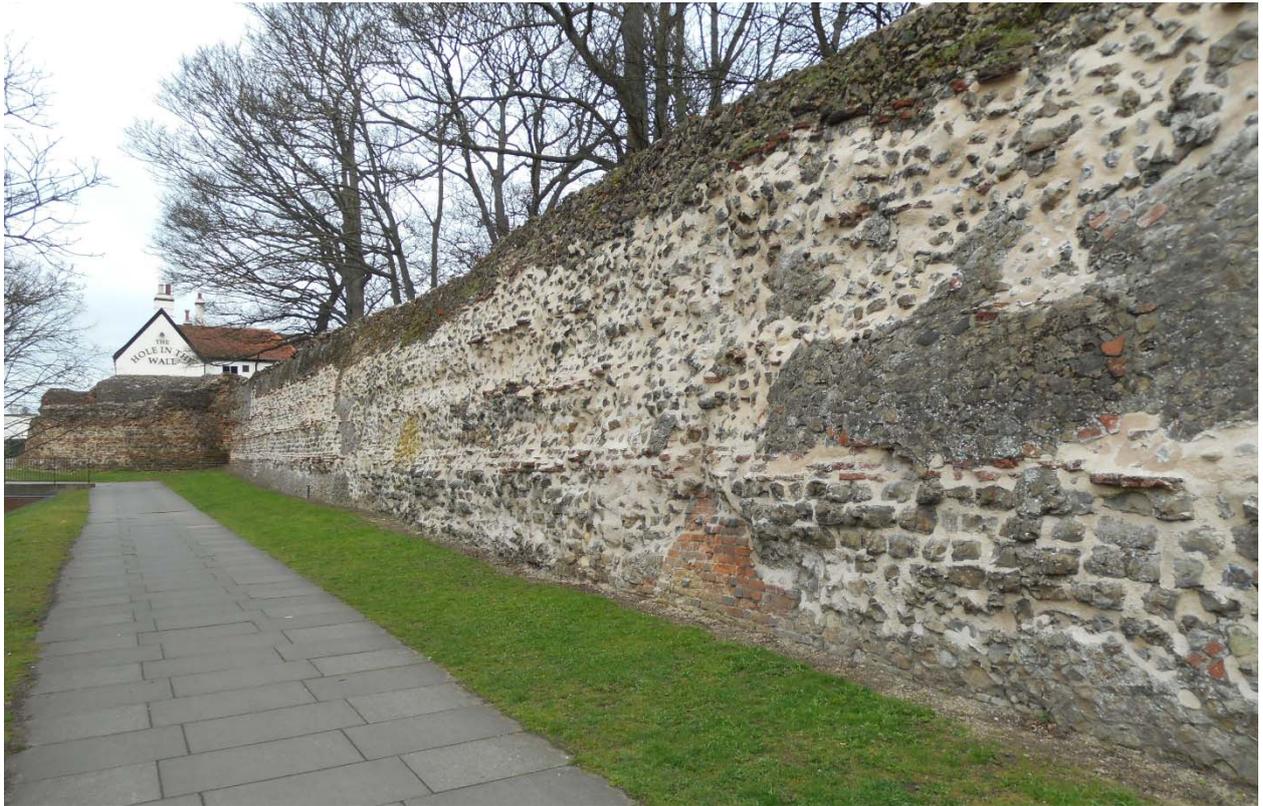
*Photograph 3: Town Wall along the southern part of Balkerne Hill (the Balkerne Gate is in the background) following repairs in 2016 (March 2017)*

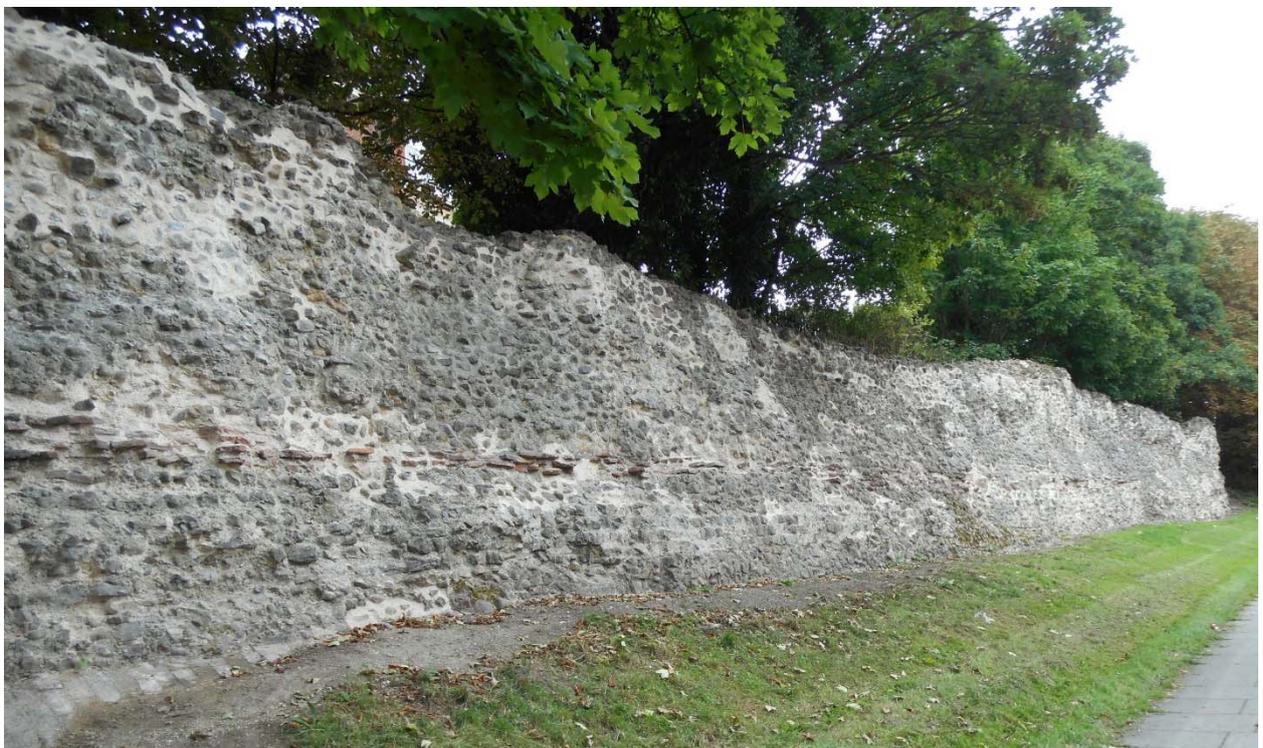
*Photograph 4: Town Wall along the northern part of Balkerne Hill following repairs in 2017 (September 2017)*

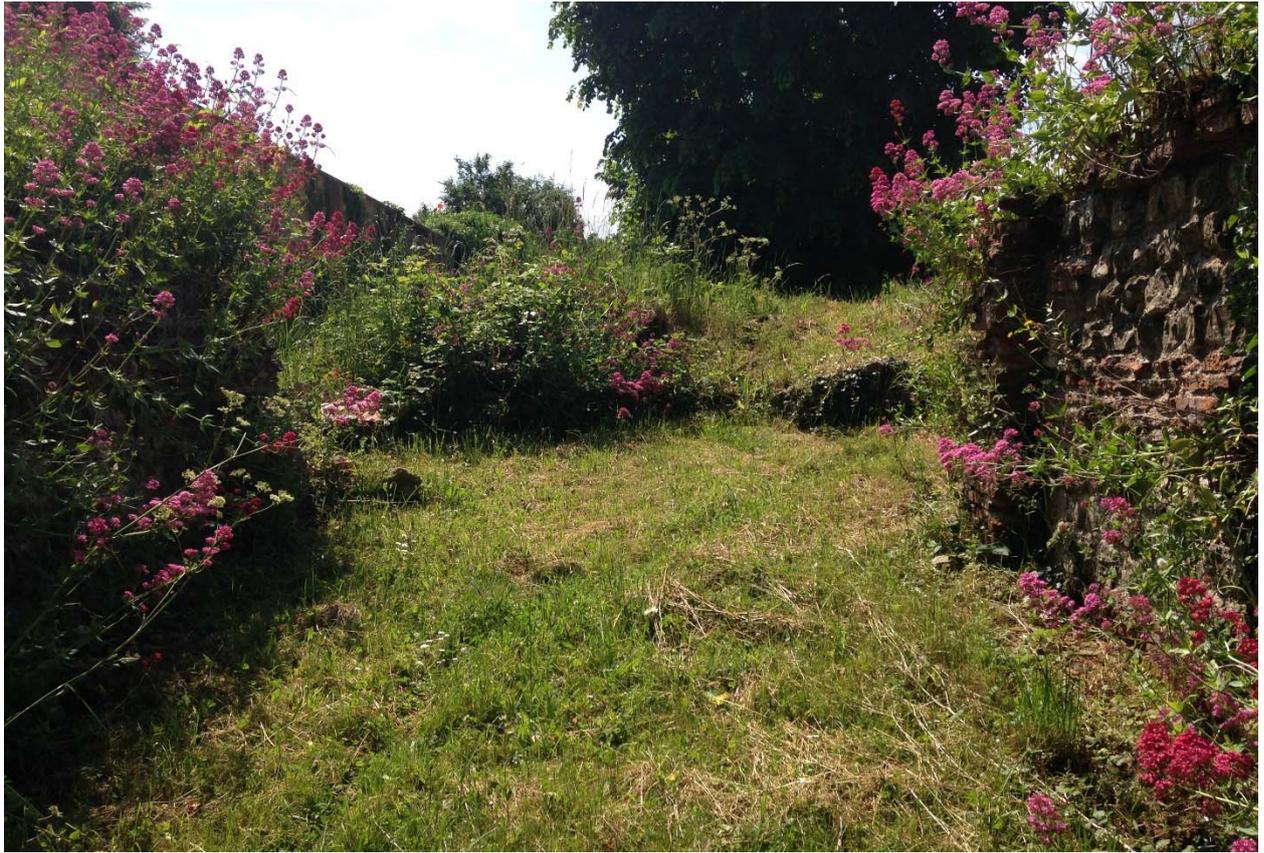
*Photograph 5: Duncan's Gate before repairs, looking south through the gate (June 2016)*

- 14.3.4 Improvements to the presentation of Duncan's Gate**  
(Strategy 5.4.2 of the previous Management Plan)
- 14.3.4.1 The remains of Duncan's Gate (and associated archaeological remains) were repaired in 2017 (Section 17), following a survey of the Wall and trial-excavation (both by Colchester Archaeological Trust). Following a survey of the flora and the identification of a rare species (Lesser Calamint) by Colchester Natural History Society, in advance of the repairs of maintenance, these plants were successfully relocated to a safe place close to (but not on) the Wall.

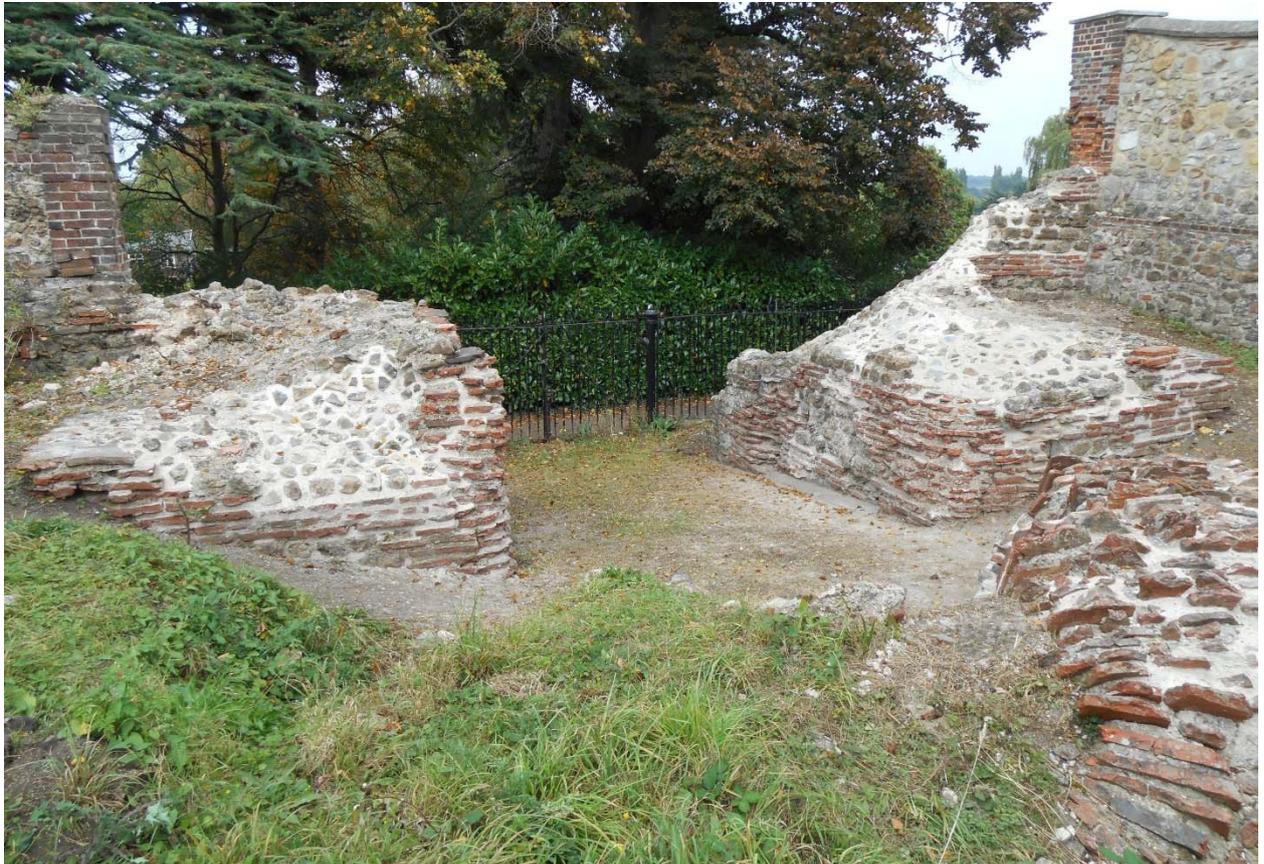
*Photograph 6: Duncan's Gate after repairs in 2017, looking north (September 2017)*

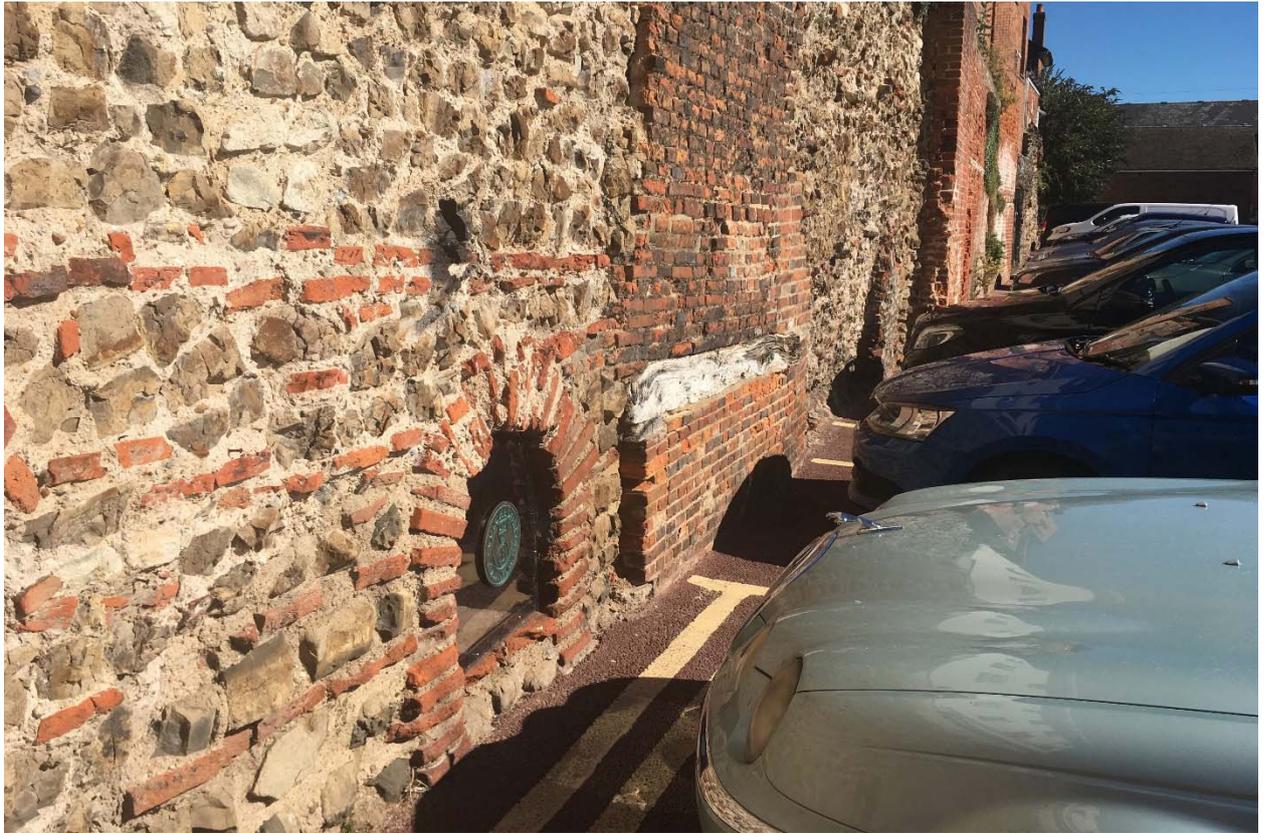
*Photograph 7: Vineyard Street Car Park showing cars parked in front of the Wall. The Roman culvert under the Wall is in the foreground (September 2018)*

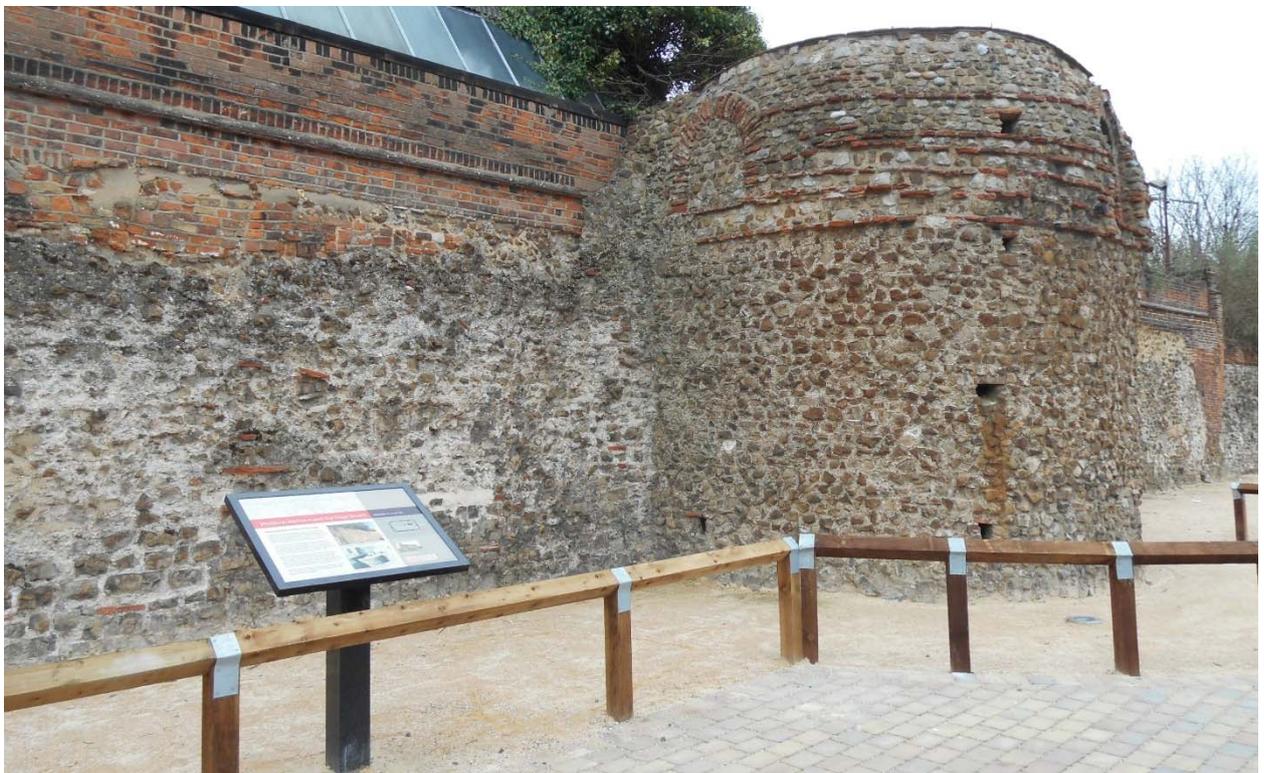
*Photograph 8: Priory Street car park and Bastion 5, following car park improvements in 2017. Car parking has been removed from the base of the Wall to better reveal the significance of the Wall and also to prevent damage from vehicles (March 2017)*

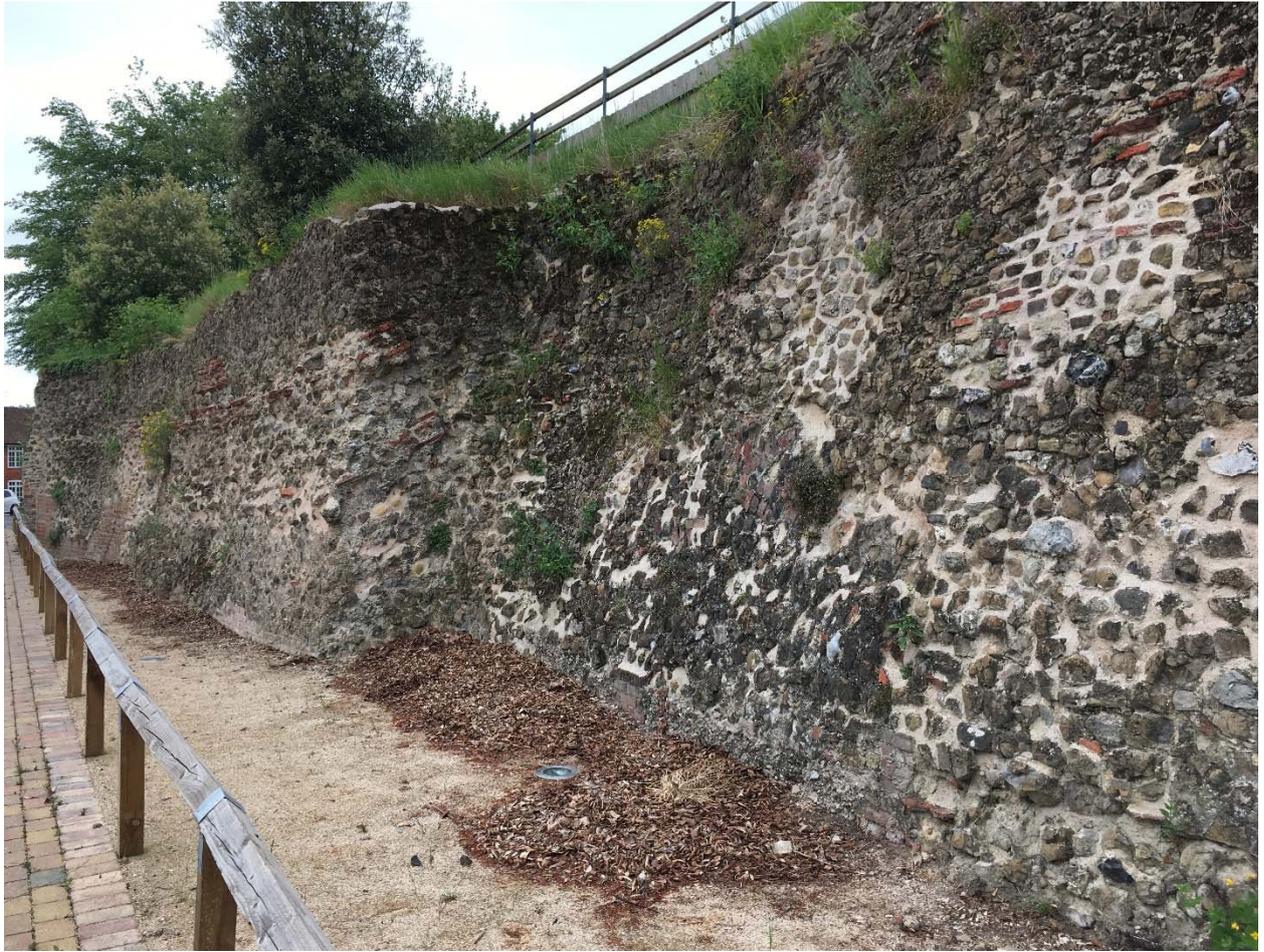
*Photograph 9: Priory Street Car Park. Leaves and other material (including rubbish) has accumulated along the base of the Wall. This needs to be monitored and material routinely collected to ensure the Wall is well presented and so the lighting is not obscured (May 2018)*

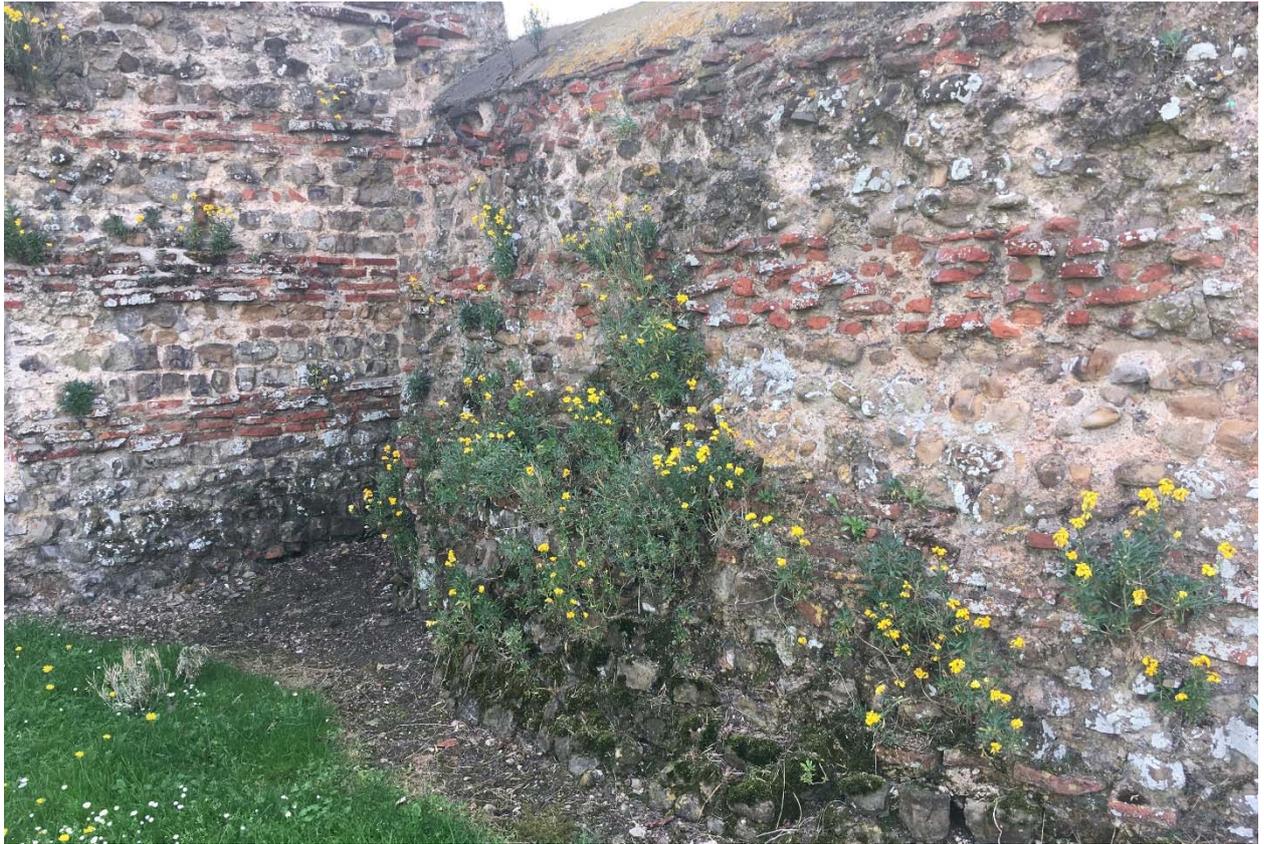
*Photograph 10: Wall flowers, which cause no damage to the historic fabric, growing on the Balcerne Gate. A wide variety of plants grown on the Wall, which is designated as Local Wildlife site (May 2018)*

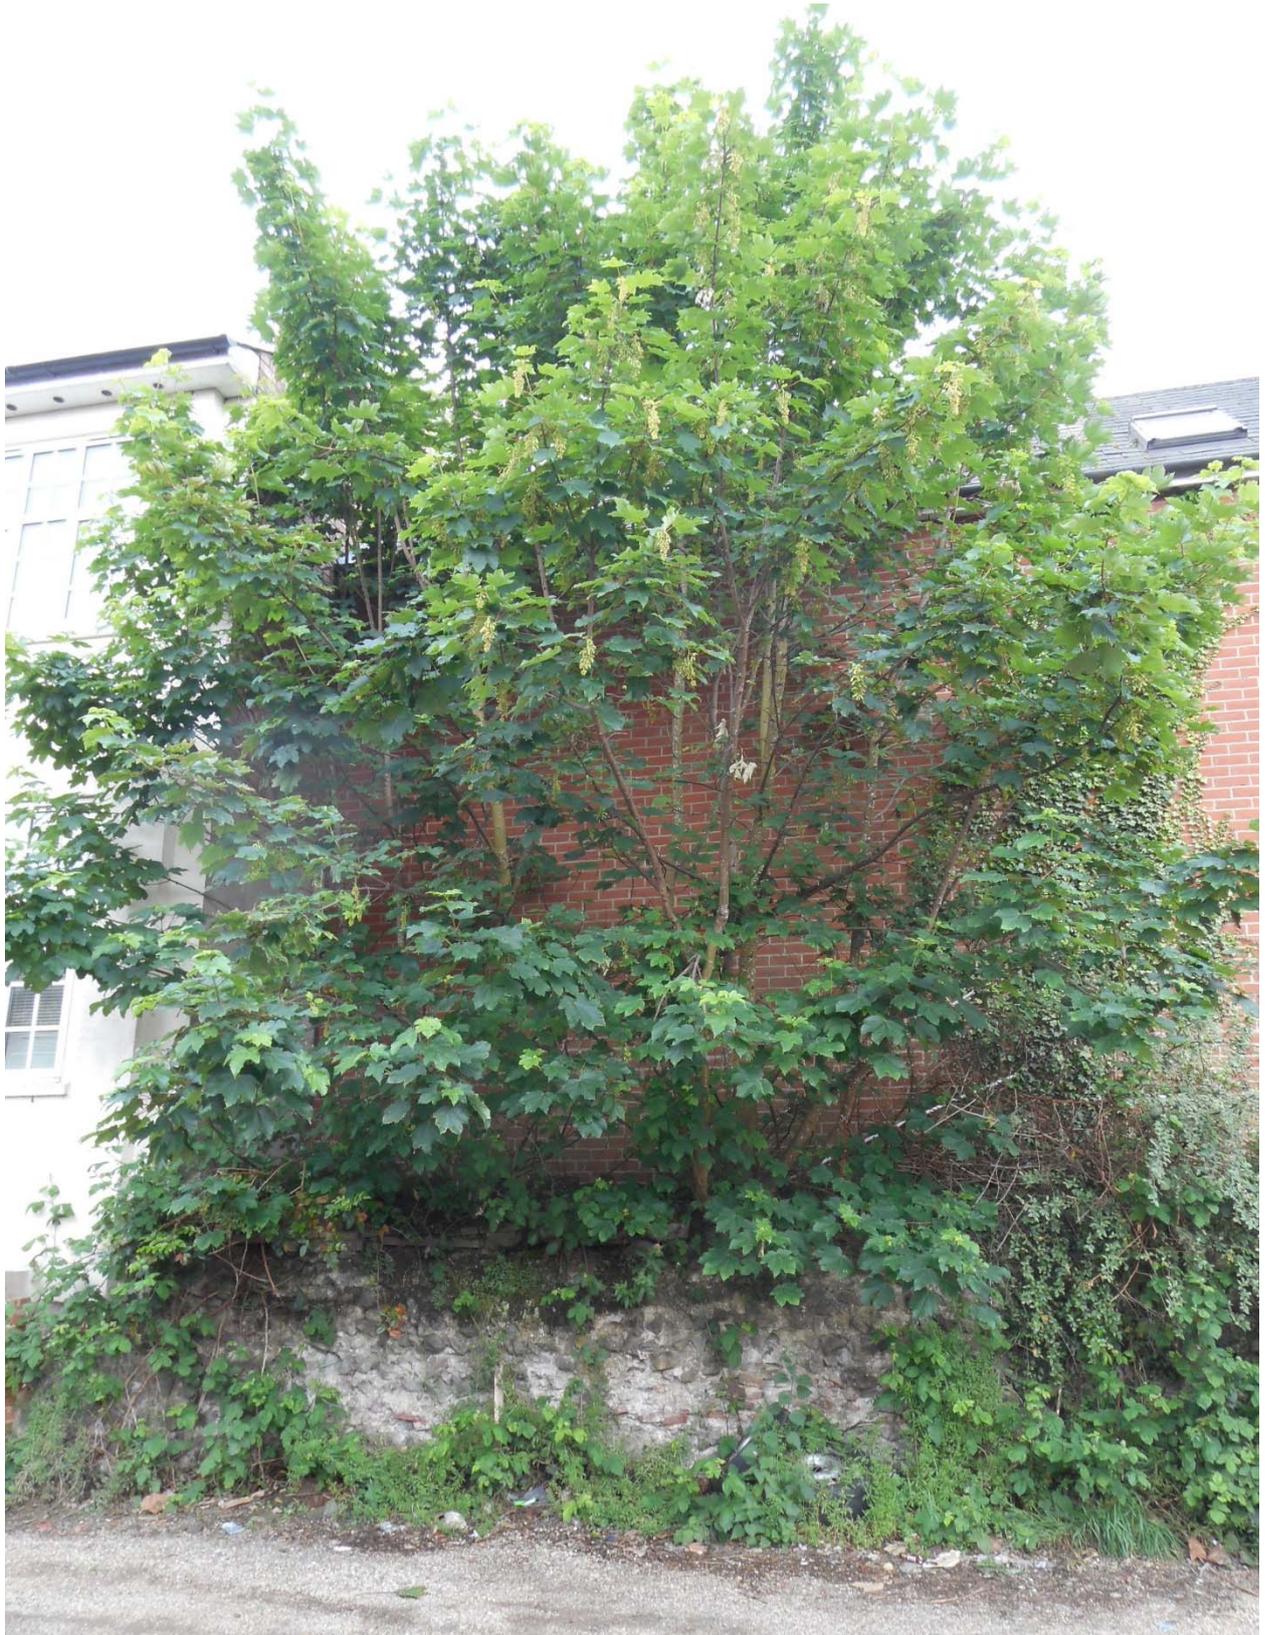
*Photograph 11: Sycamore Tree growing on the surviving Wall at St Peter's Street Car Park, prior to removal in 2017. The tree would damage the structure if it was left to grow in this location (May 2017)*

- 16.1.3 A number of shrubs and trees have established themselves on the Wall, including varieties such as Buddleia (*Buddleja davidii*), Bramble (*Rubus fruticosus* aggregate), Forsythia (*Forsythia x intermedia*) and Sycamore (*Acer pseudoplatanus*). These risk damage to the structure and will be carefully removed from the Wall (Photographs 11, 12, 13 and 14).

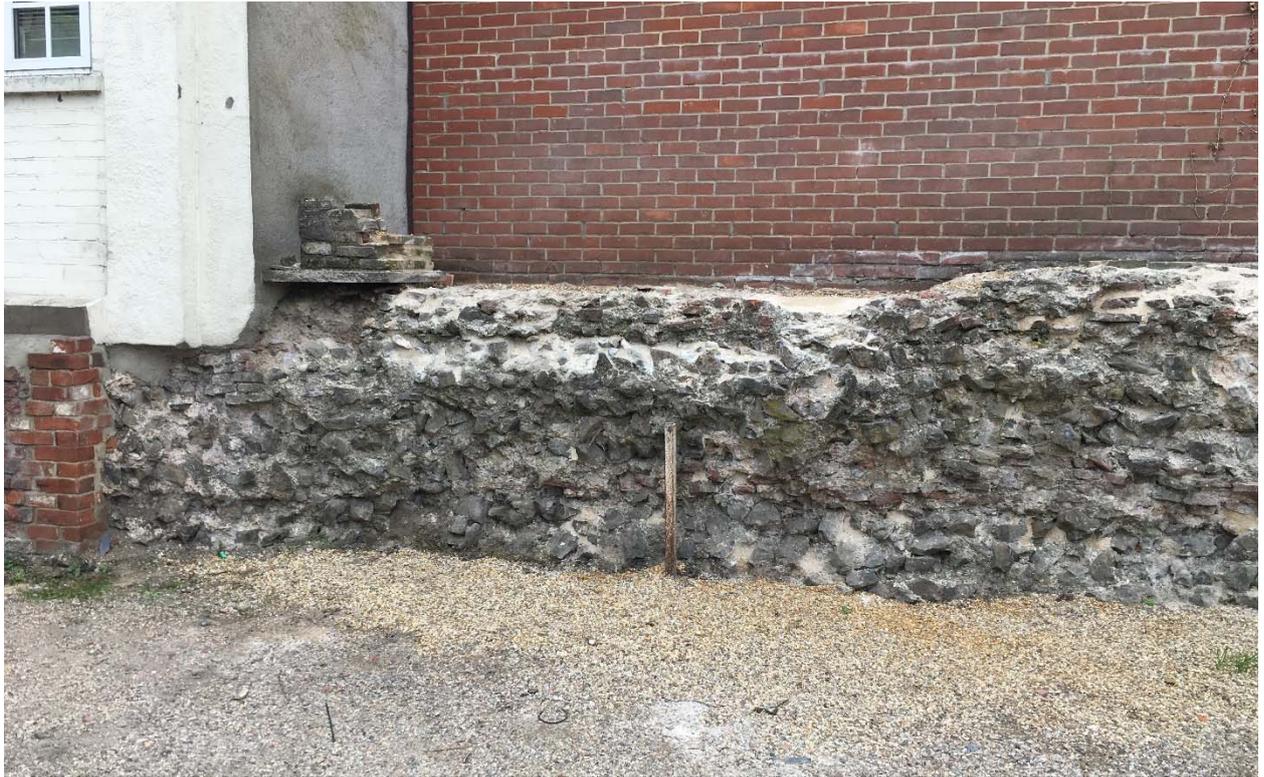
*Photograph 12: Town Wall in St Peter's Street Car Park following removal of sycamore tree and repairs in 2018 (August 2018)*

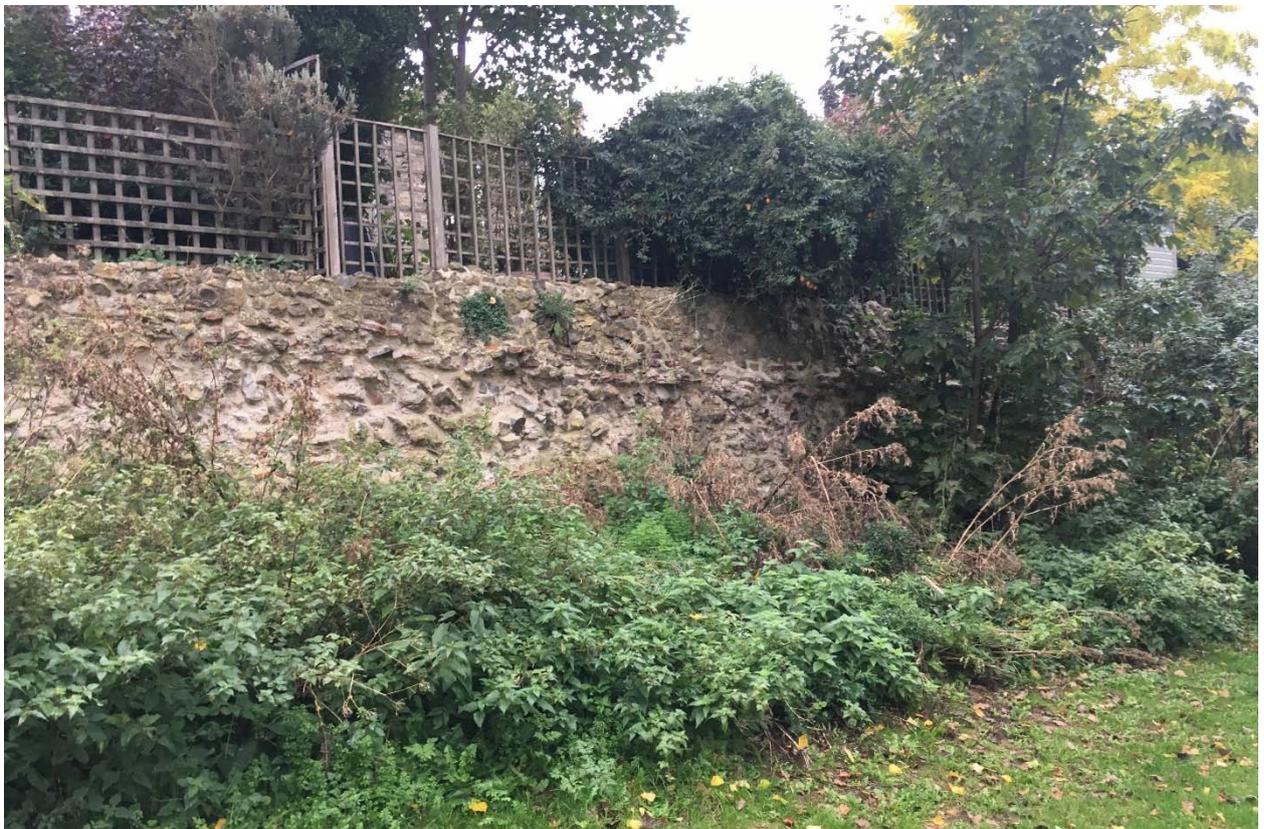
*Photograph 13: Vegetation, including a sycamore tree, growing at the base of the Wall. This will cause damage to the Wall and should be removed (October 2018)*

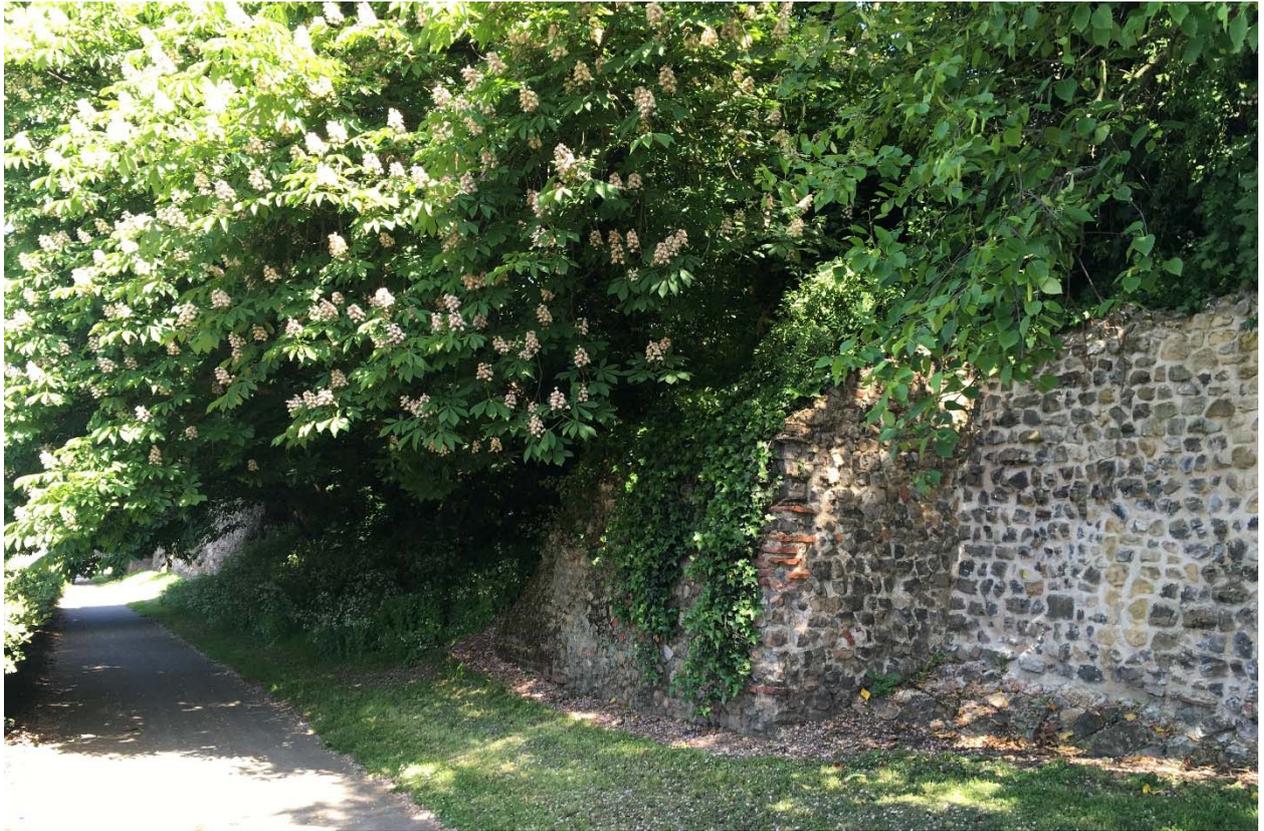
*Photograph 14: Town Wall along the northern part of Balkerne Hill showing mature horse chestnut trees on the inside of, and overhanging, the Wall. Damage can be caused both from the roots of these trees and also from branches within striking distance of the Wall (May 2018)*

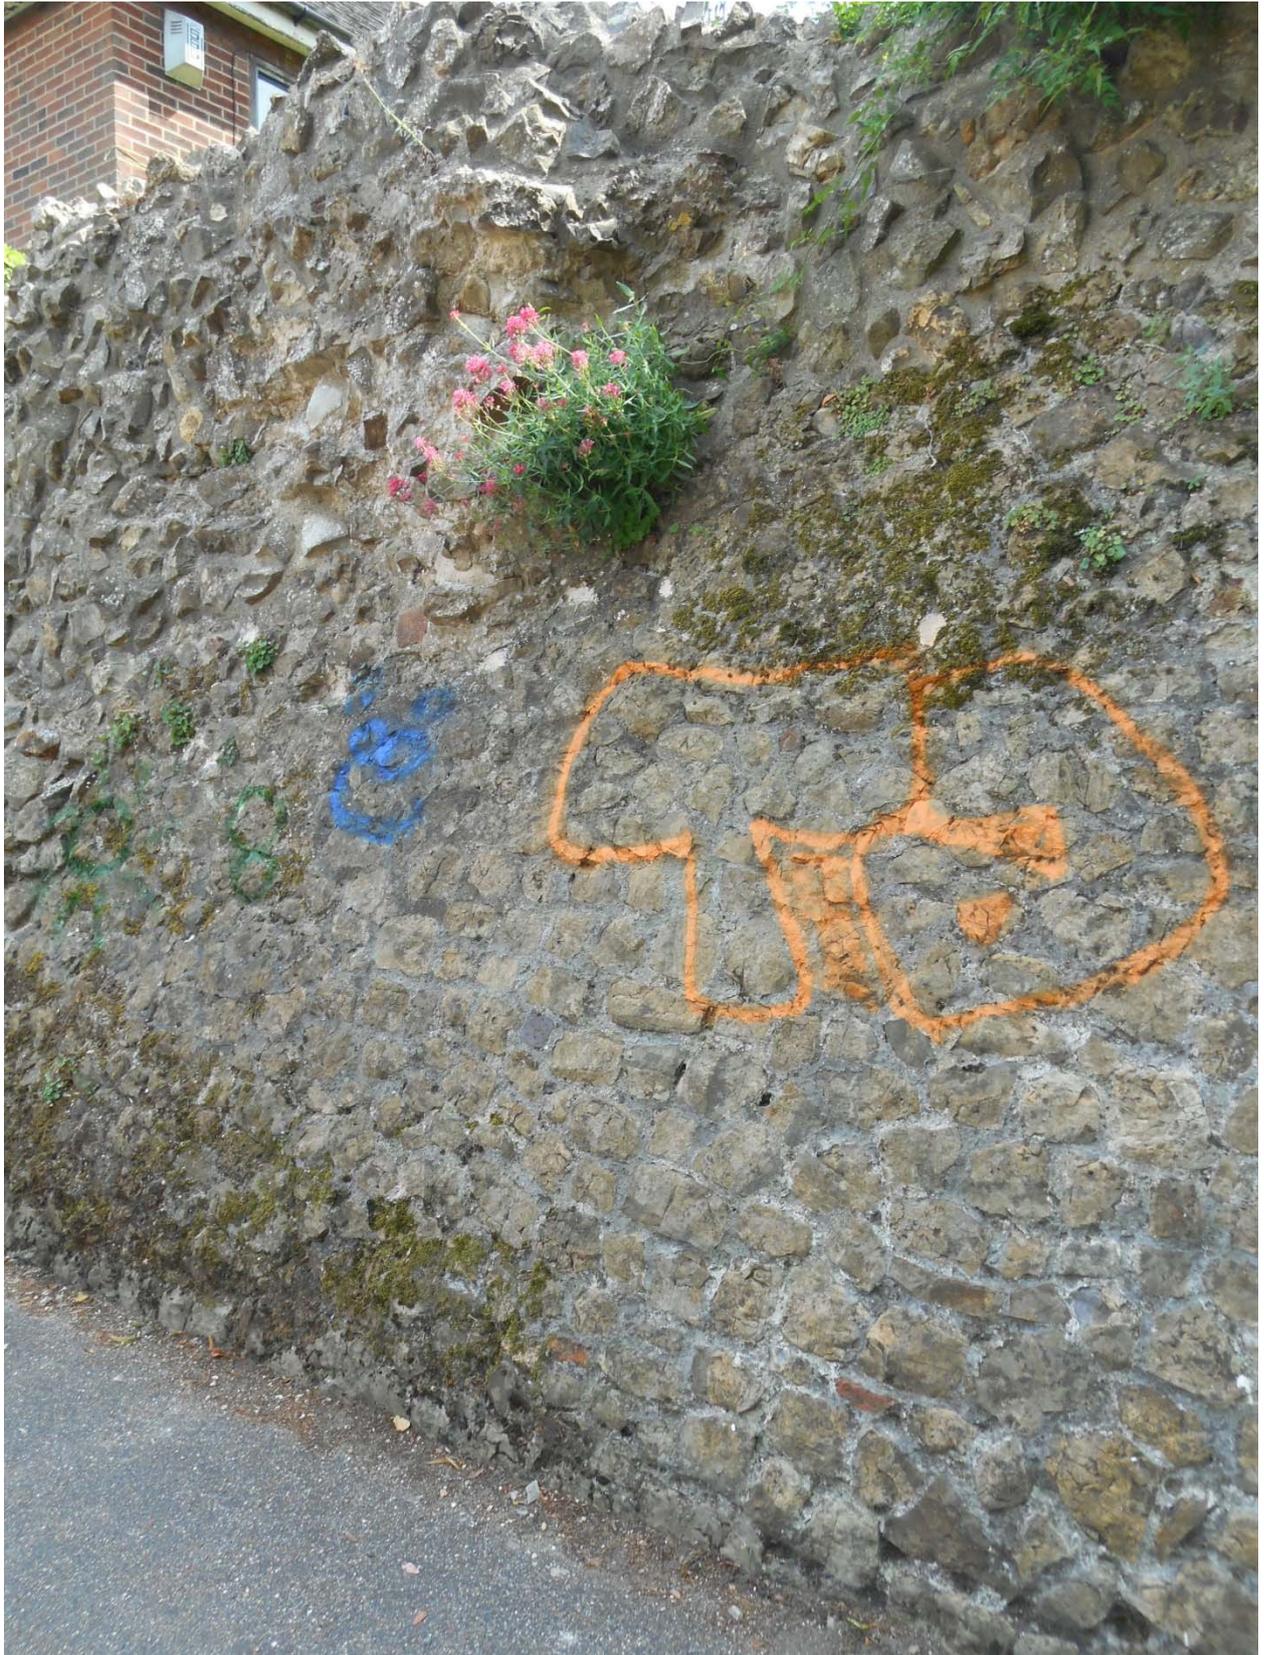
*Photograph 15: Graffiti to the Town Wall in the section through Castle Park in 2017. The graffiti was carefully and promptly removed following advice from Historic England (July 2017)*
