Colchester Roman Circus:

Draft Management Plan 2020-2025

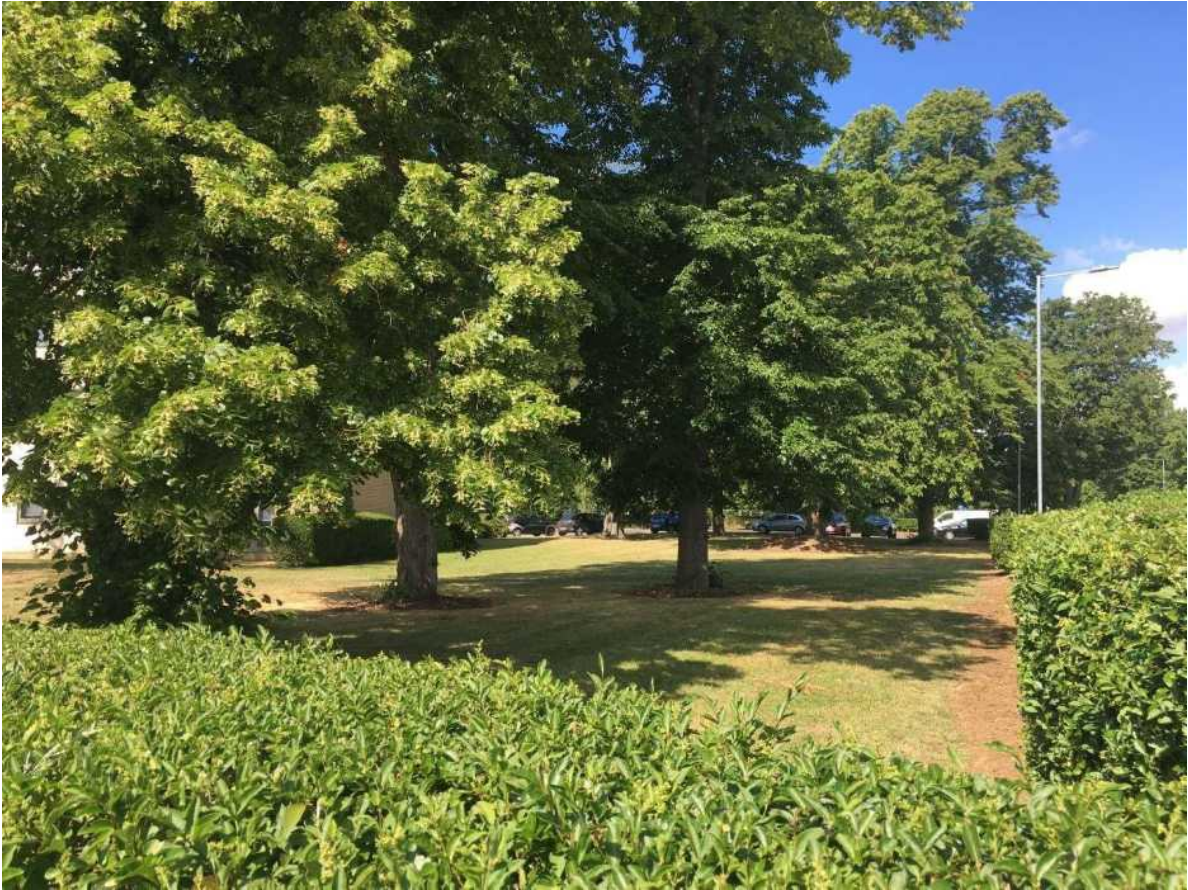
Photograph 1: View (looking west) along the line of the southern cavea (not demarcated) in EX905194 (Abacus Land 4 Ltd), June 2020. Pearce Court and Bradman Court are located on the left (south) behind the mature trees.

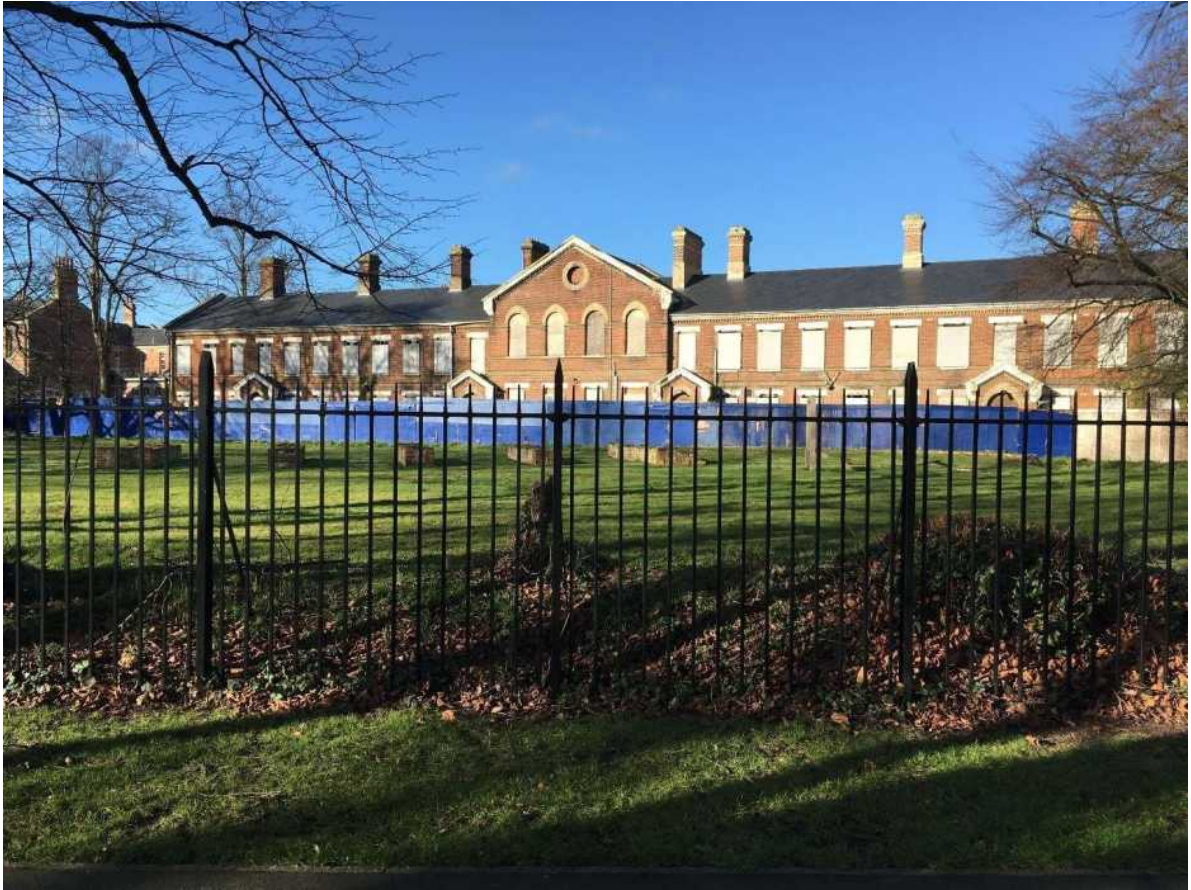
Photograph 2: View (looking west) of the D-shaped lawn EX787918 (Taylor Wimpey), January 2019. The low bank is immediately behind the railings. The reconstructed stumps of the starting gates are located in front of the blue hoarding and the Former Officers' Quarters (NHLE no. 1375581) is behind it.

- 10.2.1 EX787918 is the D-shaped lawn in front of the former Officers' Quarters, which is Grade II Listed ([NHLE no. 1375581](#)), at the west end of the Circus (Figure 12, Photographs 2 - 5). This also includes the land to the south west (and in front) of the Roman Circus House. The D-shaped lawn is demarcated by a low bank with mature trees on it, in varying conditions, and surrounded by modern black metal railings.¹³ It was originally created as part of the formal landscaping of the late 19th century, in front of the Officers' Quarters, originally planted as a tree screen. There was a path/road from Le Cateau Road that curved around the outside to a pair of gates into the Artillery Barracks - the East Gate located on the north side of the Officers' Quarters and the South East Gate located on the south side, i.e. the D-shaped lawn extended out from the boundary of the Barracks. The building, which became known as the Sergeants' Mess towards the end of the 20th century, was originally constructed as Officers' Quarters in 1874-5 for the 19th-century Artillery Barracks¹⁴, with later extensions and alterations. It is aligned NE to SW, with a SE-facing façade facing on to the lawn and Abbey Field. The building was

- 10.2.2 Replica stumps of the starting gates were constructed by CAT directly above the buried remains, following archaeological investigations, in 2014. In addition, the location of the *cavea* walls have been marked out on the ground surface with loose, white stone and an interpretation panel has been erected (a perspex panel with the outline of the reconstructed starting gates). It is fortuitous that the Circus remains fell in this relatively open area, ensuring the survival below-ground archaeological remains without significant disturbance from the construction of garrison (or other) buildings.

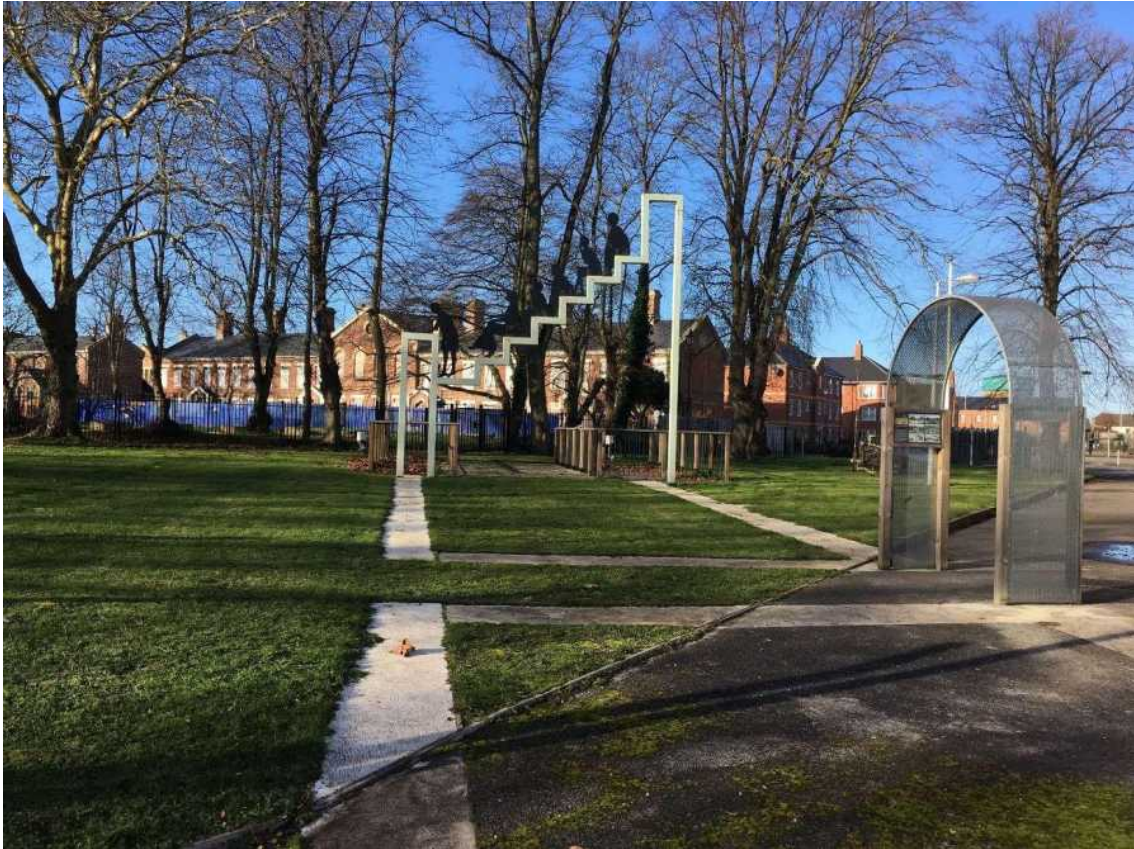
Photograph 4: View (looking west) along the line of the northern cavea (marked in concrete) in EX787918 (Taylor Wimpey), in front of Roman Circus Horse, January 2019. The Former Officers' Quarters (NHLE no. 1375581) is behind the trees.

- 10.2.4 The line of the northern *cavea* walls are marked with concrete, painted white, at ground level in the garden front garden of the Roman Circus Centre (which actually lies within parcel EX787918) (Photograph 4). In 2013, CAT undertook an excavation on the line of *cavea* in front of Roman Circus House, to expose a section of the robbed-out foundations for permanent display, below glass, with a short section of timber walkway in between; the walkway was completed in 2015 and a steel sculpture was erected to indicate the scale of the *cavea* (Photographs 4 and 5).

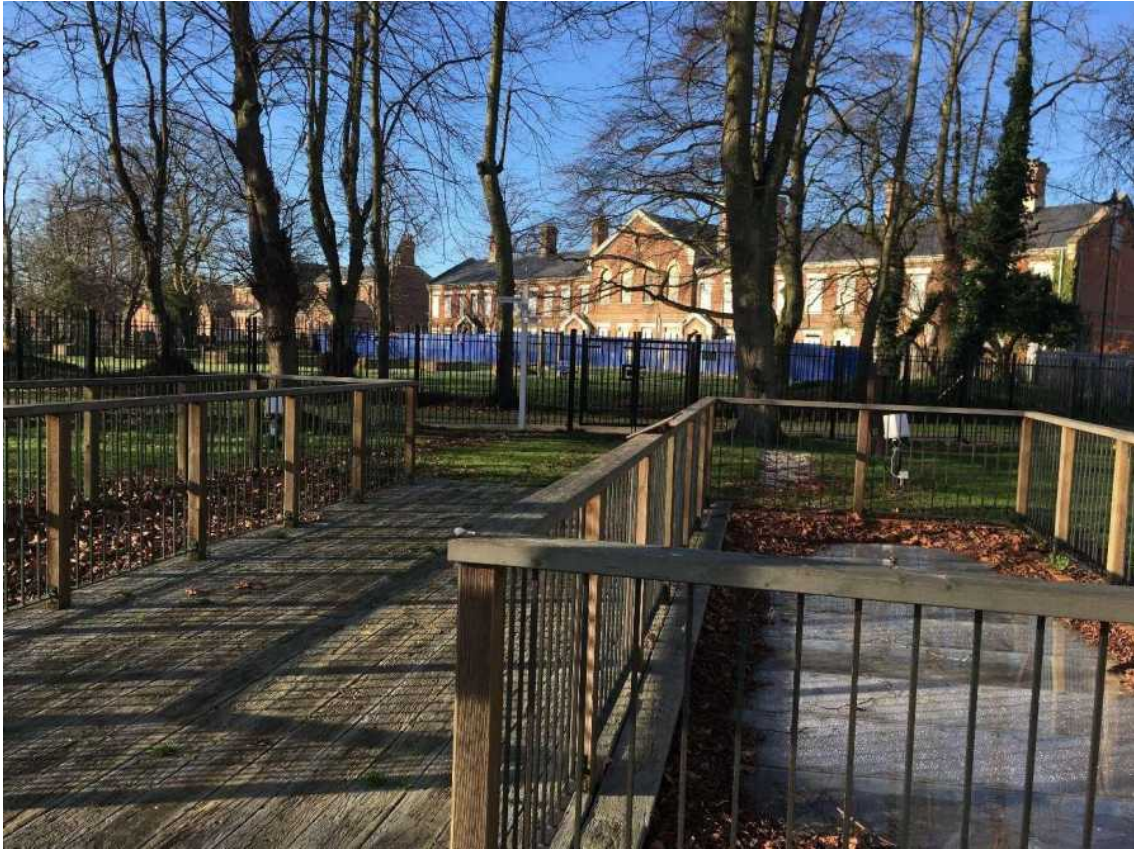
Photograph 5: View (looking west) along the line of the northern cavea in EX787918 (Taylor Wimpey), in front of Roman Circus Horse, January 2019. The foundations of the cavea have been exposed, on public display, below glass (and enclosed by the railings).

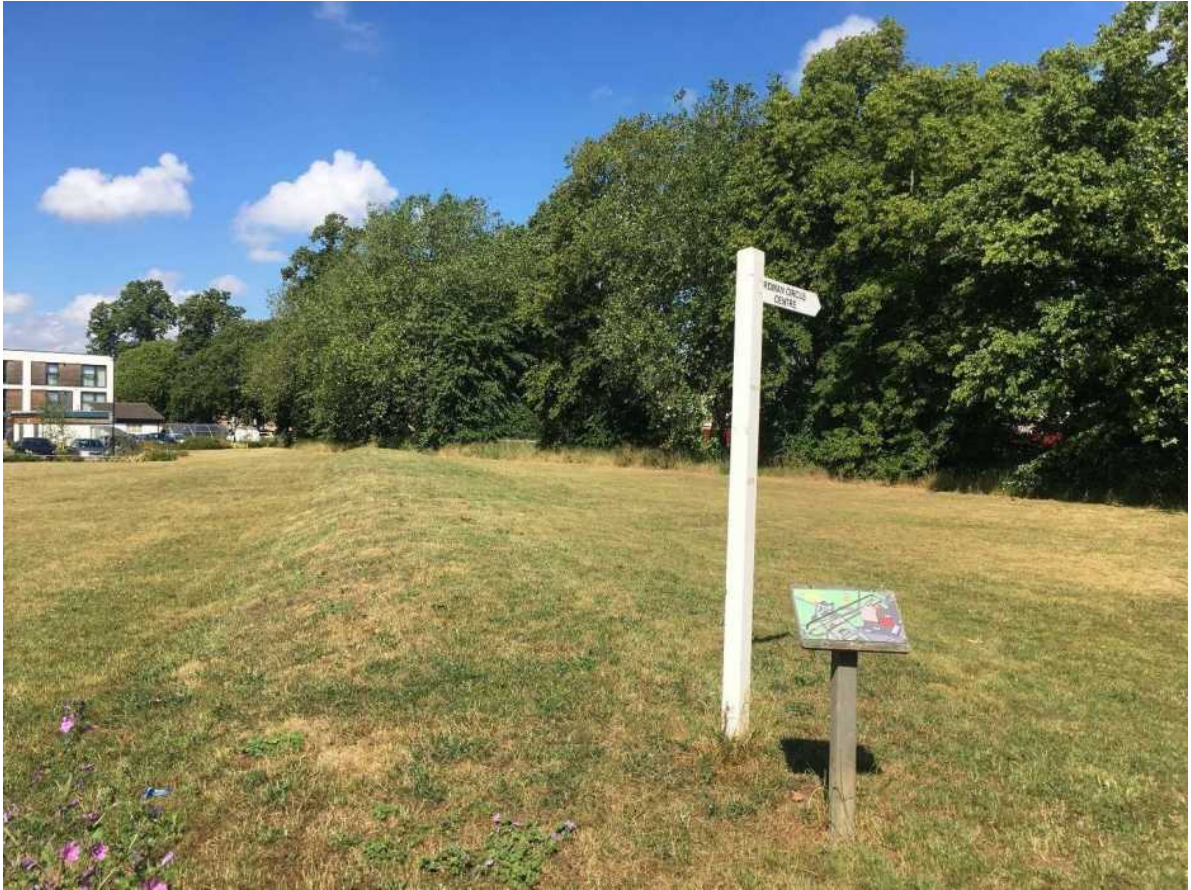
Photograph 6: View (looking west) along the line of the southern cavea, presented as a low grass bank, in EX788209 (Bovis Homes Ltd), June 2020. Whitworth House is located to the left (south).

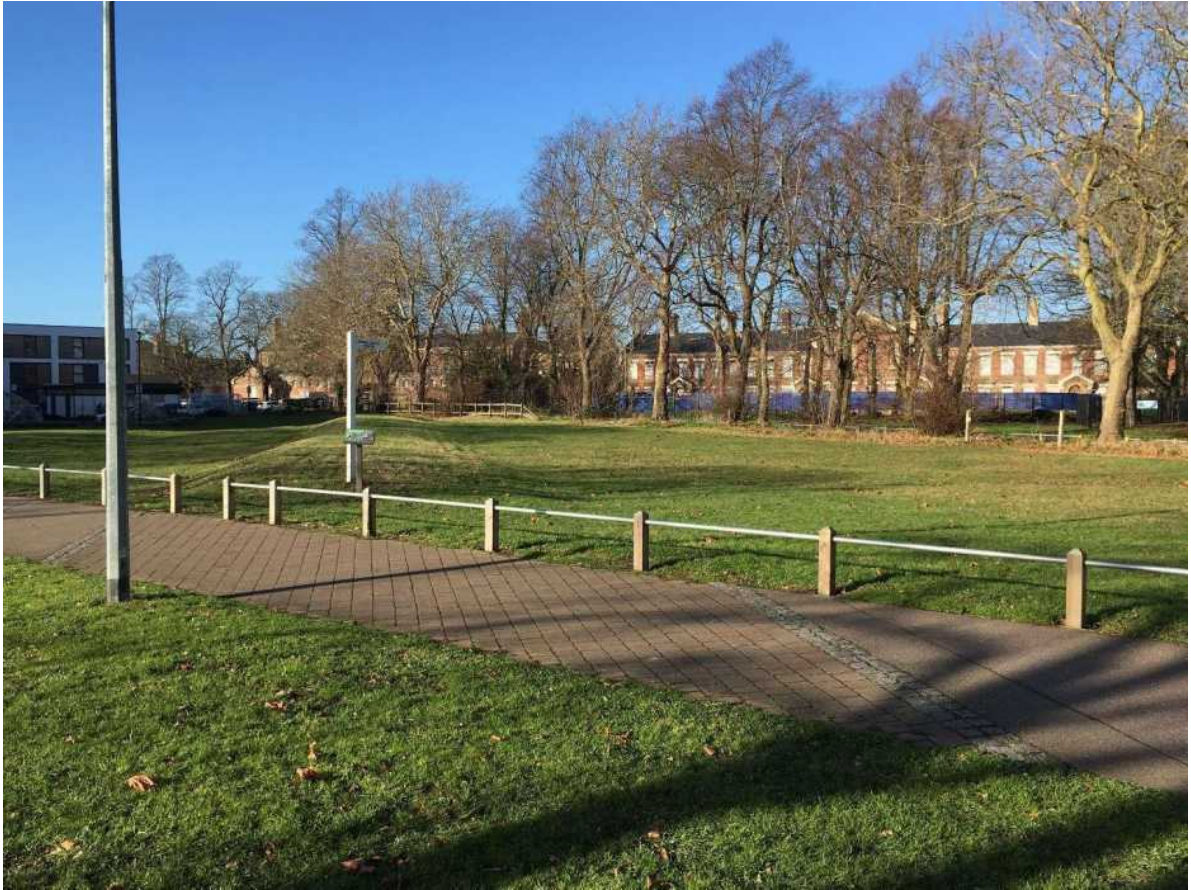
Photograph 7: View (looking west) along the line of the cavea, marked as a low grass bank, in EX788209 (Bovis Homes Ltd), January 2019. The line of the cavea is presented with coloured sets where it crosses the footpath on the west side of Circular Road North. Whitworth House is located to the left (south) and the Former Officers' Quarters (NHLE no. 1375581), beyond the west end of the Circus, is visible through the trees.

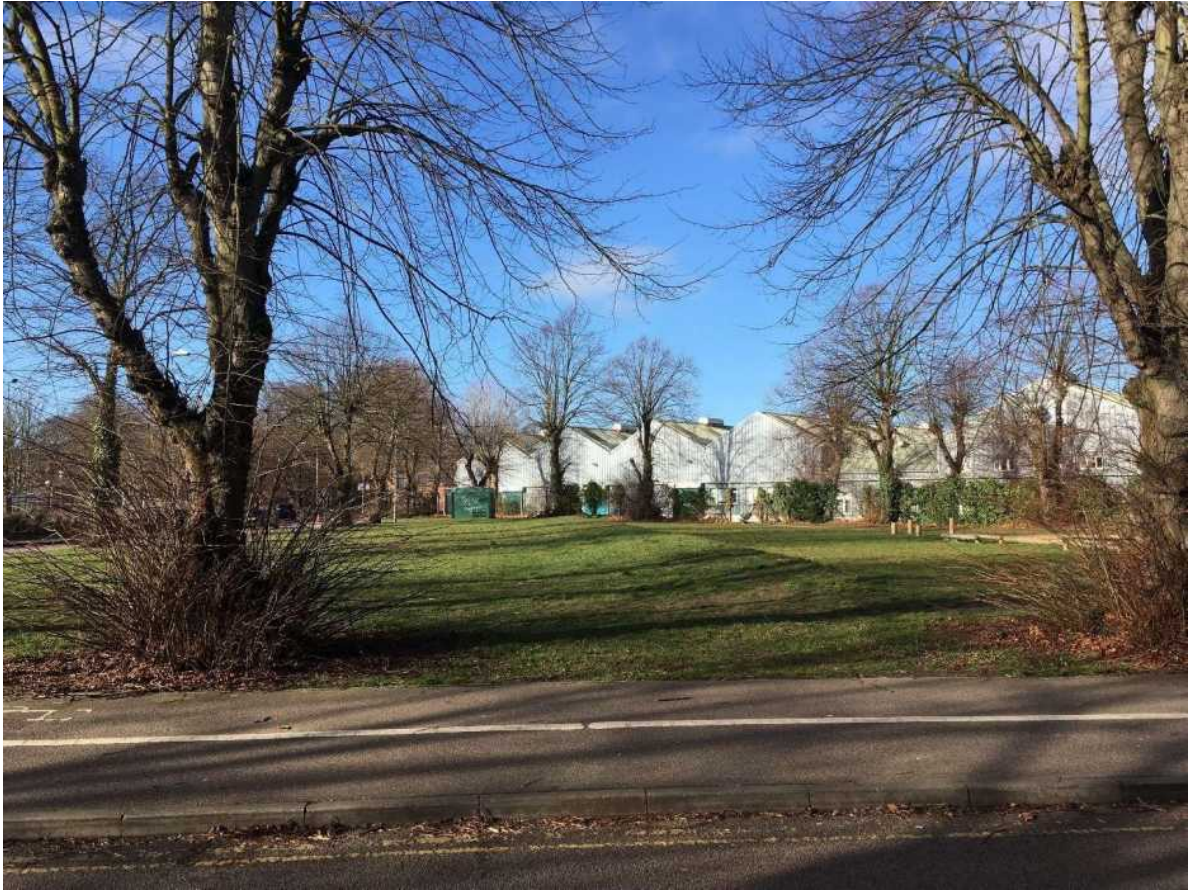
Photograph 8: View (looking west) from Flagstaff Road across the line of the northern cavea, presented as a low grass bank, in EX758172 (Taylor Wimpey), January 2019. The large warehouse-type building is within the ABRO site (EX641744).

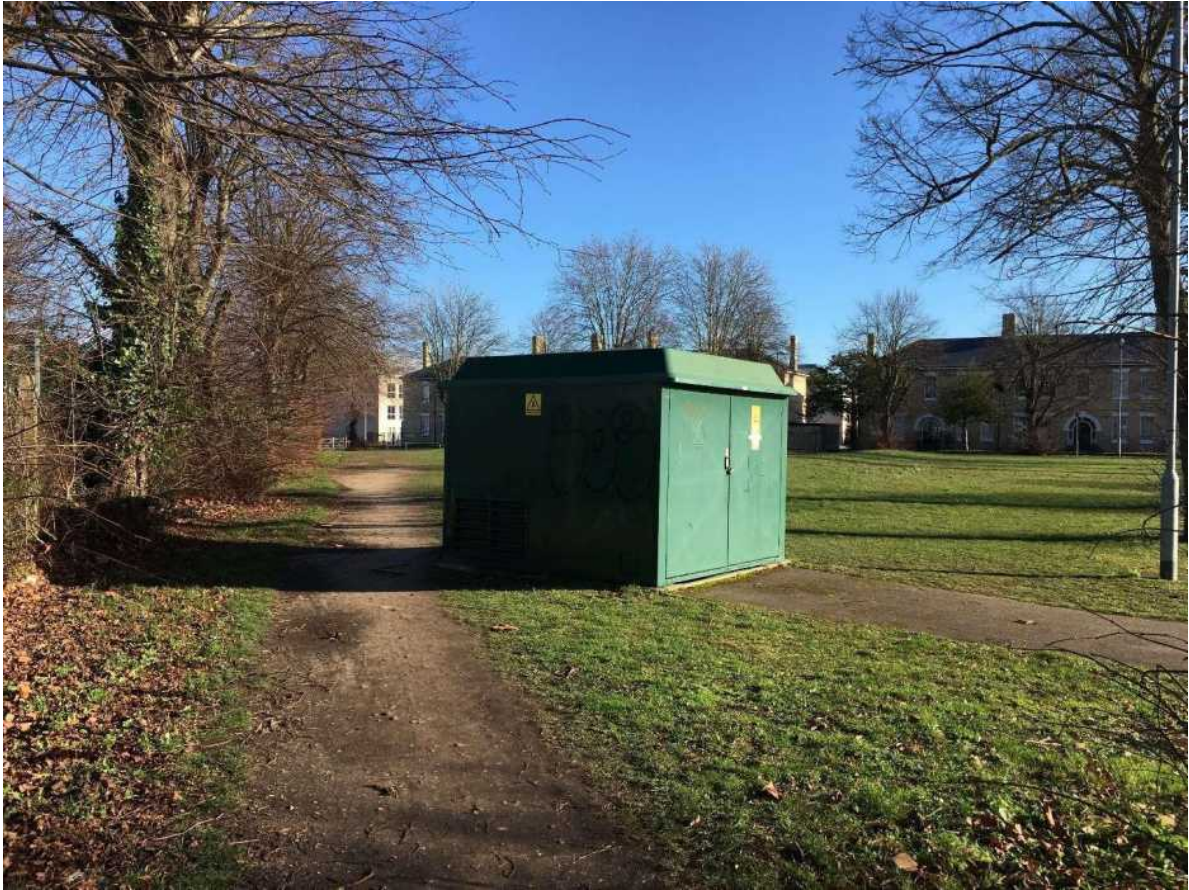
Photograph 9: View (looking north-west) across the line of the northern cavea in EX758172 (Taylor Wimpey), January 2019. The electricity substation in the foreground lies within the area of the Circus. The eroded path cuts along the side of the ABRO site (EX641744), between Le Cateau and Flagstaff Roads. Arena Place is visible in the background.

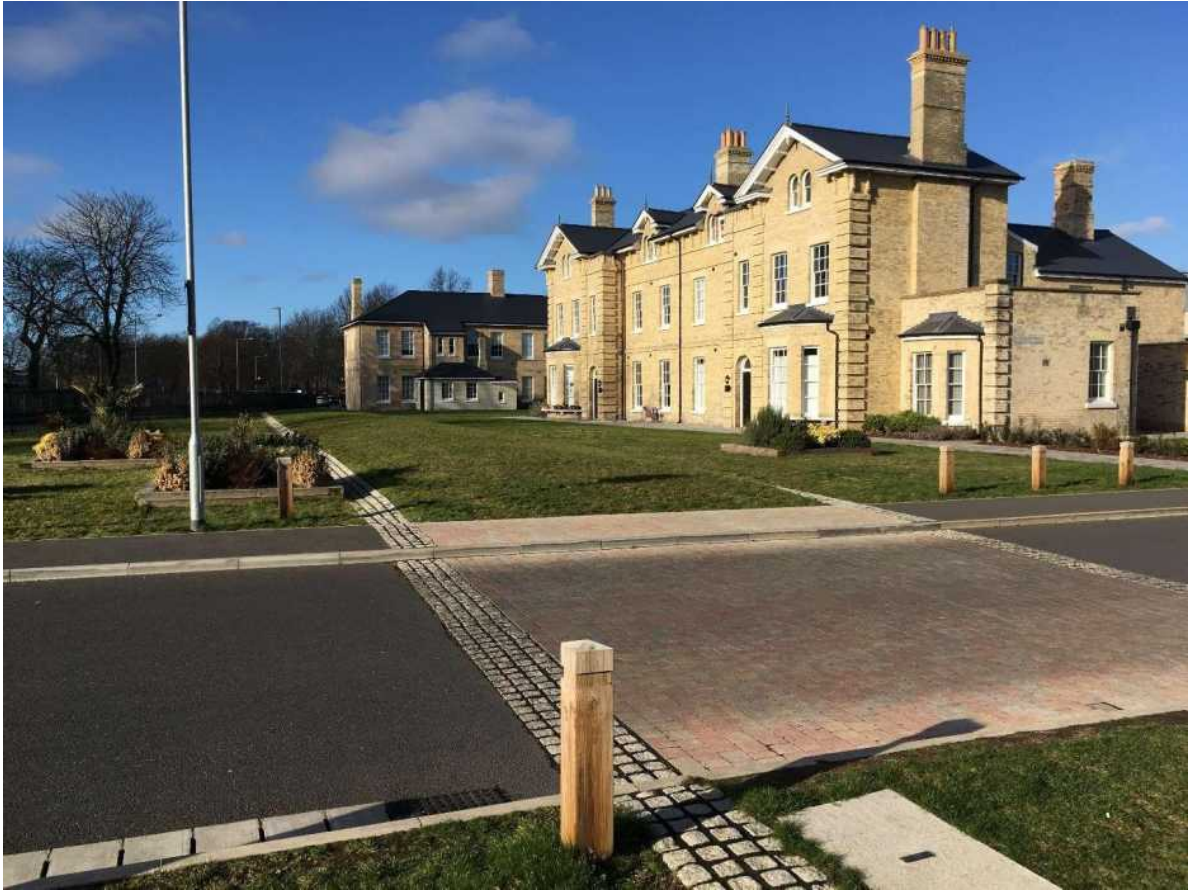
Photograph 10: View looking west from Emperor Road towards Domitian Court, the Former Commanding Officers' Accommodation FLG 5/6, EX832089 (Taylor Wimpey), June 2020. The line of spina is presented as a low grass bank edged with sets and with coloured sets where the road crosses it.

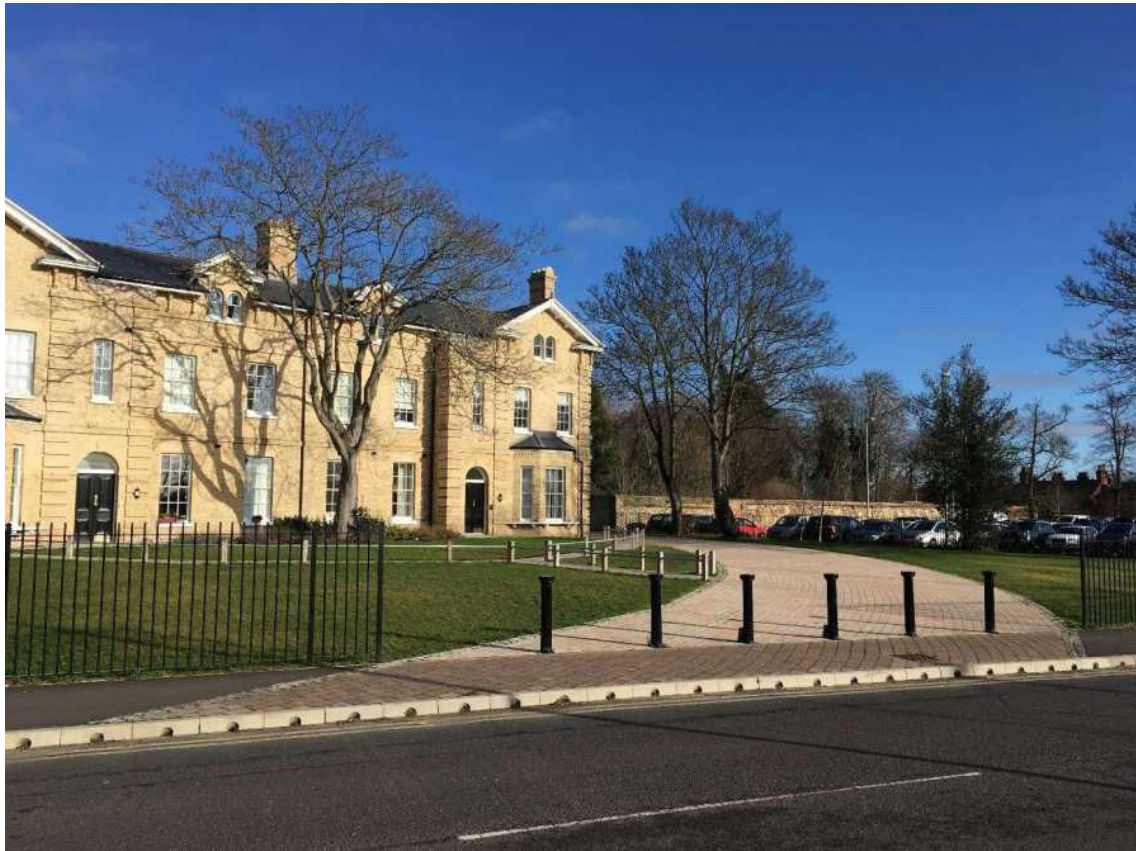
Photograph 11: View looking north-east along the line of the curving east end of the cavea, presented with coloured sets as a walkway, EX832089 (Taylor Wimpey), January 2019. The eastern extension to the Former Commanding Officers' Accommodation FLG 7/8, now Nero Court, was removed during the re-development of the Flagstaff complex (now Arena Place).

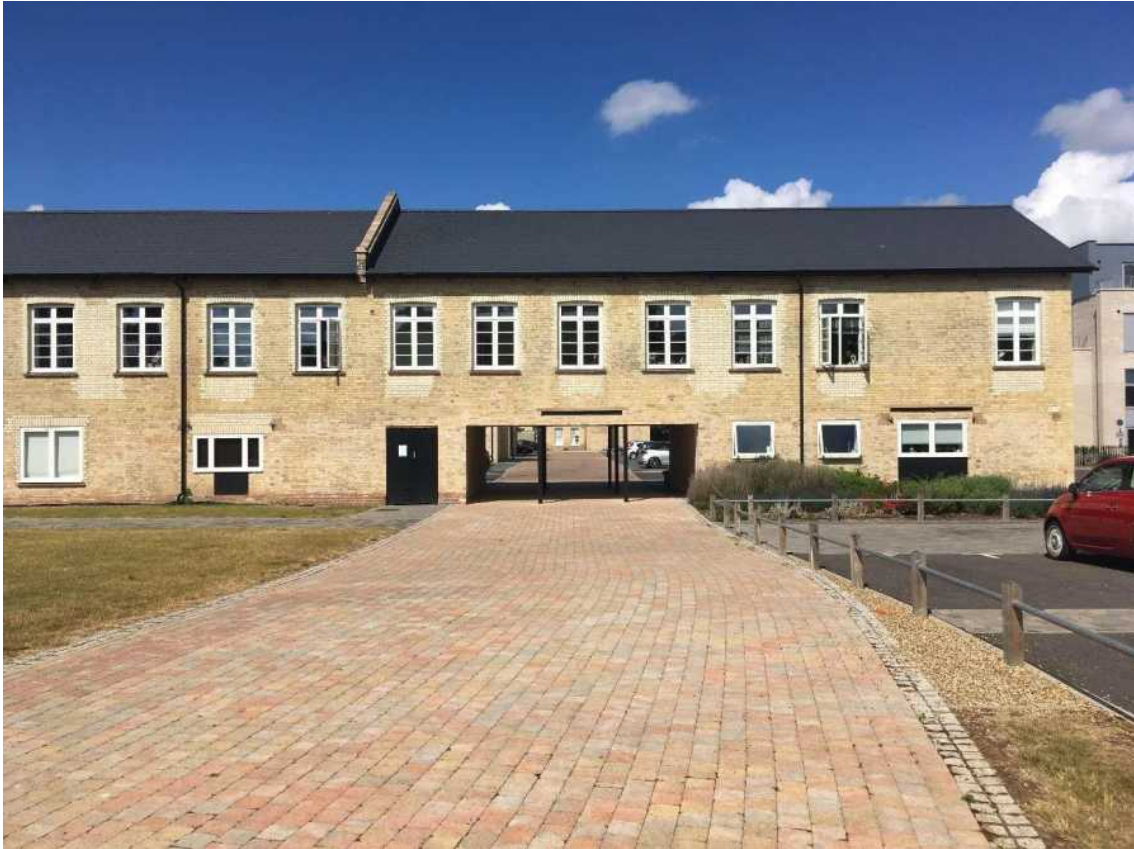
Photograph 12: View looking west along the line of the northern cavea, marked out with coloured sets as a walkway, EX832089 (Taylor Wimpey), June 2020. That part of the locally listed Former Wagon shed K Block built across the cavea was removed during the residential conversion.
