Report of	Head of Sustainability	Author	Fiona Shipp ☎ 589250
Title	Middle Mill Weir Collapse - Briefing		
Wards affected	Castle

- 1.1 This briefing sets out the position at Middle Mill following the recent collapse of the weir in December 2023.
- 1.2 Middle Mill Weir is a structure that is owned by Colchester City Council (CCC), located on the River Colne next to Castle Park and consists of three flow channels. The northern and southern channels have flow control sluice gates, and the central channel is uncontrolled over the weir. The northern and middle flows, pass under a footbridge and the southern end passes under two brick arch culverts with a replica water mill wheel between the culvert sections.

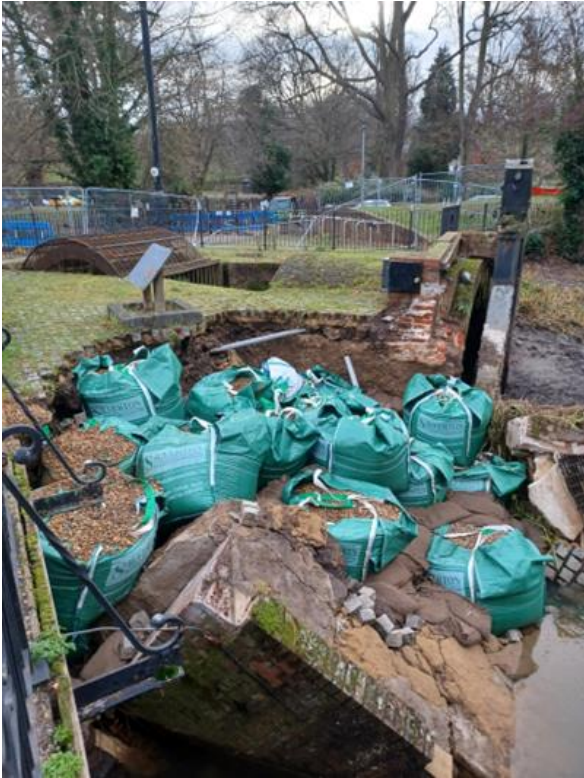
Weir Showing ballast bag protection installed 20th Dec 2023

20th December 2023 – 30 x Tonne bags of ballast installed in river around part of the collapsed structure to try and prevent further erosion of the remains of the structure. See Appendix A.

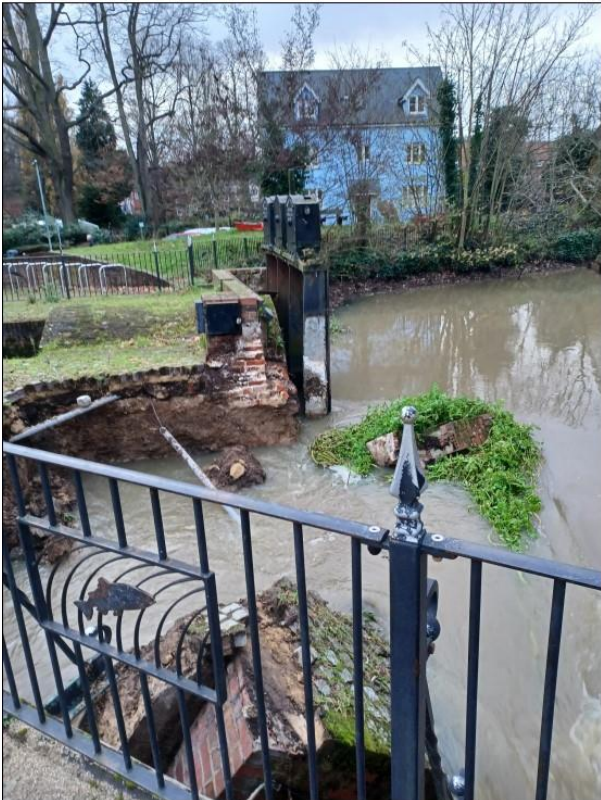
Week beginning 4th December 2023 – Park Ranger noted on inspection that part of the weir had been undermined by water erosion causing a significant sudden drop in water levels in the river. The Environment Agency were informed. Cracks noted in brickwork.

10th December 2023 – Park Ranger reported collapse of part of the weir structure. Bridge was then closed, initially by CCC staff as a temporary measure, then Essex County Council did this more formally later the same day. See appendix A.

Weir showing initial collapse in December 2023
