**Colchester Conservation Area 4:
North Station Road and Environs
Character Appraisal and Management Proposals**

February 2024

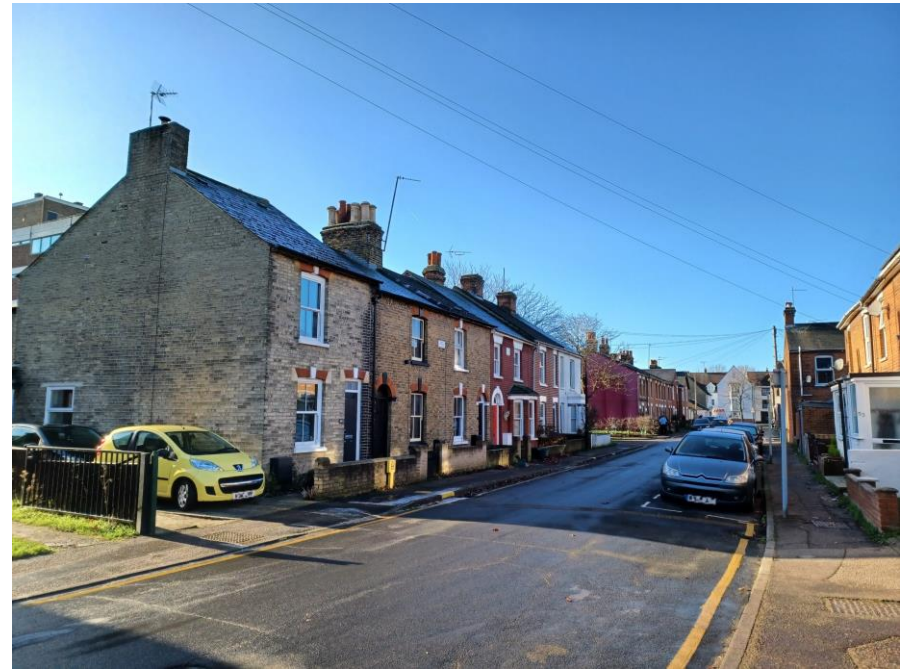
Fig. 13: View of Causton Road (south front) , with the terrace of nos. 12 to 18 in the foreground

The present report proposes the amendment of the boundary on Causton Road, to include the terrace of nos. 12 to 18 Causton Road. By virtue of its date, style and quality, these properties form a group with the buildings on Causton Road within the existing boundary despite the disruption from the access to the site of the Riverside Office Complex that interrupts the continuity of the street frontage (Fig.13).

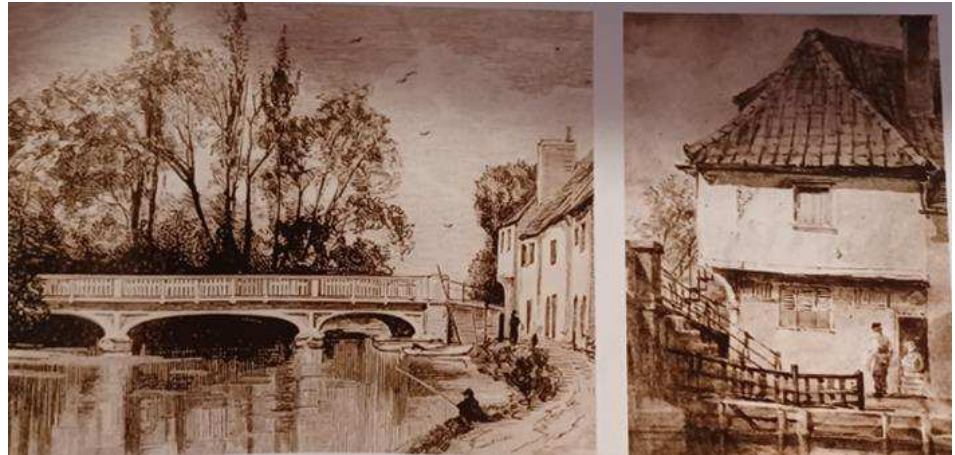
Figure 38: a (L). View of North Bridge and the Riverside Cottages in 1880 , prior to demolition of the westernmost cottage. b (R). The cottage that was demolished for the widening of the Bridge.

he 17th century Riverside Cottages on the north bank were truncated when North bridge was widened (see Fig.38), and two dwellings replaced a modest house to their east (Fig.41 and 42). The two office blocks further east, three storey Digby House and six-storey Fairfax House are part of the Riverside Office Complex that was erected in the later 1960's.

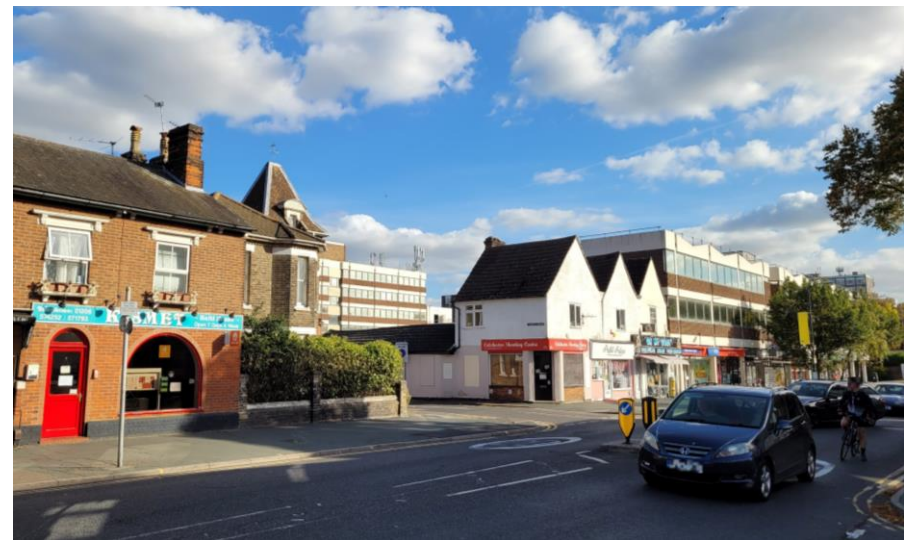
Fig. 58: View of 25-27 North Station Road from the north-west.

The Grade II listed timber framed 25-27 North Station Road comprises the former jettied cross wing of a 15th century hall house (No 27) and the gabled 17th or 18th century no 25 which replaced the former open hall. The third gable to the north is probably an 18th century addition as well. The appearance of the building is altered by the 20th century windows and shopfronts which detract from the remaining historic character of the group (Fig.59 and 60).

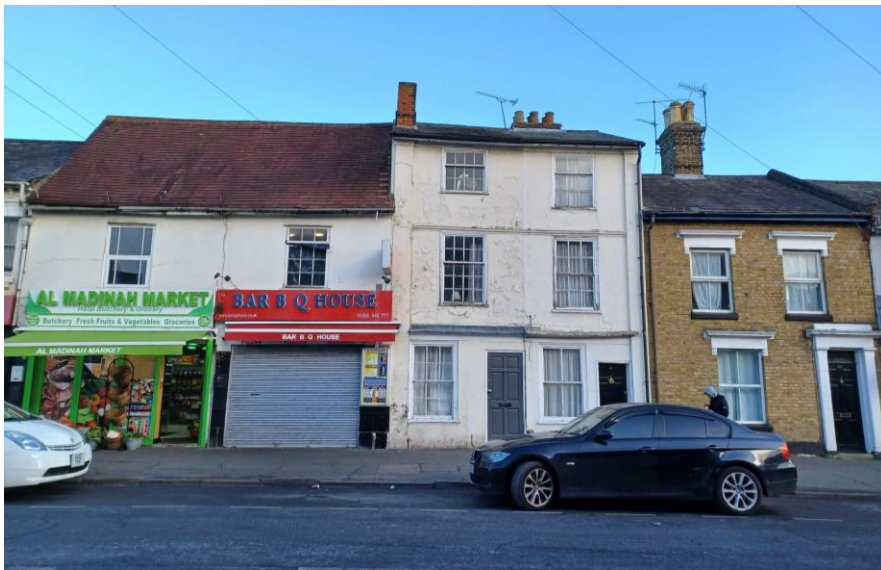
Fig. 62: 41-43 North Station Road (three storey) and the 16th century 45-47 to its left.

not been altered with shopfronts. The adjacent timber framed no 45-47 dates from the 16th century (Fig.62). The gabled elevation of the no 57 bookends the terrace before the three storey 59-61, now much altered by the unsympathetic shopfronts, thick cement render and uPVC replacement windows.

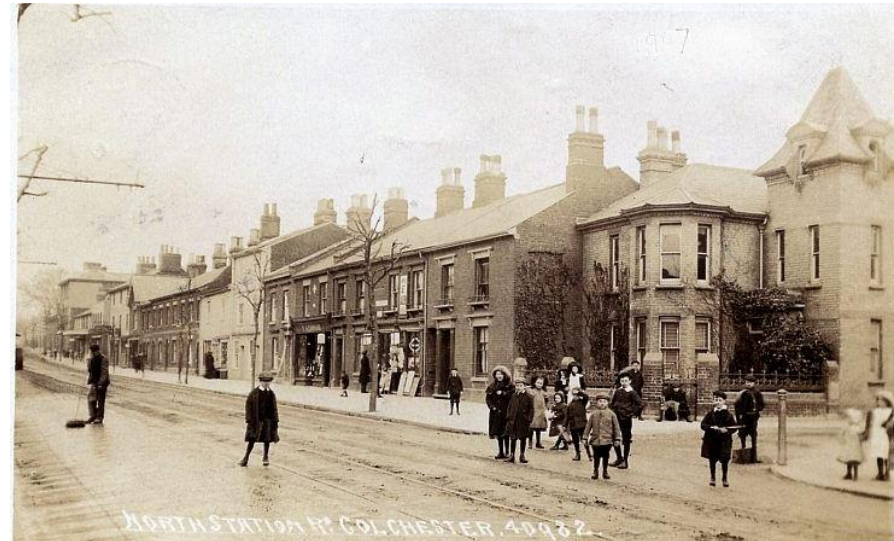
Fig. 66: North Station Road. East side from No 29 to the Globe Hotel (unknown date).

The appearance of this section (from North bridge to the roundabout) is compromised by the modern development at each end. However, the character of the surviving section between 29 North Station Road and Globe Hotel has eroded by unsympathetic alterations, including the introduction of modern shopfronts and unsympathetic signage, painting of brickwork, the loss of original architectural details and the replacement of the timber fenestration by uPVC windows. The loss of the chimneys is also a notable change that detracts from the street scape (Fig. 66 and 67).
