**Appendix B. – Condition Survey 57 Rosabelle Avenue (garage)**

**Address: 57 Rosabelle Avenue (Garage site)**

**Report type: Dilapidation survey**

**Report date: 23/11/2022**

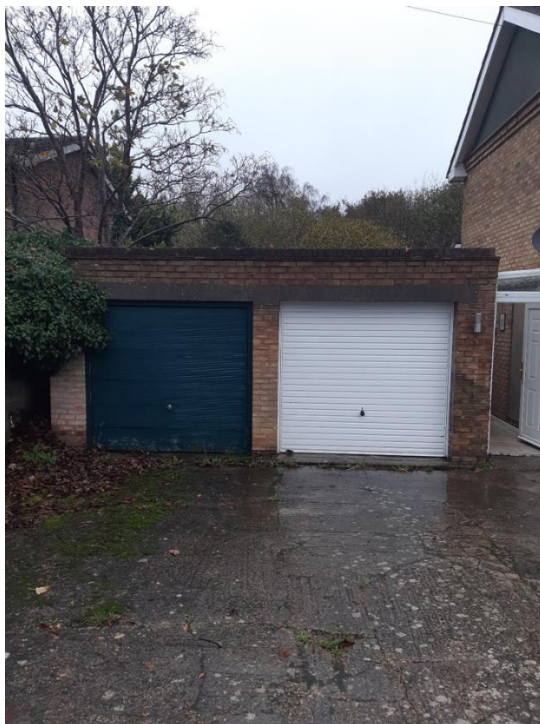
**Front elevation**

The garage brickwork is in poor condition, I suspect this is because of the large tree growing next to the garage. I think it has undermined the concrete footings and subsequently the brickwork is cracking and buckling (as can be seen in photos). The damage is only on this garage next to the tree, the garage next door is structurally sound but does have a roof leak. Also the metal garage door is in poor condition (but still secure), the guttering and fascia is in poor condition.

The left hand side and back of the garage appears to have been damaged by the tree growing next to this area. I would recommend that the tree is removed, left hand side and a section of the back brickwork taken down and new footing installed. have the brickwork rebuilt, also a new roof, fascia, gutter and door installed.

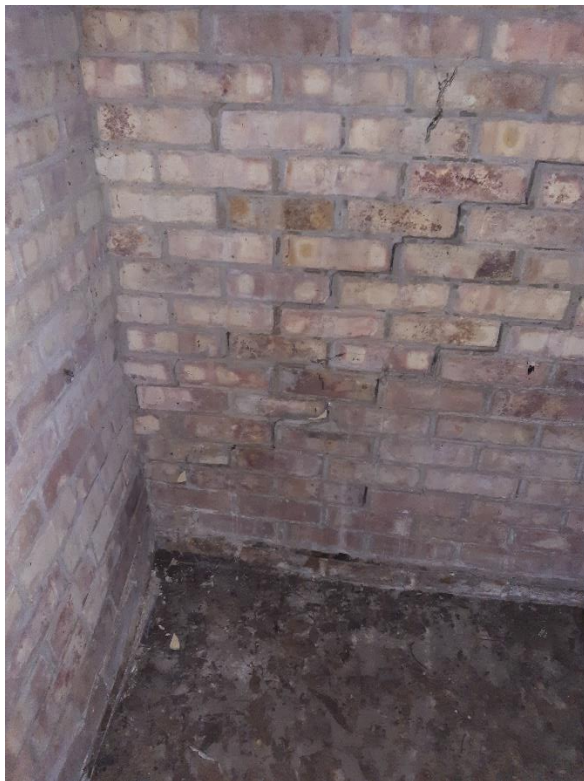
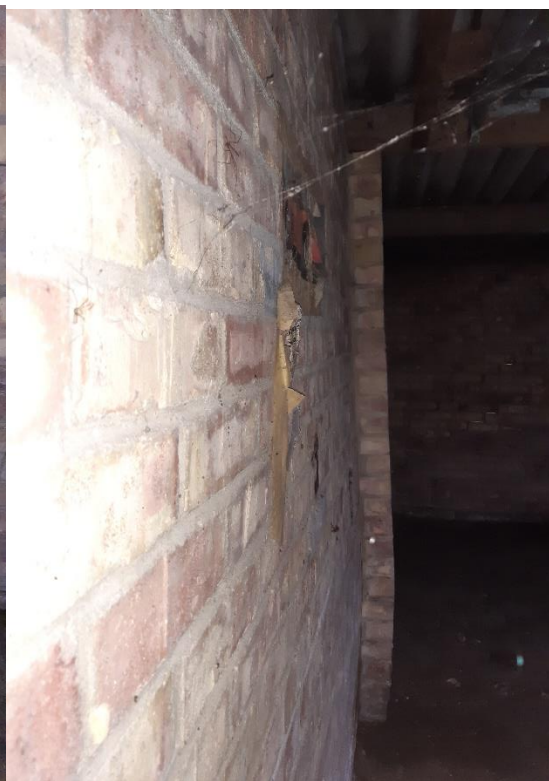
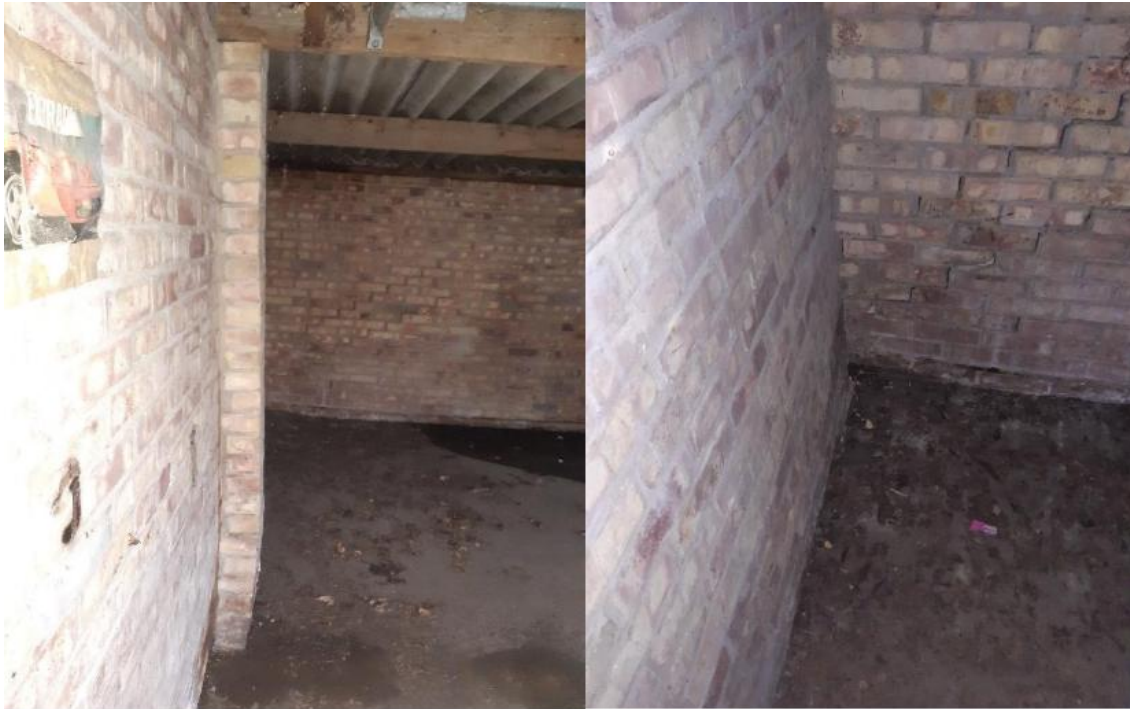
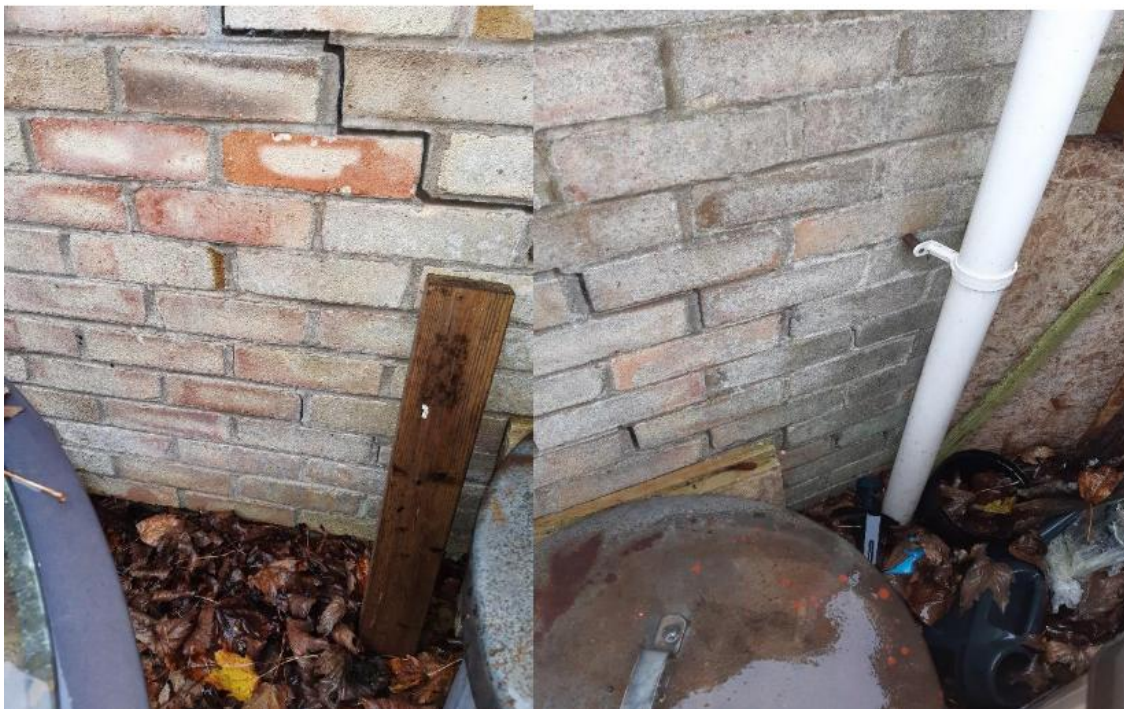
**Defects**

Having completed a survey with access inside and front/back of the garage, I have noted that this garage is in poor condition with defects as set out below.
