Proposed Works at Gatehouse Farm Tiptree  
Assessment of Significance.

Title: 30,01,2018.  
Project: Gatehouse Farm  
DWG No: 1458-Report 01.

Gatehouse of Cherry Chase Tiptree.  
Former farm house for Gatehouse farm.  
Has been lived in by directors & managers of the  
Wilkin & Sons company for 100 years, as part of  
the fruit growing and Jam making business.

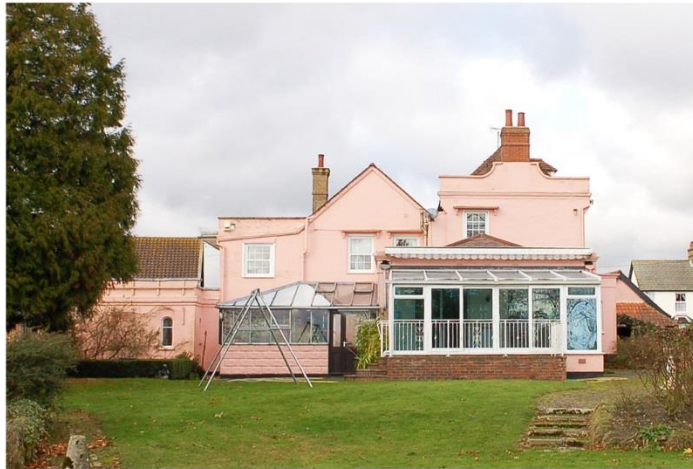
SOUTH EAST ELEVATION

Assessment of Age. East Elevation. Garden elevation masked by poor quality conservatories and extensions.

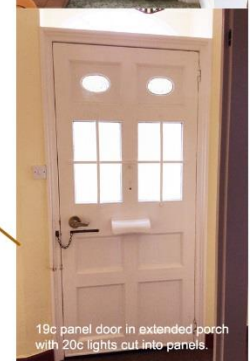
19c panel door in extended porch with 20c lights cut into panels.

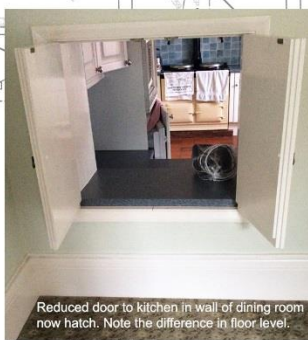
Reduced door to kitchen in wall of dining room now hatch. Note the difference in floor level.

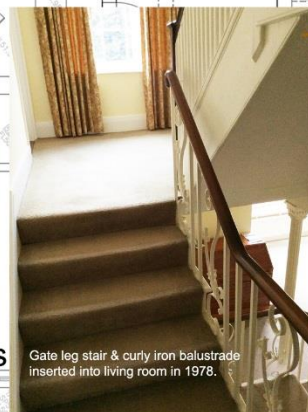
Gate leg stair & curly iron balustrade inserted into living room in 1978.

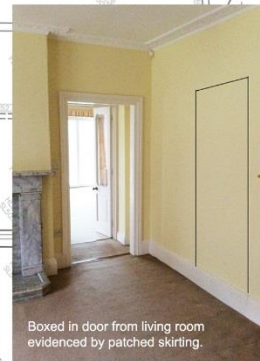
Boxed in door from living room evidenced by patched skirting.

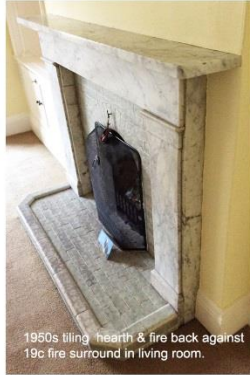
1950s tiling hearth & fire back against 19c fire surround in living room.

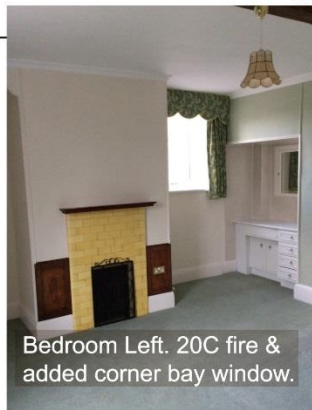
Bedroom Left. 20C fire & added corner bay window.

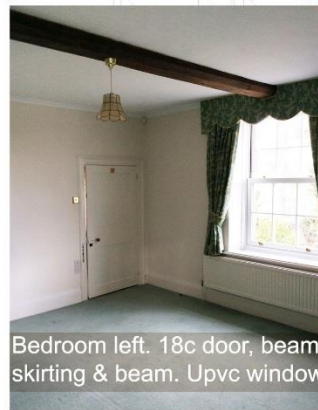
Bedroom left. 18c door, beam skirting & beam. Upvc window

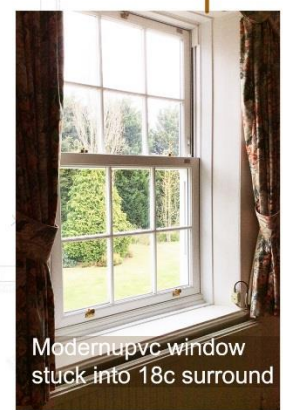
Modern upvc window stuck into 18c surround

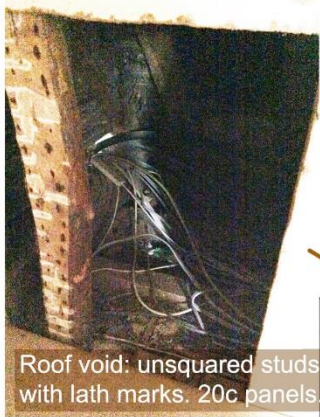
Roof void: unsquared studs with lath marks. 20c panels.

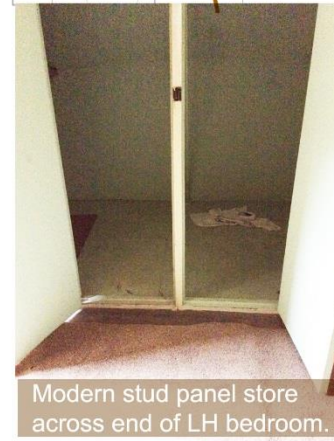
Modern stud panel store across end of LH bedroom.

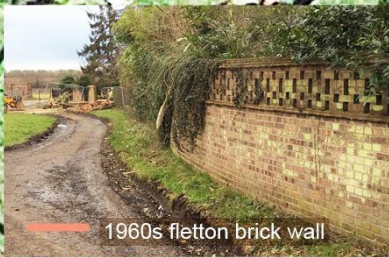
1960s fletton brick wall

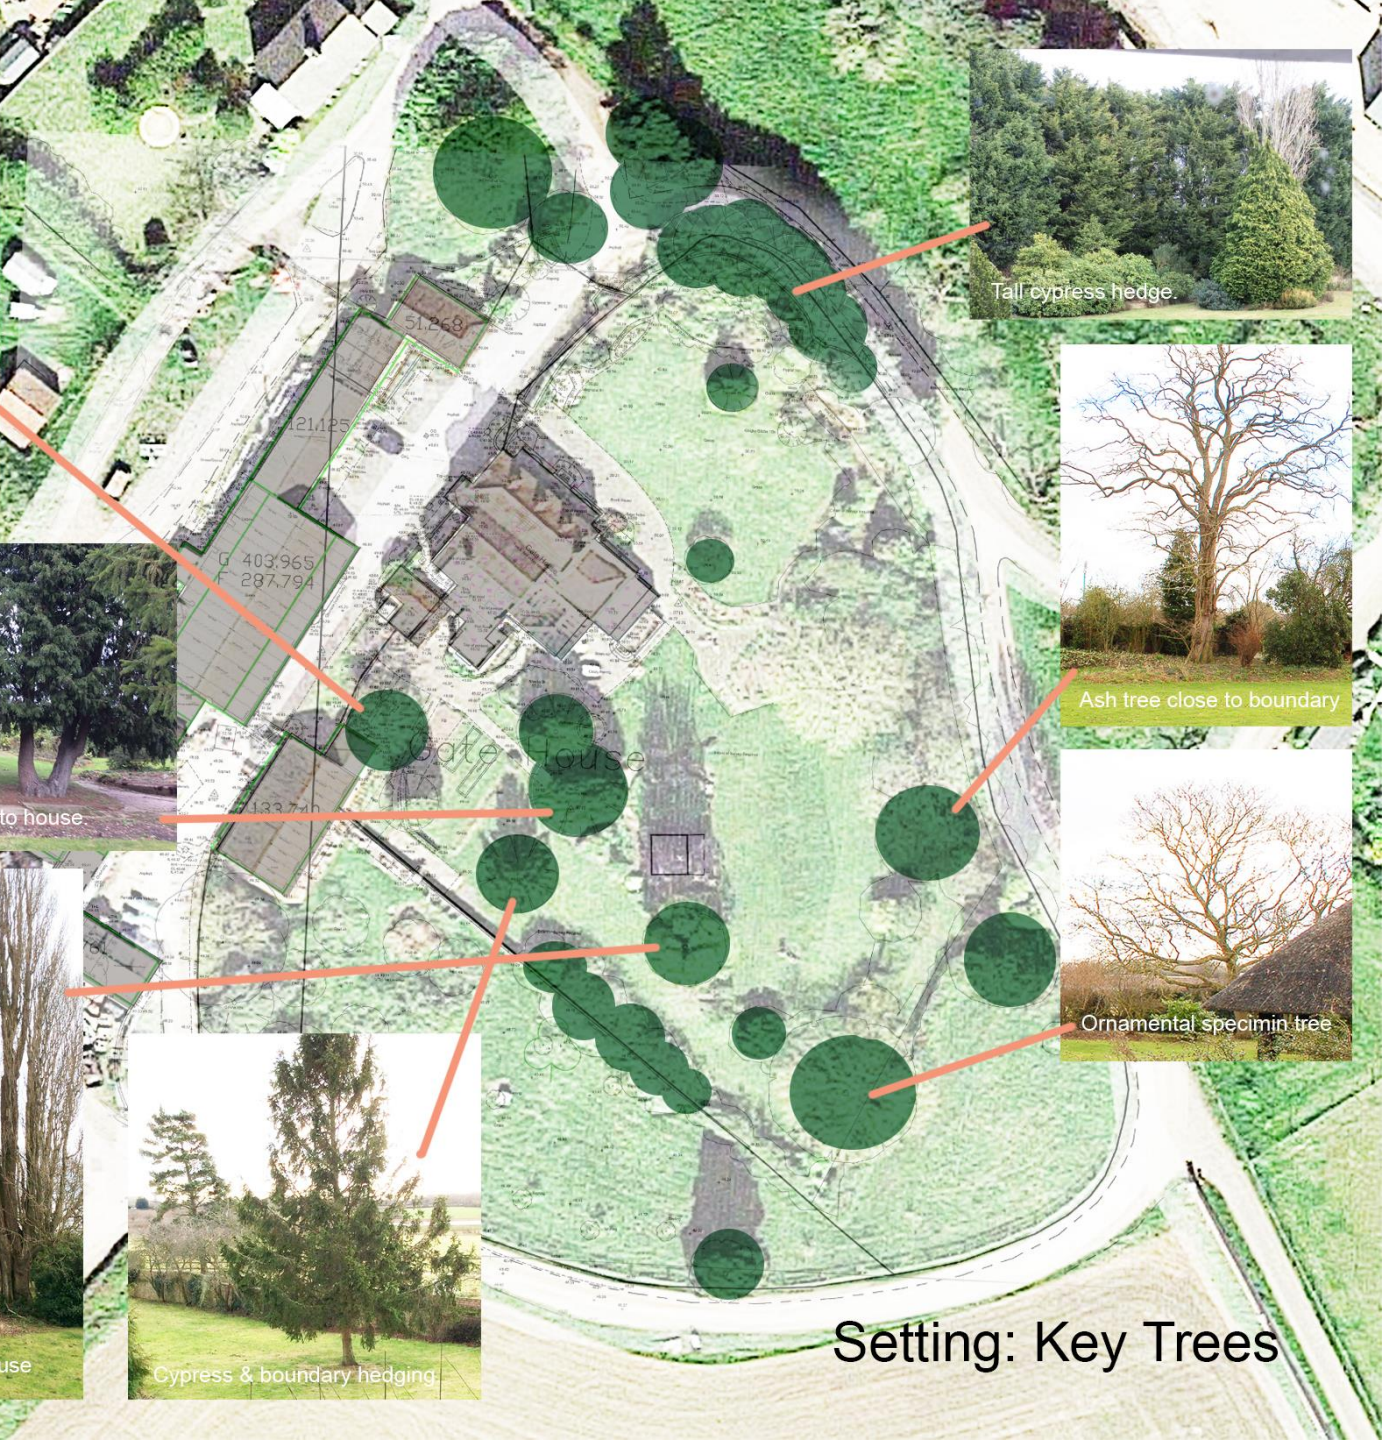
Ornamental specimen tree

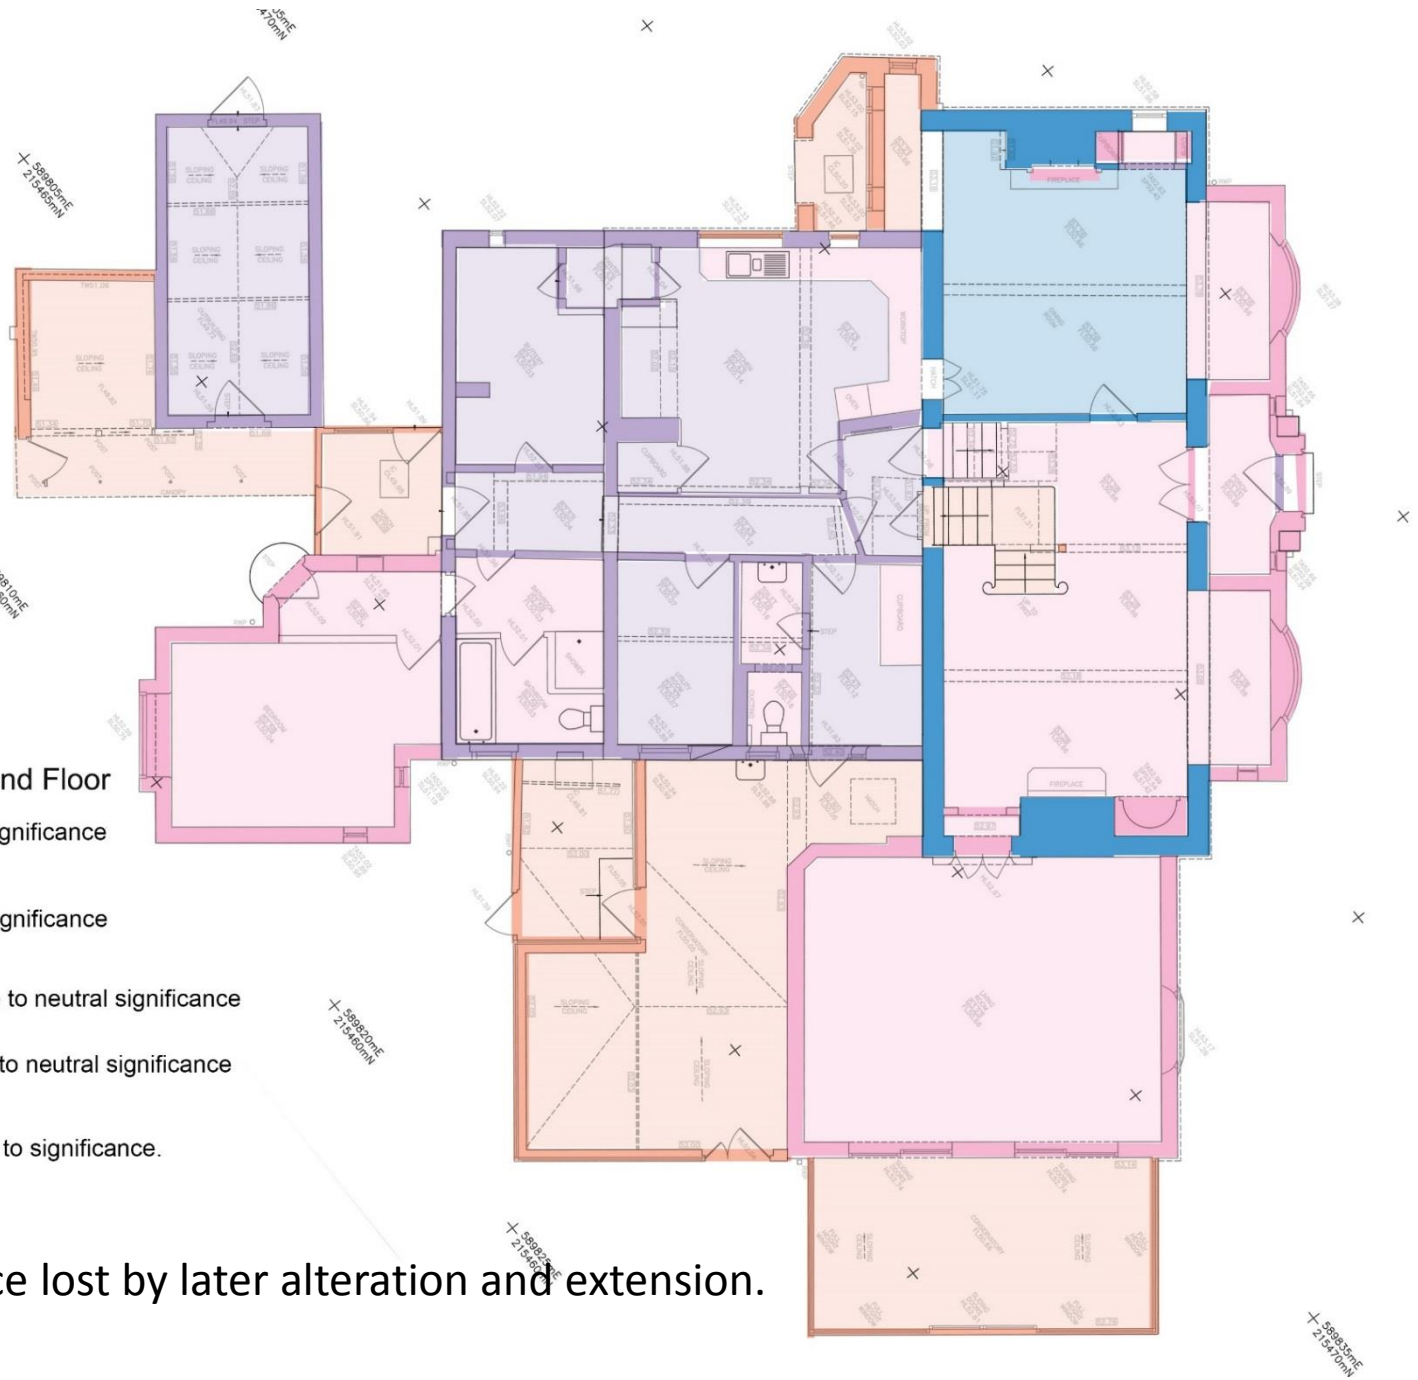
# Gatehouse Ground Floor Assessment of Significance

Much significance lost by later alteration and extension.

- Much of the 20 century alterations and extensions obscure and detract from the original building and reduce its significance.
- Alterations to the ground floor stair, replacement upvc windows & pink render over the original bricks, all damage the fabric and reduce the heritage significance.
